PIP5686A Engine Air Leak from The Foul PCV Tube, Whistle Noise, P0171 and/or P0174

Models

Brand:	Model:	Model Years:	VIN:		Engine:	Transmissions:
			from	to		
Chevrolet	Silverado 1500 (New Model)	2019 - 2020	All	All	5.3L L84	All
GMC	Sierra 1500 (New Model)	2019 - 2020	All	All	5.3L L84	All

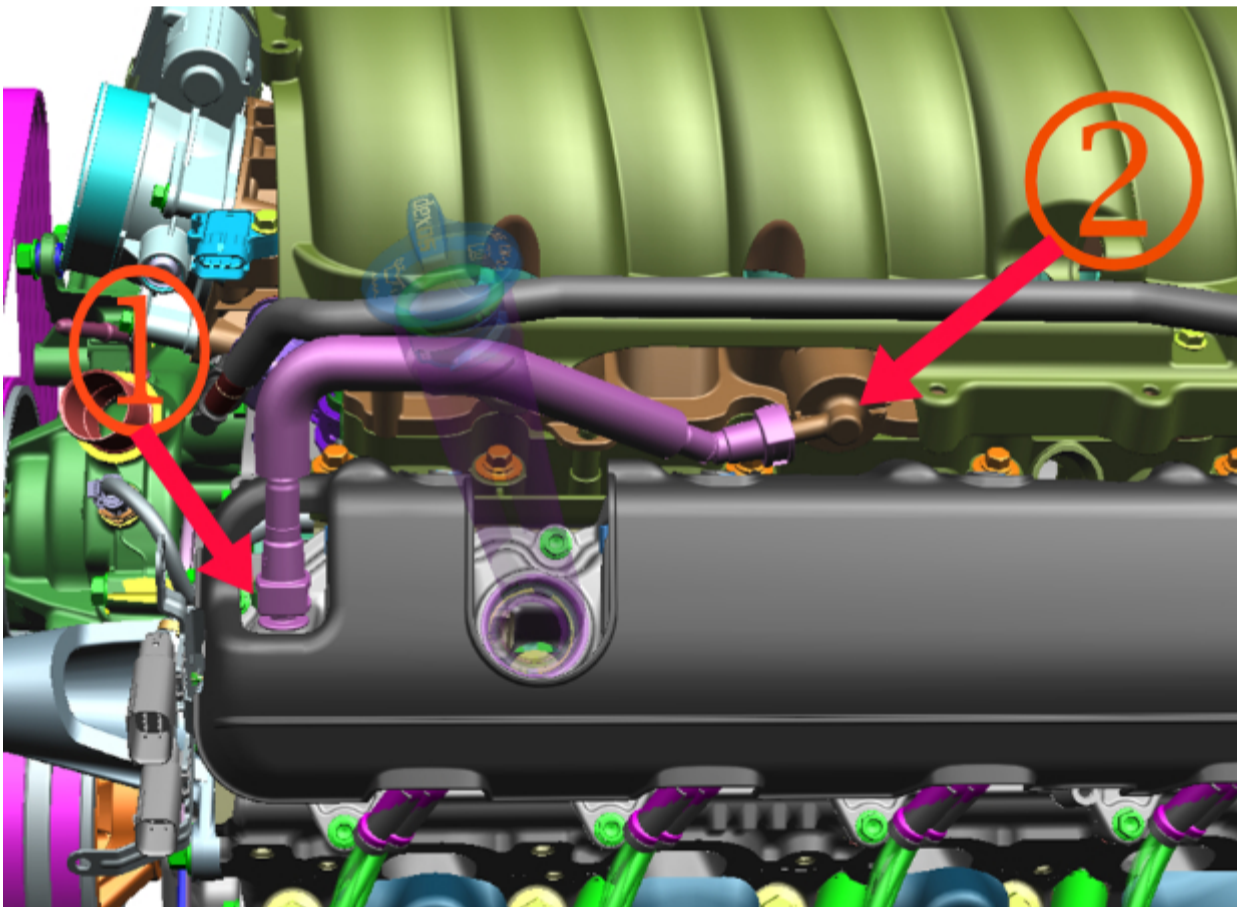
Involved Region or Country	North America
Condition	A vehicle may come into the dealer with a rough idle, lean running concern and/or air leak noise from the PCV system. Upon inspection the technician may find the SES lamp is illuminated and/or DTC 's P0171 and/or P0174 may be in active or stored history.
Cause	This condition may be caused by an incorrectly installed foul air PCV tube or tube may be damaged.

PCV Tube Locations: Location 1- Connector to Rocker Cover, Location 2- Connector to Intake Manifold

- a. **If no smoke is detected, then tug on PCV tube ends (Location 1 or 2) to ensure the tube is seated. If tube was not fully seated, then properly secure connection by pressing tube in until it clicks, and the tube does not come off by pulling on it. Proceed to step 4.**

- b. **If smoke is detected, at either at the cover or manifold (Location 1 or 2) Remove and reinstall the same PCV tube to ensure both latches click. Proceed to Step 2.**

- c. **If the tube is cracked or other damage in any other location besides (1 or 2) then it will be necessary to remove and replace with a new tube. Proceed to step 4.**

2. Repeat smoke test to verify condition is still present. If leak is still present at (Location 1 or 2) remove tube and inspect O-ring seals inside, look for damage or missing O-rings. Take images of findings. Replace with new tube if damage is found. Proceed to step 4.
3. Clear the ECU codes.
4. Start vehicle up, idle for 5 minutes in park, shut engine off, repeat (Total needs to be 2 times)
5. Verify if code/s return:
 - If Yes - if condition is still present or DTC returns, then it will be necessary to follow SI diagnostics in the service manual for that DTC or condition.
 - If No - PCV tube was not correctly seated during assembly. Return vehicle to customer and document findings on repair order.
