PIP5548A Diagnostic Aid For CVT7 Transmission Fluid Pan Magnet Inspection To Avoid Unnecessary Transmission Replacement

Brand:	Model:	Model Years:	VIN:		Engine:	Transmissions:
			from	to		
Chevrolet	Spark	2014 - 2020	All	All	LLO LV7	M4M MR8

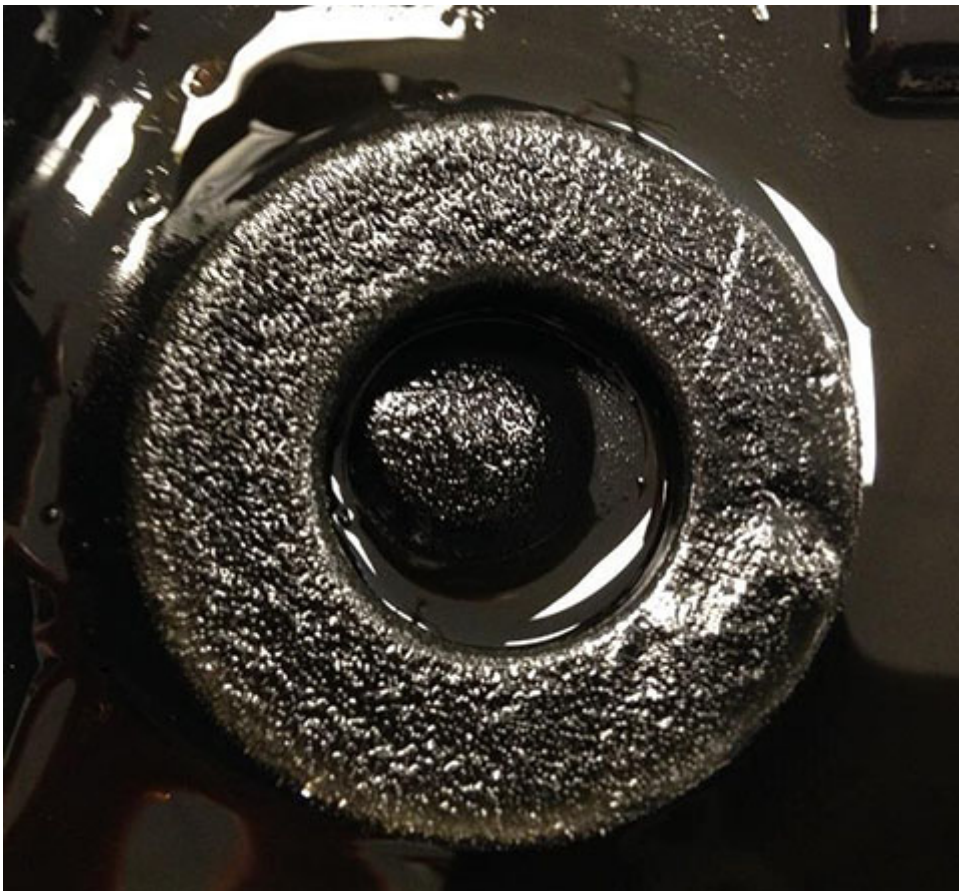
The following picture shows normal appearance of metallic dust. Please continue with diagnostics.

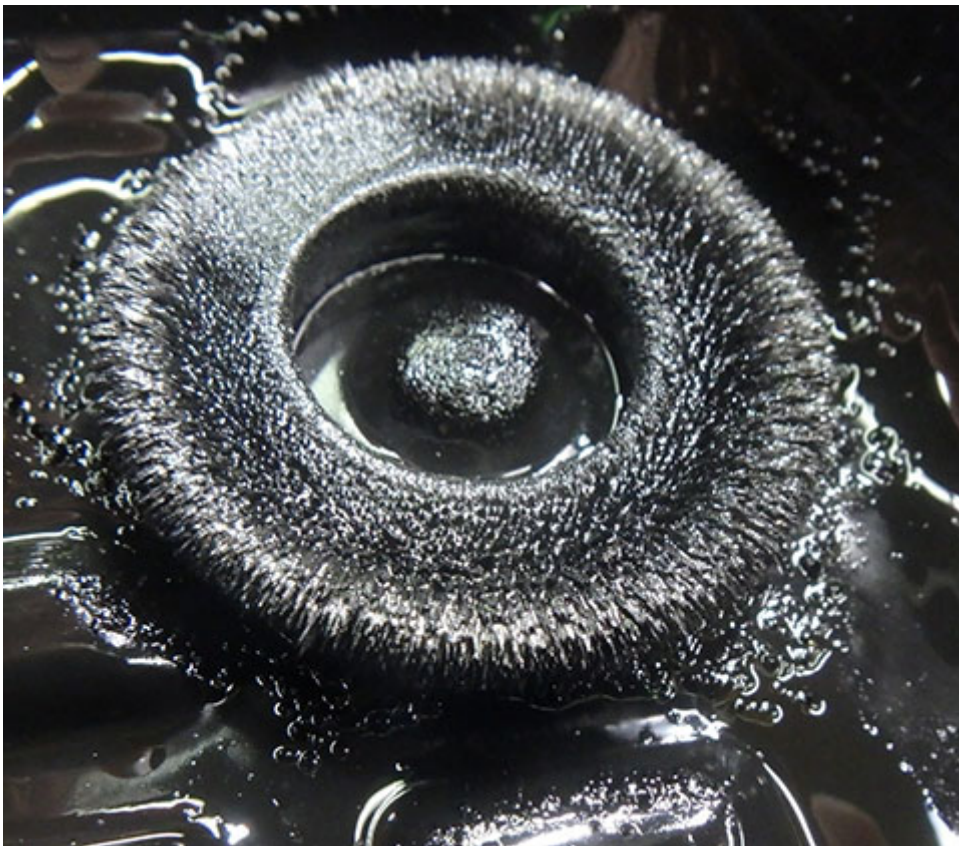
The following picture shows particle buildup that may appear as fuzz, strands or chips. Using gloves, rub a small amount of the magnetic debris between your fingers or onto a hard surface. If the debris breaks down and feels almost smooth, please continue diagnosis. If there are actual chips in the debris, the transmission should be replaced.
