## Preliminary Information

### PIP5335D SES Lamp With Camshaft Position Codes P0340 and/or P0341

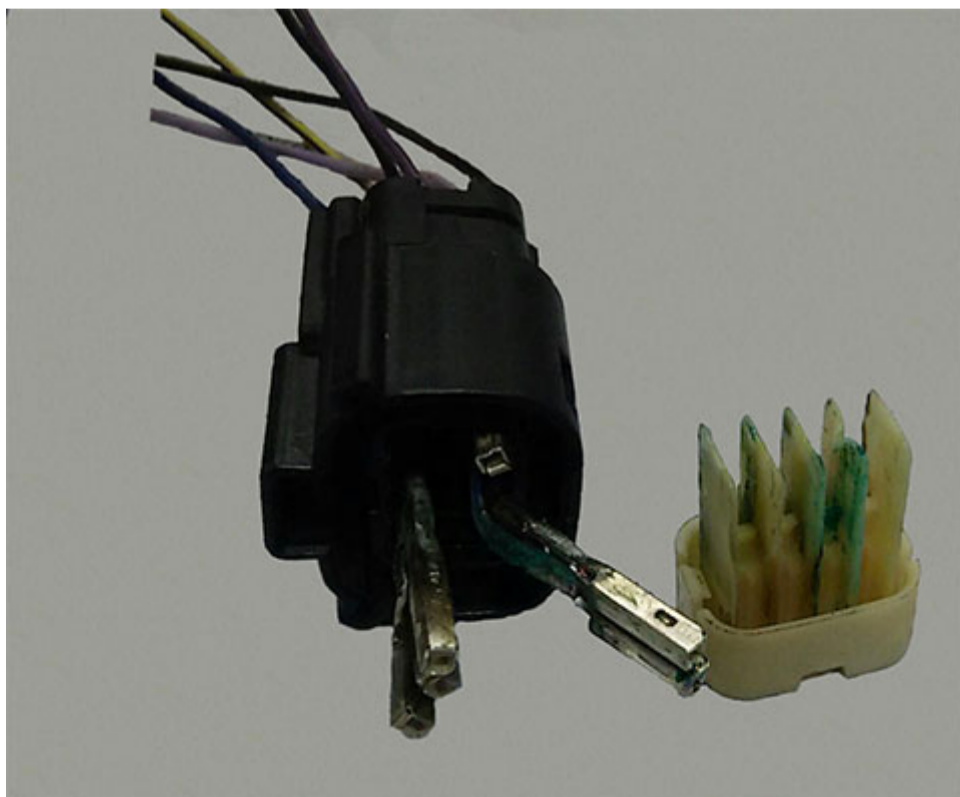
A vehicle may be setting DTC's P0340 and P0341 at times.

If normal SI Diagnostics does not isolate the concern, inspect for corrosion in connector X154 or X159 (2015 only) located on the front cover next to the vacuum pump.

If this condition is encountered repair as needed.
