# Preliminary Information

## PIT5404F Squeak Chirp Whistle Rattle Type Noise from Rear of Vehicle (Passive Exhaust Valve) or Buffeting Vibration Drone Exhaust Tone Change Body Pressure Booming (AFM Exhaust)

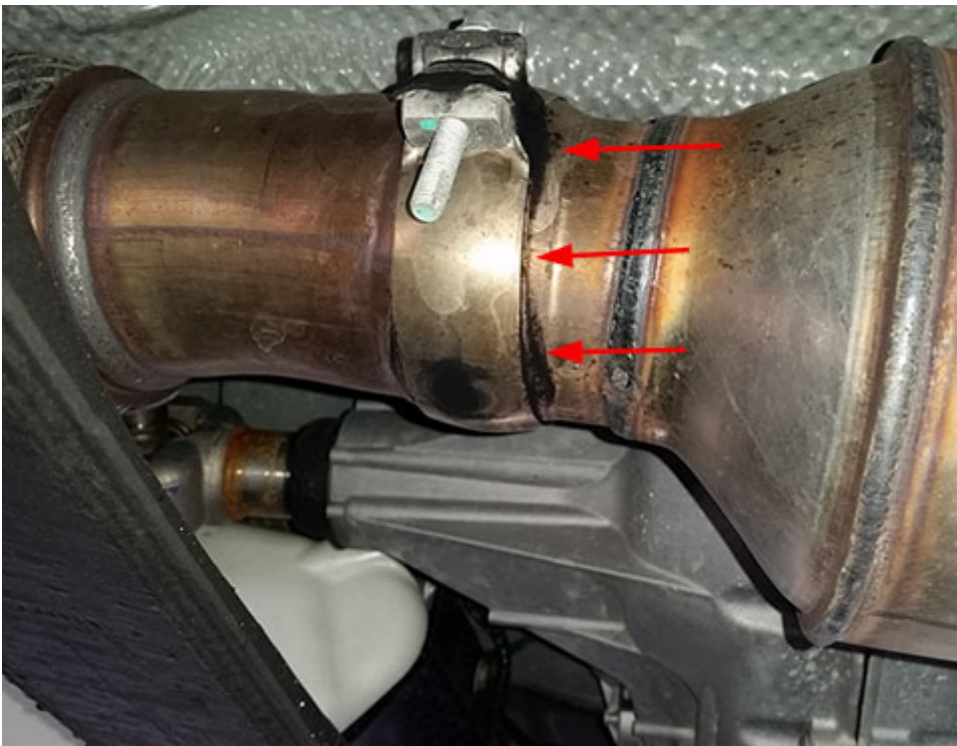
**1.** Ensure there are no leaks at the exhaust band (Norma) clamp joint. It has been found in some cases that a leak at the clamp joint could allow some level of exhaust tone change or exhaust vibration/drone type noise and/or buffeting vibration or body pressure booming to occur. Refer to latest version of [PIP5442](#).
