Preliminary Information

PIC6374 Unable To Deactivate The Brake Boost System Using Global Diagnostic System (GDS) After Replacement Of the Master Cylinder Assembly

Brand:	Model:	Model Years:	VIN:		Engine:	Transmissions:
			from	to		
Cadillac	XT4	2019 - 2020	All	All	All	All

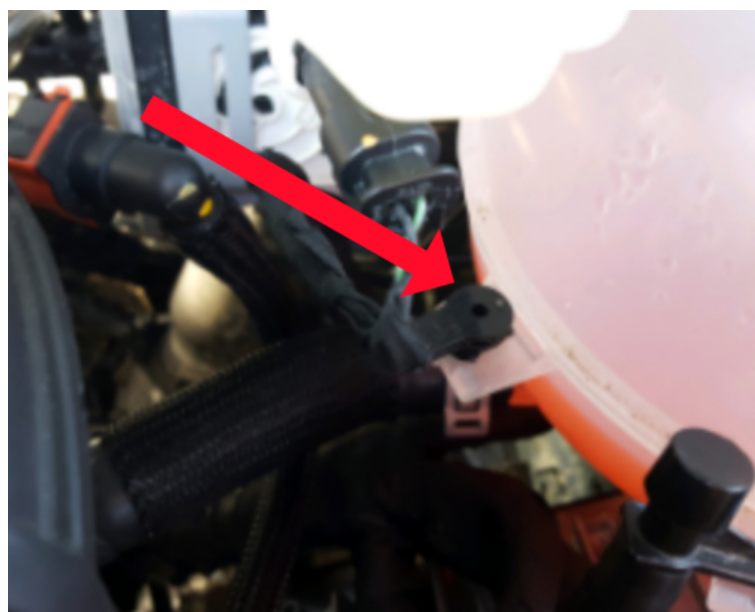
Above shows the brake fluid level sensor correctly connected.

Verify that the connectors are in the correct location. Refer to the pictures below.

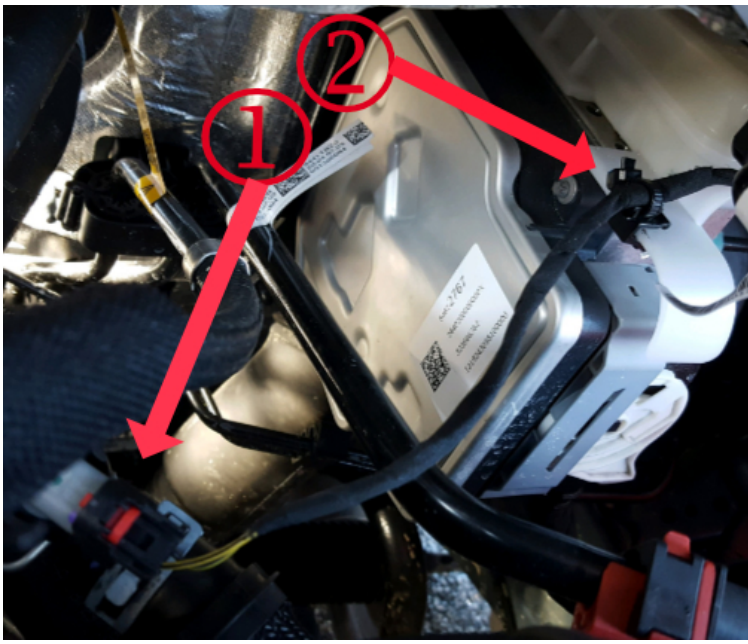
Above shows the engine coolant sensor 4 correctly connected.

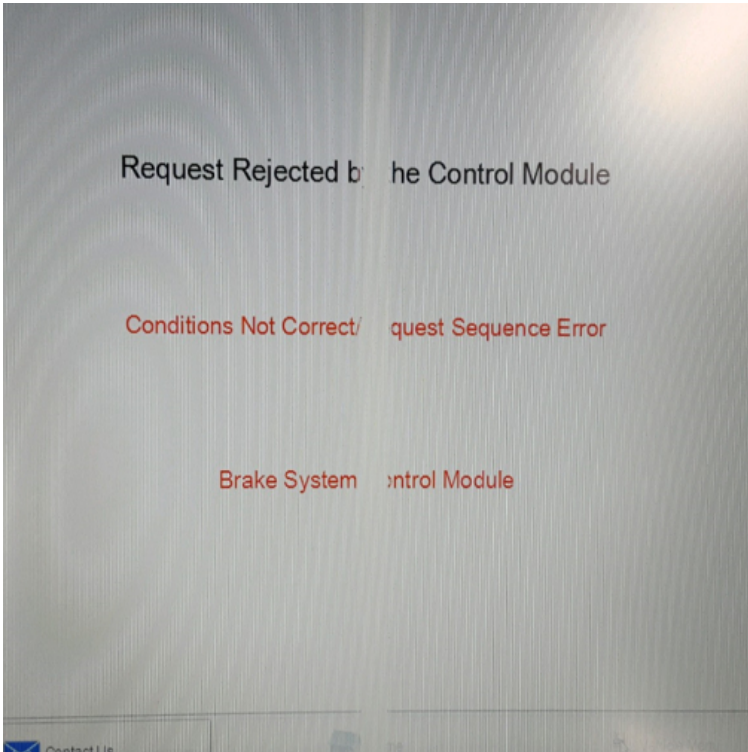
Involved Region or Country	North America
Condition	After the Brake Master Cylinder Assembly has been replaced, a GDS2 error message (see below) might occur when trying to deactivate the boost system when performing the hydraulic bleed procedure.
Cause	<p>This concern could be caused by the B20 Brake Fluid Level Switch Connector and the B34D Engine Coolant Temperature Sensor 4 Connector being swapped during reassembly.</p> <p>If these connectors are swapped, DTC's C0049 SYM05 will be stored in the EBCM and a P2AFF SYM will be stored in the ECM.</p> <p>These connectors are identical and can be easily swapped. The harness retainers are different, as well as the wire colors. Refer to the pictures below for the correct connector/retainer location.</p>

Above shows the GDS2 error message when trying to deactivate the brake boost system.
