# Preliminary Information

## PIT5689A No Restart after an Auto Stop Event / No Crank / DTC U0102 U0284 U0285 U0672 P0617 P26E6 P305D U111A U111E U1348

### Models

Brand:	Model:	Model Years:	VIN:		Engine:	Transmissions:
			from	to		
Chevrolet	Silverado 1500 (New Model)	2019 - 2020	All	All	L3B L84 L87	All
GMC	Sierra 1500 (New Model)	2019 - 2020	All	All	L3B L84 L87	All

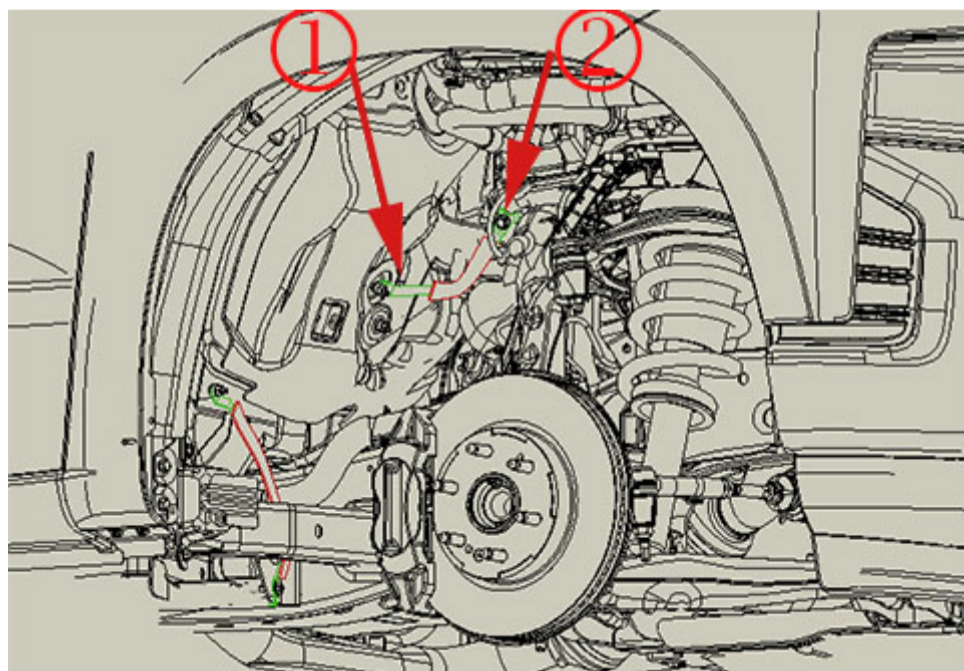
1 - G132  
2 - G134

Involved Region or Country	North America
Additional Options (RPO)	L3B, L84 or L87
Condition	<p>Some customers may comment of the following:</p> <ul style="list-style-type: none"> <li>- After an auto-stop event the engine does not restart.</li> <li>- No crank (may be intermittent)</li> <li>- SES MIL with any of the following DTCs: U0102, U0284, U0285, U0672, P0617, P26E6, P305D, U111A, U111E, U1348</li> </ul>
Cause	These concerns could be caused by a broken or loose engine ground cable/strap, which grounds the engine (2) to the body (1), as shown below.

Inspect the engine to body ground cable/strap, G132 and G134. Tighten any loose ground connections or replace any damaged ground cable/strap. Ensure that the ground cable/strap is properly orientated to prevent damage to the ground cable/strap caused by powertrain movement.
