Preliminary Information

PIC6376 A/C Evaporator TXV Tubes Bent

Brand:	Model:	Model Years:	VIN:		Engine:	Transmissions:
			from	to		
Chevrolet	Impala	2016 - 2020	All	All	All	All

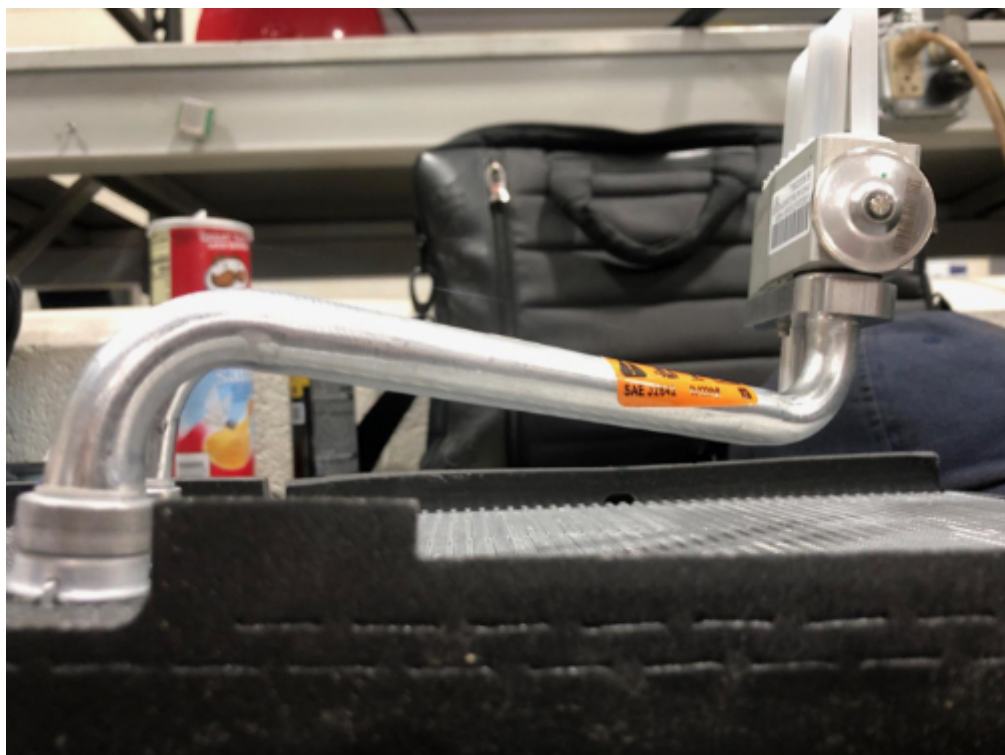
Involved Region or Country	North America
Condition	When replacing an evaporator a technician may notice when removing it from the box that the tubes appear to be bent downward. It may also be found that when attempting to install the evaporator in the HVAC case that the tubes will not align with the holes in the case or the evaporator will not fully fit into the case.
Cause	Current packaging procedures from the supplier may allow the evaporator tubes to be bent during shipping.

Inspect the new evaporator to see if the TXV tubes are bent at a downward angle as shown below.

If the TXV tubes on the new evaporator are bent down order a new evaporator and return the damaged part as "new defective". Do not attempt to adjust the tubes to allow installation of the evaporator in the HVAC case. If the tubes are bent or adjusted back into position this will result in a slow leak from the lock ring joint.

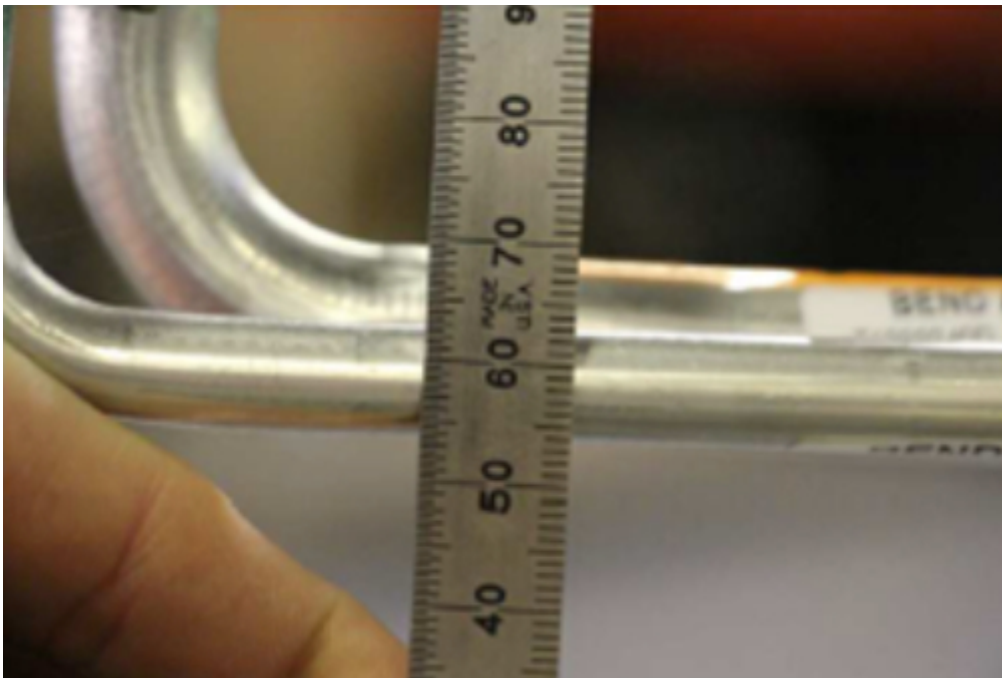
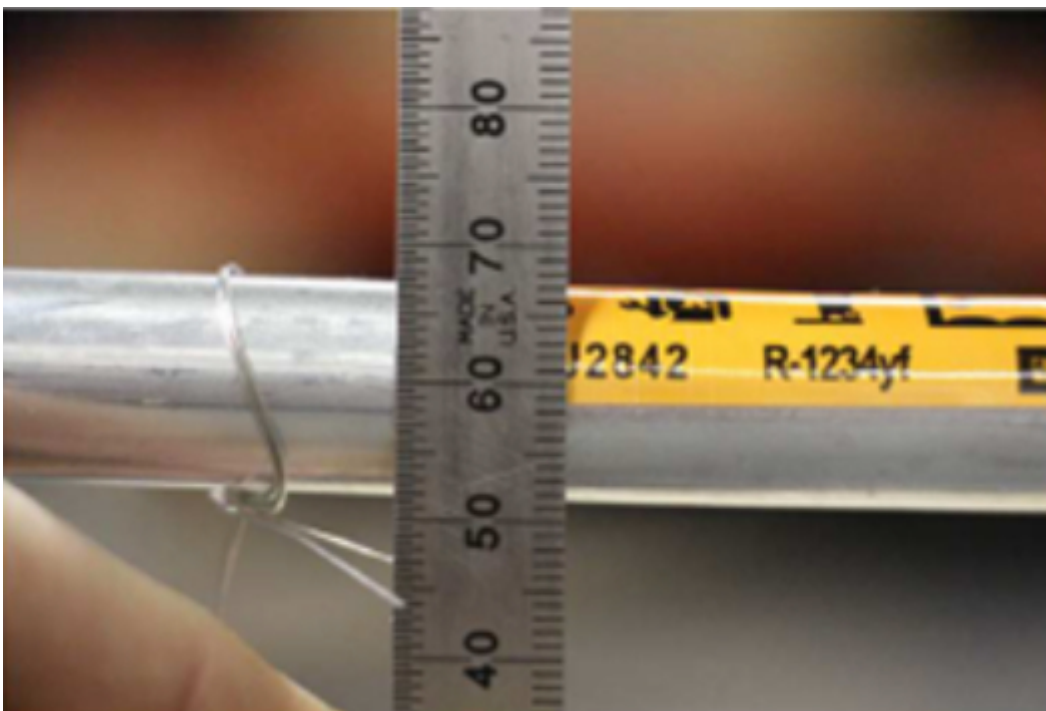
There should be a distance of 60 mm. when measuring from the core to the center of the TXV tubes as shown below.
