Title Diagnostic Trouble Codes ( DTC ) P0016-76 - Crankshaft Position - Camshaft Position  
Correlation - Turbo Compound ( TC ) - **Model Year 2018 and Newer**

**Mack Model** AN - Anthem , GR - Granite , PI - Pinnacle

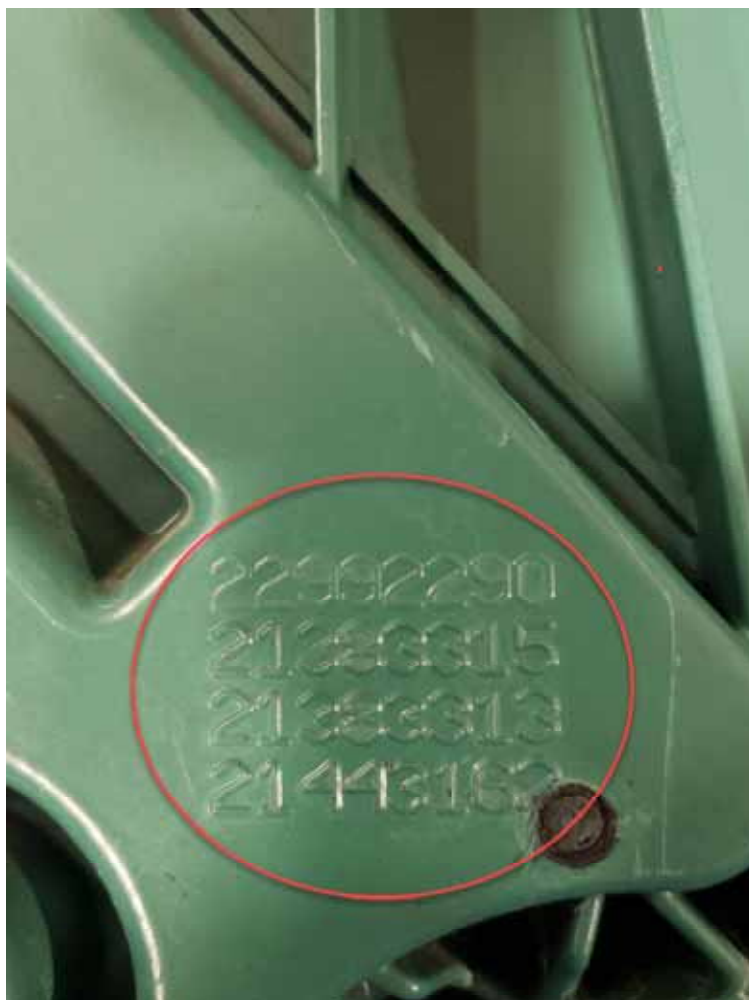
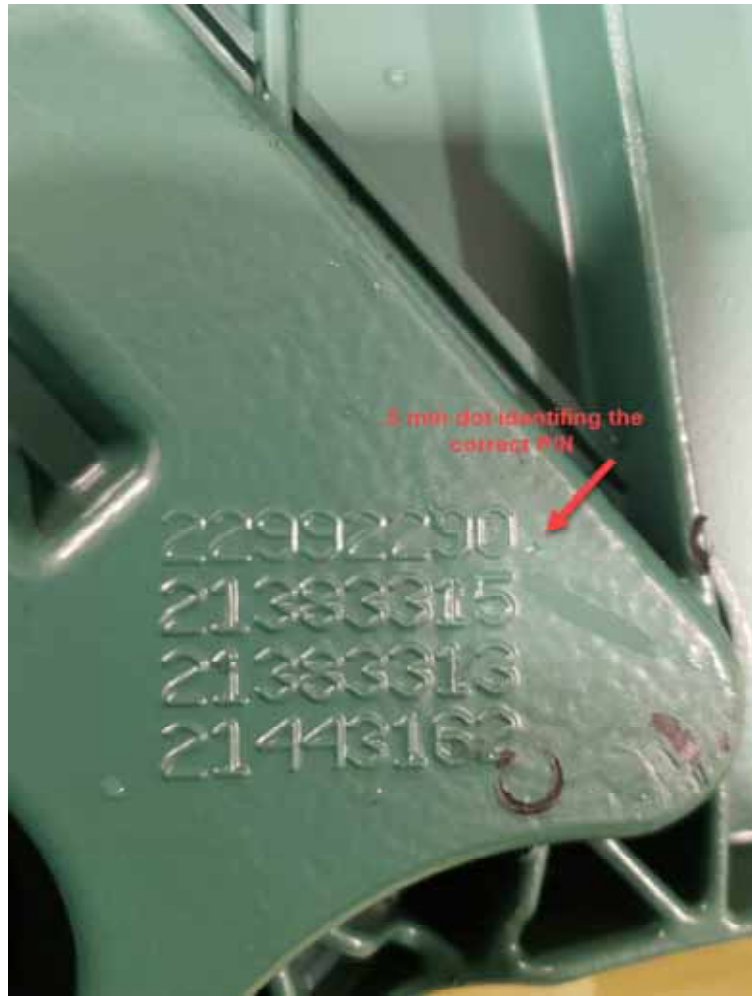
Each cover is stamped with the same 4 P/N's. The appropriate number of the four will be marked with a .5 mm dot beside the correct number.

**Solution** If fault code P0016-76, Crankshaft Position - Camshaft Position Correlation, is active on a TC chassis please confirm the rear upper timing cover installed is the correct P/N for your particular engine.

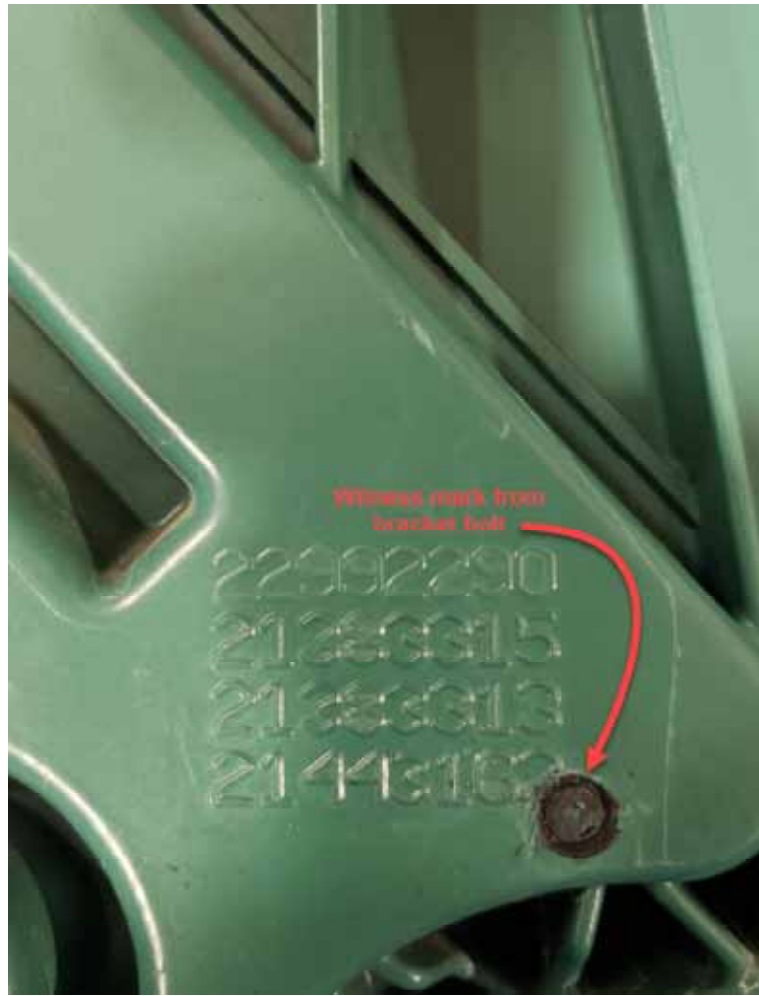
Looking for this dot can be difficult on the lower number due to a witness mark from a bracket bolt that runs into the cover when installed in frame.

**NOTE:** In this instance IMPACT calls out a 22121029 rear upper timing cover which, according to the drawing, supersedes to a 21443162. On the cover from the original engine the “dot” is hidden by the bolt witness mark. When the 2 covers are compared you can clearly see a difference in Cam sensor mounting holes. The incorrect cover came with a dot beside p/n 22992290.

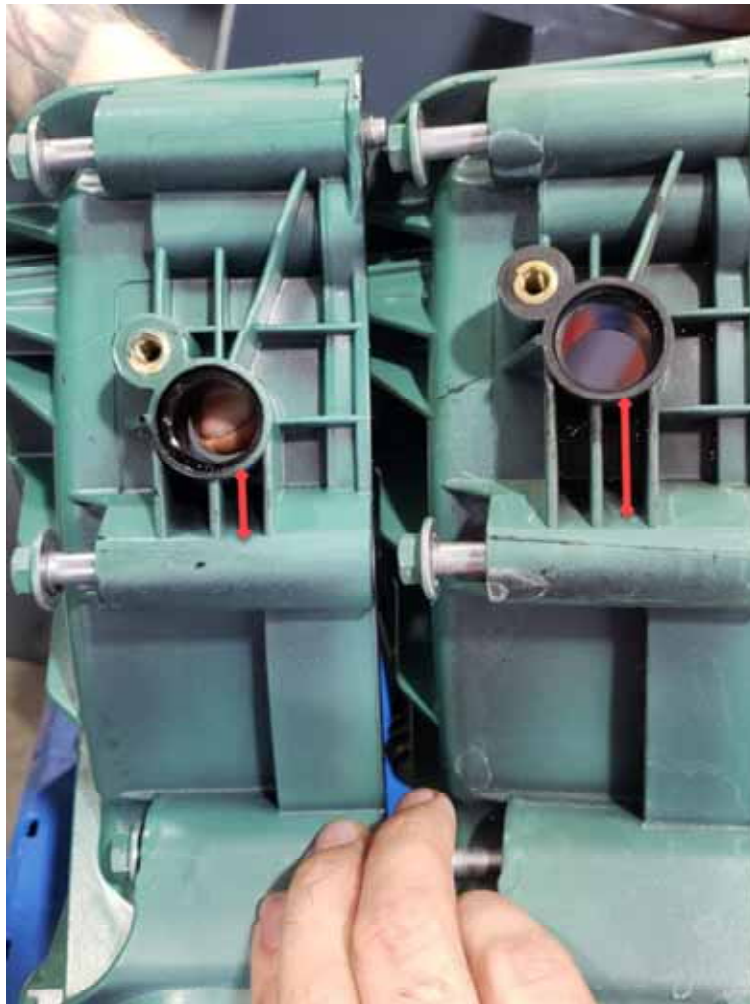
When the 2 covers are compared you can clearly see a difference in Cam sensor mounting holes.
