# NON COMPLIANCE RECALL

Mack Trucks Inc.  
Greensboro, NC USA

Date	Number	Release	Page
11.2019	EC0020C	01	1(18)

## Conventional, Analysis & SCR Hardware Replacement - 2 box GR, GU, AN, CX

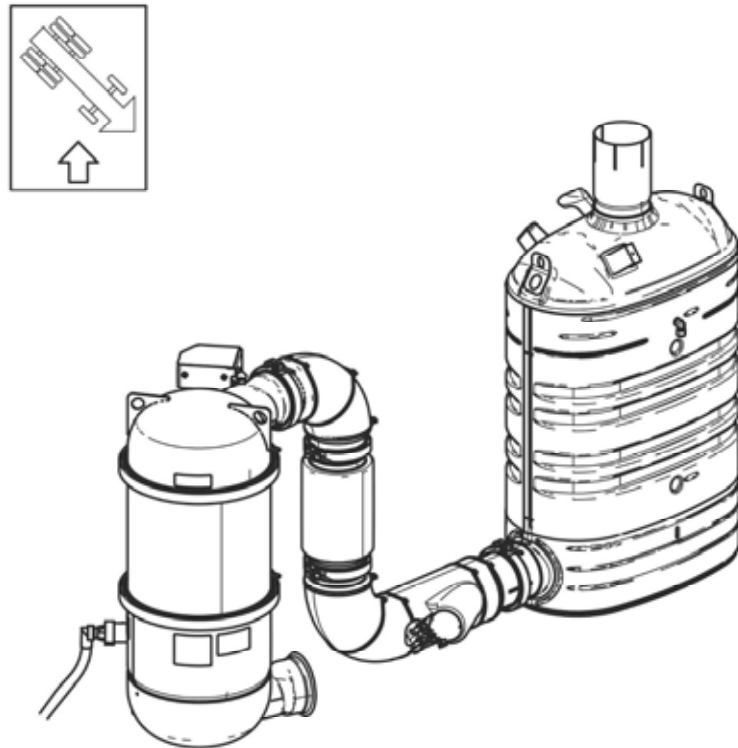
**Image #1 - Left side mount, side inlet, Selective Catalytic Reduction**

21. Chassis configuration with left side mount, side inlet, SCR. Follow standard repair instructions and parts list per model key listed below (Ref. Image #1).

Operation ID		
Model	Repair Operation	Repair Identity
GR	2586-03-02-01	146072147
GU	2586-03-02-01	146072124

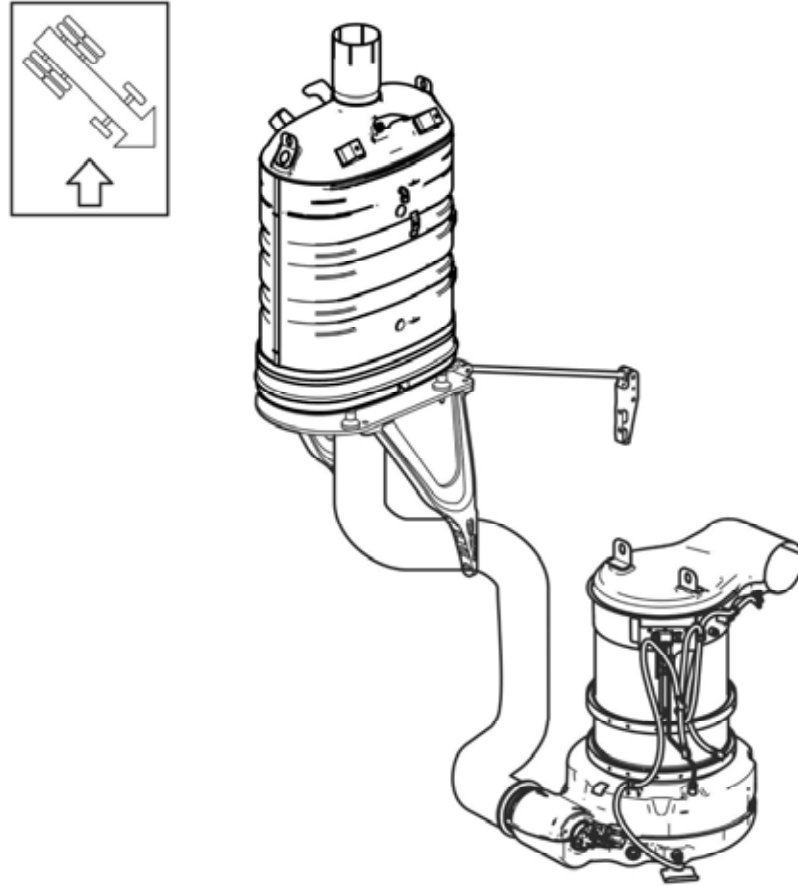
**Image #2 - Right side mount, bottom inlet, Selective Catalytic Reduction**

22. Chassis configuration with left side mount, bottom inlet, SCR Follow standard repair instructions and parts list per model key listed below (Ref. Image #2).

Operation ID		
Model	Repair Operation	Repair Identity
GR	2586-03-02-01	144517560
GU	2586-03-02-02	138458119
AN	2586-03-02-03	144517578
CX	2586-03-02-04	138458143
