Technical Journal

Seat hard to push back, second row seat (7 seater)

REF NO: TJ32025.5.0	ISSUING DEPARTMENT: Technical Service	CAR MARKET: United States and Canada	
PARTNER: 3 US 7510 Volvo Car USA		ISSUE DATE: 2019-09-26	STATUS DATE: 2019-10-10
FUNC GROUP: 8531	FUNC DESC: Rear seat, complete	Page 1 of 6

2:nd row in 7-seater: Hard to fold back backrest

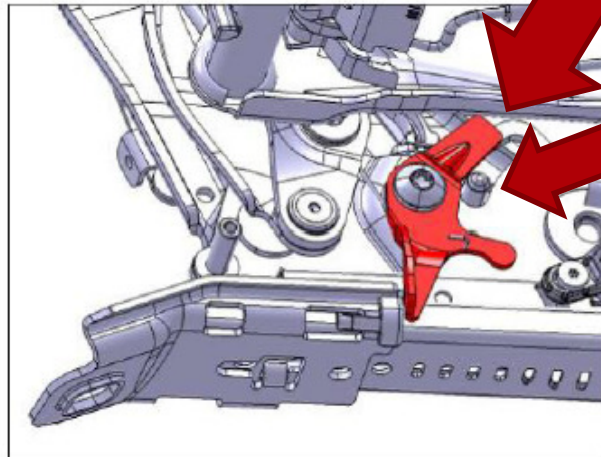
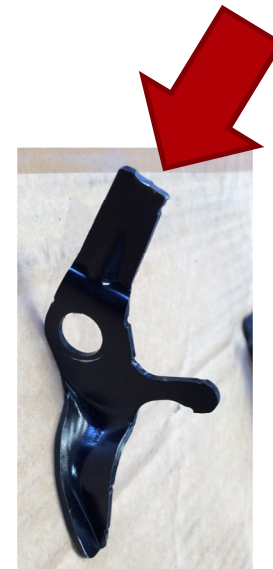
Issue:

- Outer seat in 2:nd row is hard to move back after entrance to 3:rd row.
- Backrest folds back too early (before seat is slided back).

Reason:

Stopping edge of rebound bracket wear against the stop screw. This wear prevents it from releasing.

Solution:

- Replace the rebound bracket.
- New concept "knee lever" to be introduced.

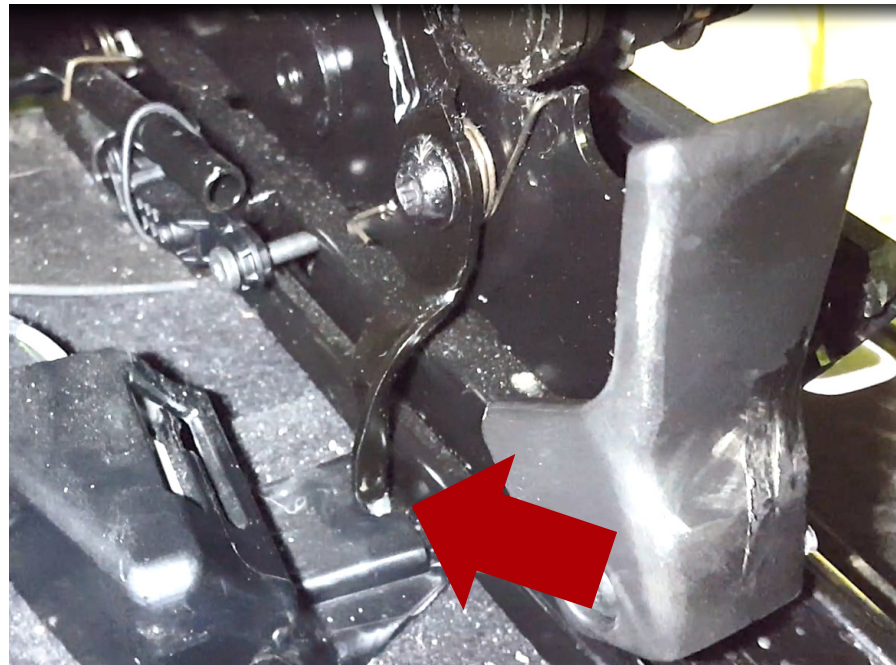
Issue:

Outer seat in 2:nd row is hard to move back after entrance to 3:rd row.

Reason:

Lower part of rebound bracket sticks on screw head.

Solution:

- Grind down the screw head.
- New concept with lower screw head.

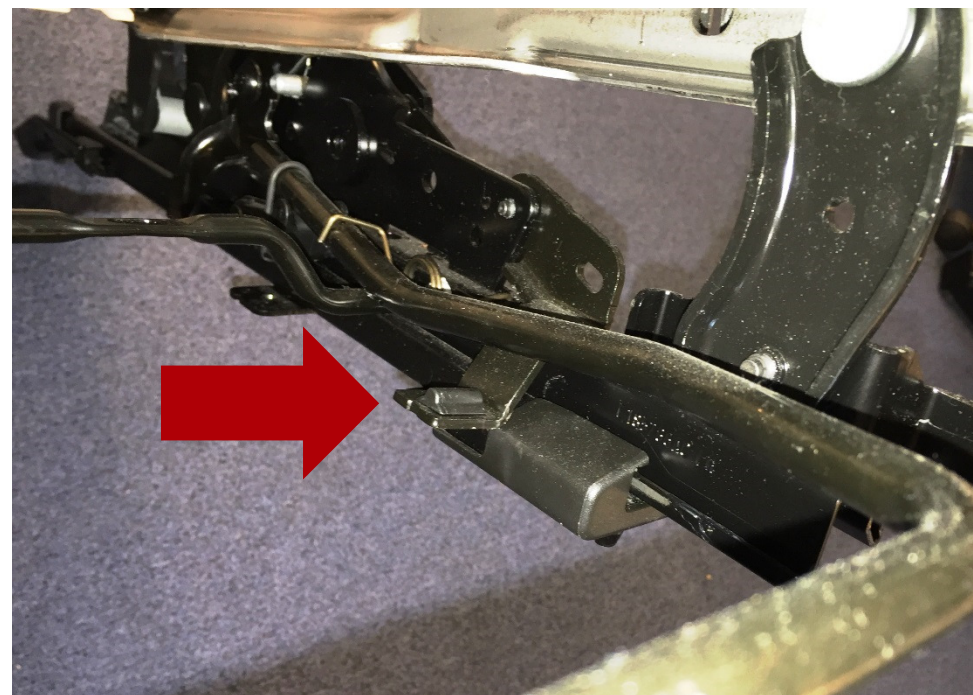
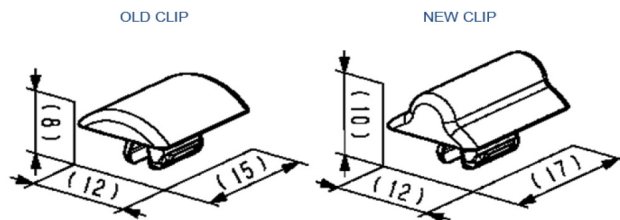
Issue:

Outer seat in 2:nd row is hard to move or makes rattling noise over the rails.

Reason:

Plastic stoppers for adjustment lever forward/backward too low.

Solution:

Replace stoppers to new, higher model.
No p/n change.

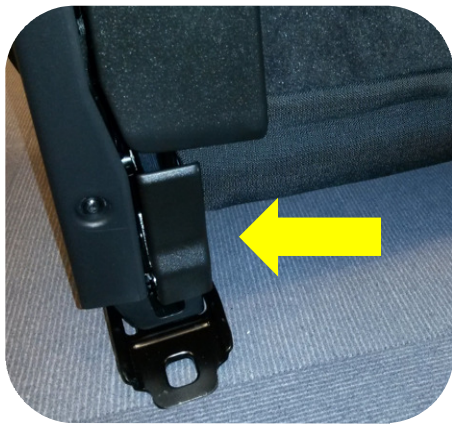
Issue: 2:nd Row outer seat, 7 seater

Gap closer can get stuck and damaged when back rest is folded back.
To avoid on current cars: Always start from normal position when seat are supposed to be flat folded. (Do not start from easy entry position.)

Solution step 1 Current Gap closer will be redesigned.
