Subject: Service Action S39920 – XC40 Tailgate Handle Modification

# Quality Bulletin

**Service Action S39920: XC40 Tailgate Handle Modification  
Model Year 2019 - 2020 XC40**

# Parts Bulletin

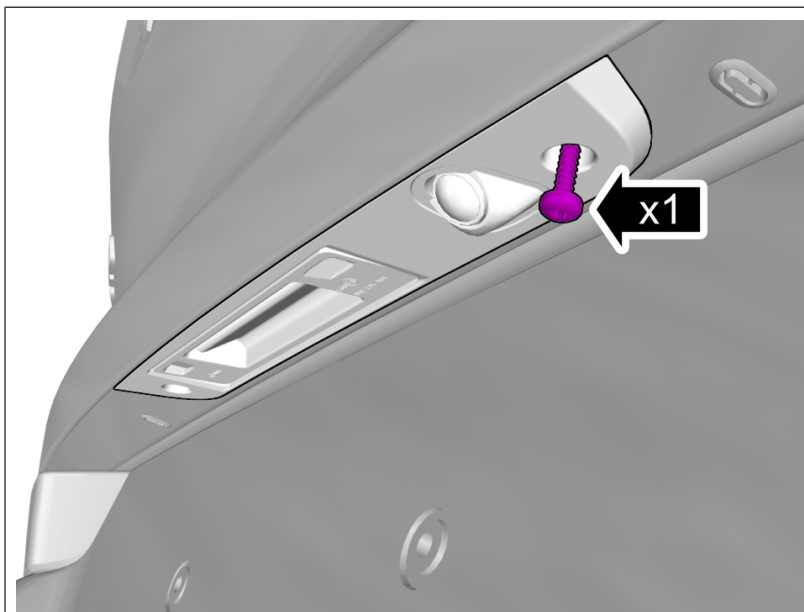
**Note! One side at a time.**

Remove the screw.  
The part is not to be reused.

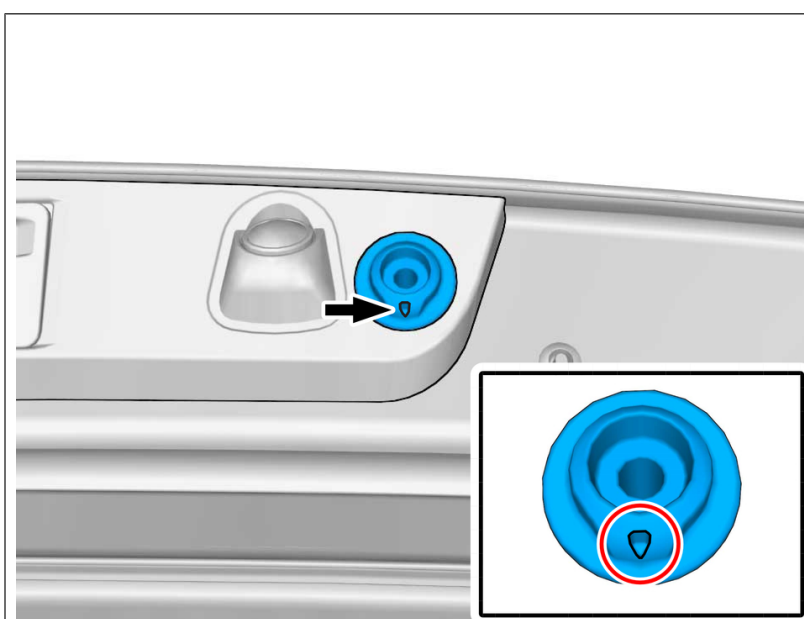
**Note! Orientation view**

Note the position.

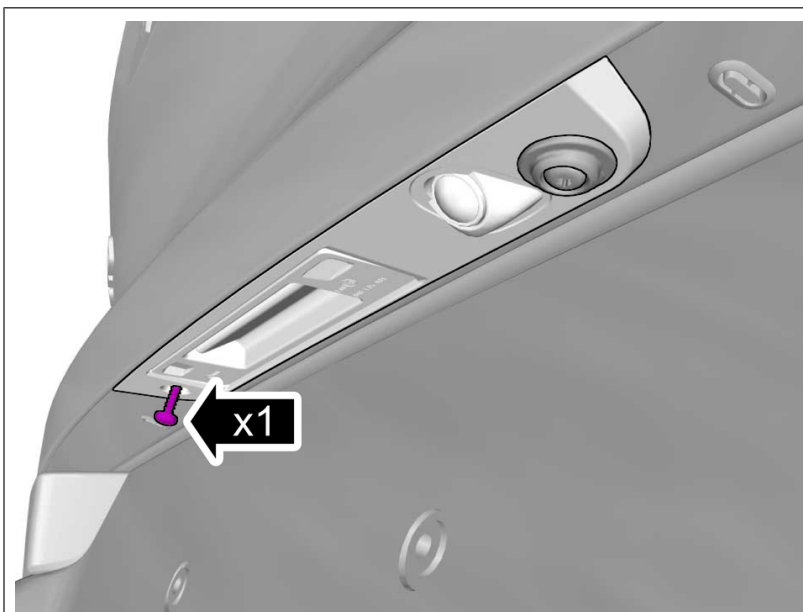
**Note! One side at a time.**

Remove the screw.

The part is not to be reused.
