VOLVO CAR SERVICE AND PARTS BUSINESS

Technical Journal

TITLE: Yellow stains at rear bumper and D-pillar

Technical Journal 35161.2.0

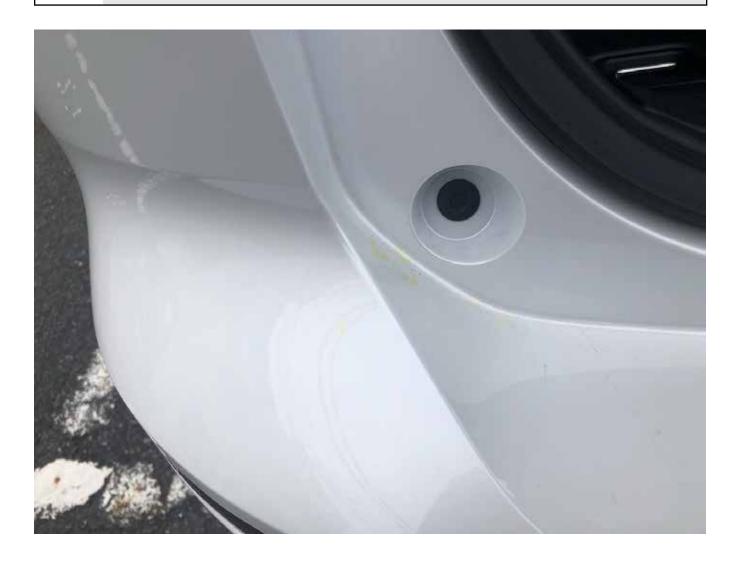
File Name	File Size		
Yellow stain.jpg	0.1588 MB

If vehicle shows symptom to have yellow stains on rear bumper or D-pillar follow advice under "service". See attachment for yellow stains

Only cars with power operated tailgate is affected, VDN L702

Use clean hot water (90-95 degrees Celsius / 195 - 204 degrees Fahrenheit) and keep pouring over the yellow stains until the stains disappear (from 30 seconds up to 3 minutes). Don't use a cloth or similar to wipe of the stains, just pouring water will remove them.

Note! Be careful due to the heat of water.
