Norco Gearbox Drip Tray Installation

This process describes the repair where under certain temperature conditions the Norco slide cable system gearbox may leak oil/grease on the slide roof membrane. The following procedure describes how to install a drip pan to prevent damage to the roof membrane, and make repairs if necessary.

Affected Production Dates: Keystone, Dutchmen, and CrossRoads units with Norco slides produced in 1/1/2017 through 3/31/2018 and 8/1/2018 through 9/30/2018.

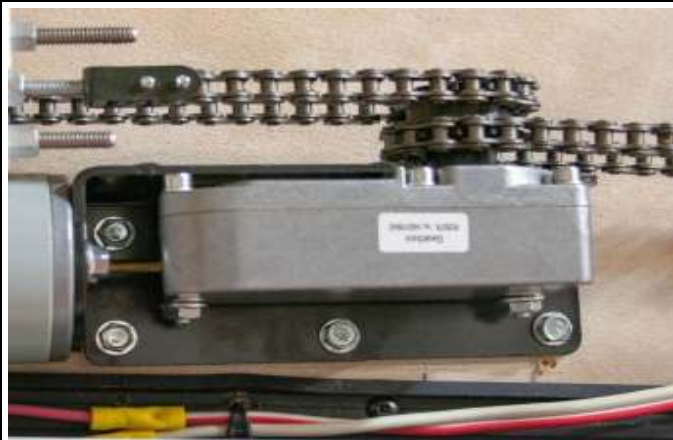
Motor/gearbox installed in unit.

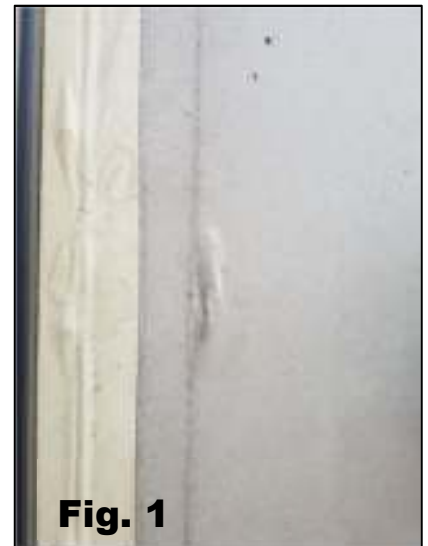
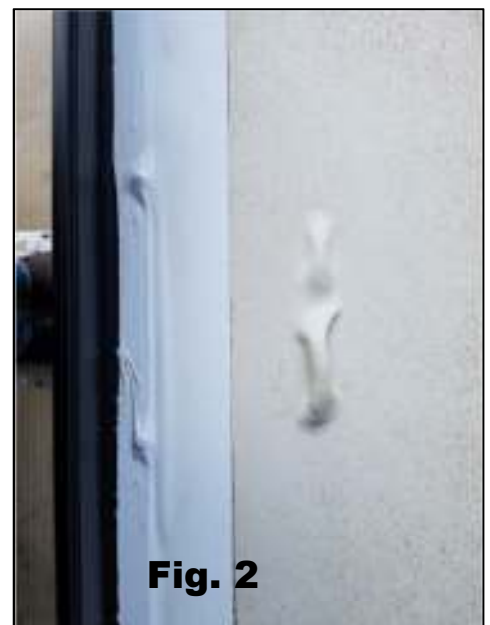
Locate bubble on roof membrane. **Clear pictures are required for pre-authorization, Figure 2.**

Locate bubble on roof membrane. **Clear pictures are required for pre-authorization.** If the bubble is small, use a non-abrasive and solvent-free cleaner like Simple Green, Dawn Dish Soap, or Murphy's Oil Soap to clean the membrane, Figure 1.
