Technical Service Bulletin

91 Navigation, Bluetooth, smartphone interface, and voice recognition is not available

91 19 18 2058007/1 December 9, 2019.

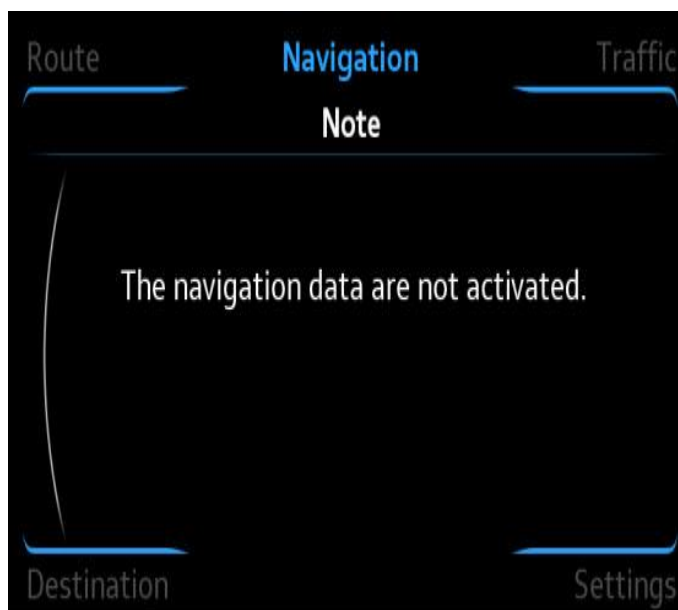
- Navigation is not activated (Figure 1 and Figure 2).
- Bluetooth is unavailable.
- Audi smartphone interface (ASI), including CarPlay or Android Auto, is not available.
- Voice recognition is unavailable in all cars except A3 Cabriolet. (For A3 Cabriolet, see TSB 2038136: *91 Voice recognition is not available or not enabled*).

Figure 1. Navigation not activated message (Original MIB HMI).

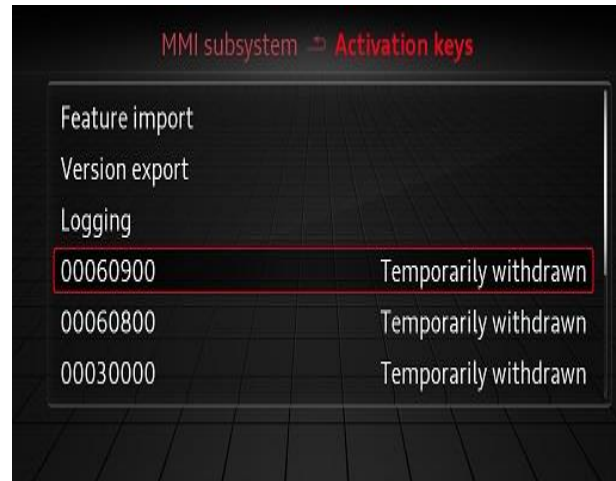
Temporarily withdrawn or Temp illegal = This indicates that the SVM activation test plan was not completed (Figure 4). This status is normal for all parts that have been swapped from a different vehicle. Perform the SVM Activations test plan as indicated below, under *Repair Procedure*.

Figure 4. Activation keys showing “Temporarily withdrawn”.

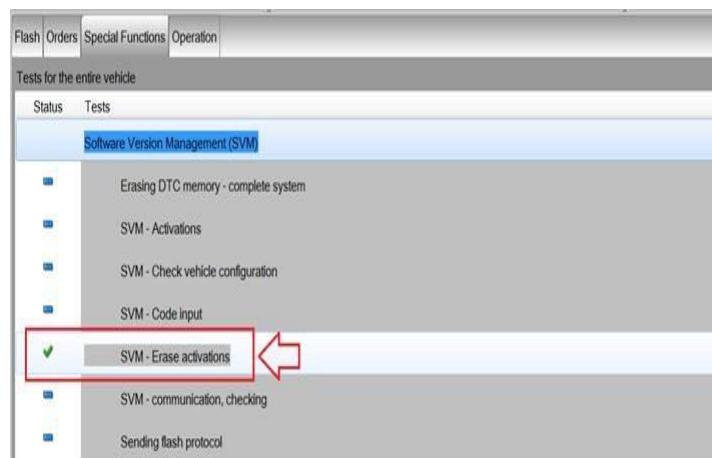
Figure 5. SVM – Erase activations.

1. There is a known issue with the activations keys stored in the MMI where they can become corrupt, thus the first step will be to delete the activation keys in the MMI. Delete the activations of the affected system using the ODIS test plan *DIAGNOSIS >> START DIAGNOSIS >> SPECIAL FUNCTIONS >> “SVM – Erase activations”* (Figure 5).

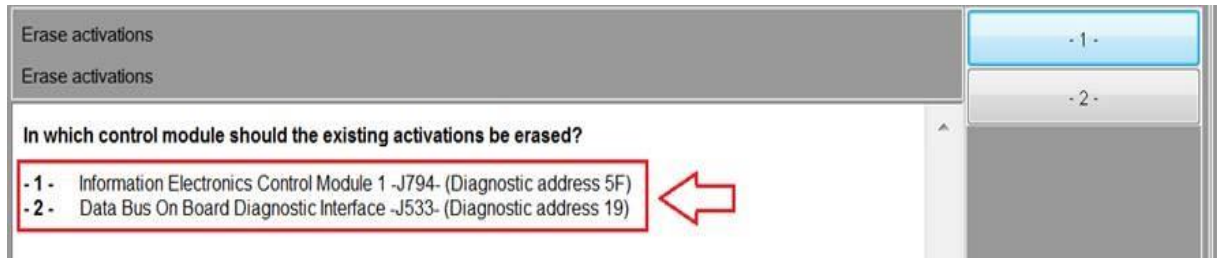
Figure 6. MMI (Information Electronics Control Module 1); Gateway (Data Bus On Board Diagnostic Interface).

2. When prompted choose the appropriate system to delete activations based on the customer’s concern:
 - For concerns with Navigation, Bluetooth, Audi smartphone interface, or voice recognition, select option -1- for the MMI (Information Electronics Control Module 1).
 - For concerns with Audi drive select, adaptive and regular cruise control, select option -2- for the Gateway (Data Bus On Board Diagnostic Interface) (Figure 6).

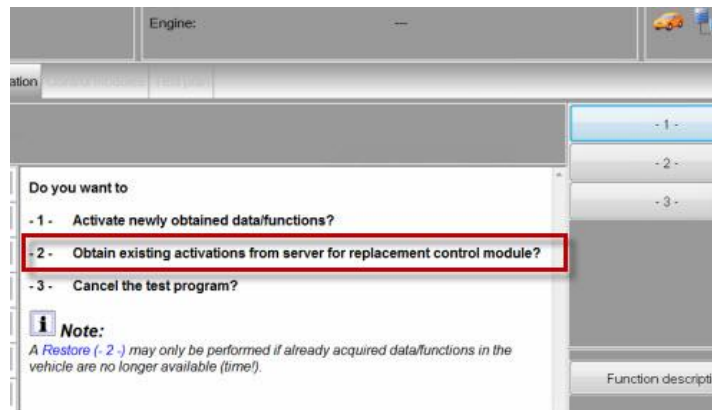
Figure 7. Obtain existing activations.

5. When prompted, select “obtain existing activations” (Figure 7).
