# Technical Service Bulletin

## 93 Sudden loss of range and shows less than 140 miles

93 19 15 2057985/1 December 4, 2019.

Model(s)	Year	VIN Range	Vehicle-Specific Equipment
Audi e-tron quattro	2019	VIN Specific	Not Applicable

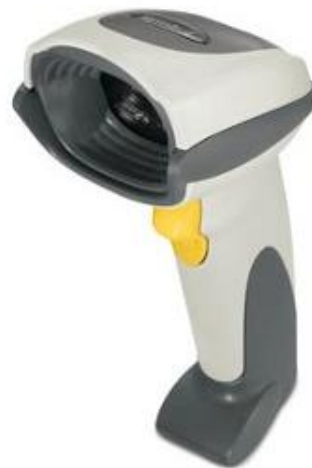
*Figure 1. 2D scanner VAS 6161/1.*

4. **Enter the serial number of the HV modules with the 2D scanner VAS 6161/1 (Figure 1):**

- Connect the 2D scanner VAS 6161/1 to the tester and set it up before starting the above test plan.
