# Technical Service Bulletin

## 94 Exterior lights, moisture accumulation

94 19 18 2012749/14 December 6, 2019. Supersedes Technical Service Bulletin Group 94 number 17-91 dated July 31, 2017 for reasons listed below.

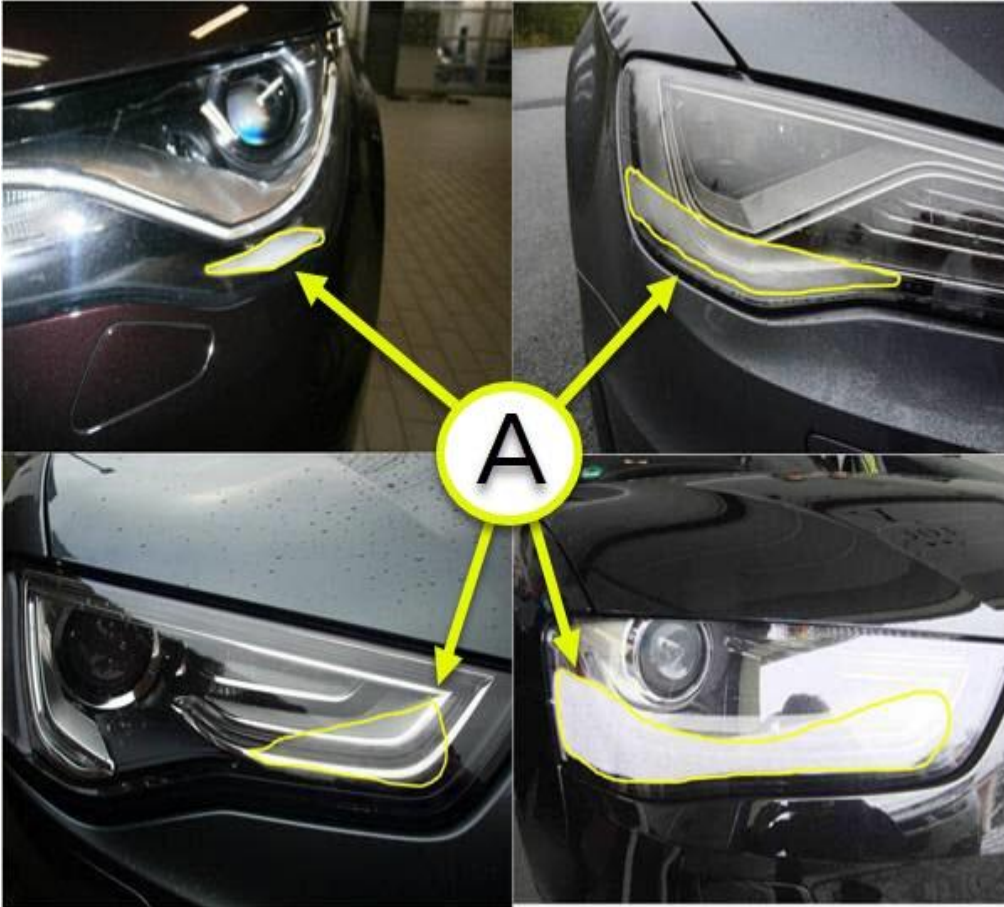
- Condensation is visible on the inside of the headlight, taillight, fog light, side marker light, front turn signal, daytime running lights, and/or third brake light lens (Figure 1).

*Figure 1. Condensation on the inside of the lights.*

The headlight ventilation system allows air from the exterior of the assembly to pass through the headlights. This open water-protected ventilation system (which is needed for pressure compensation) creates different climate zones in the headlight: very warm areas, where the lens is warmed up by the light, and relatively cool areas, where the lens is cooled down by the airflow.

Considerable differences in humidity and temperature between the inside and the outside of the headlights, even when the car is being driven, can create condensation. While condensation is most common in cold and wet weather, it can also occur after a car wash, or when the temperature changes. Condensation is more visible on lenses made of clear glass than on lenses with patterns. The moisture does not affect the headlight function or light performance, and it does not lead to corrosion or damage to other headlight parts.

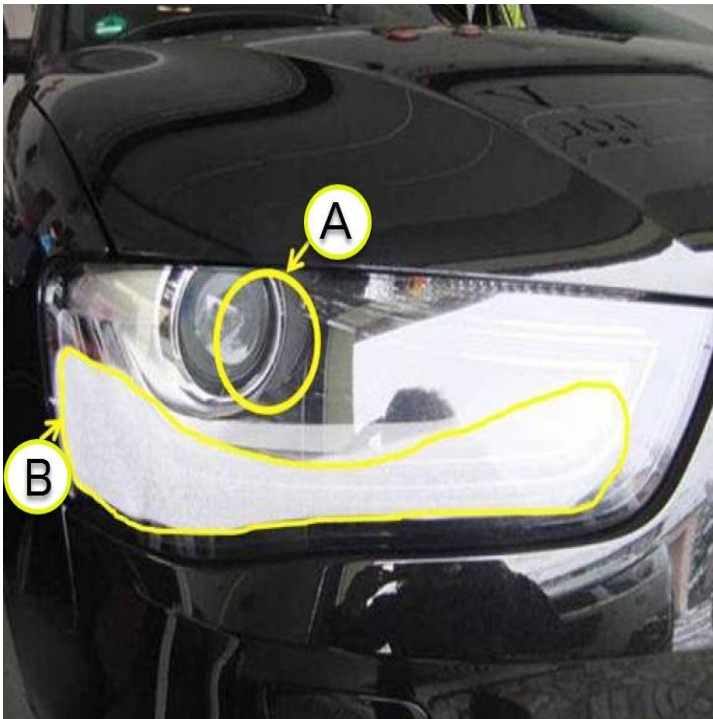
1. The light emission surface (Figure 2A) of the main beam should be clear after driving 10 minutes with the main beam on.
  - Driving speeds must be consistently over 45mph for the ventilation system to properly function.
  - Residual condensation (Figure 2B) may be present depending on ambient conditions, this is normal.

**Figure 2.** A: Main beam light emission surface. B: Condensation of the headlamp.

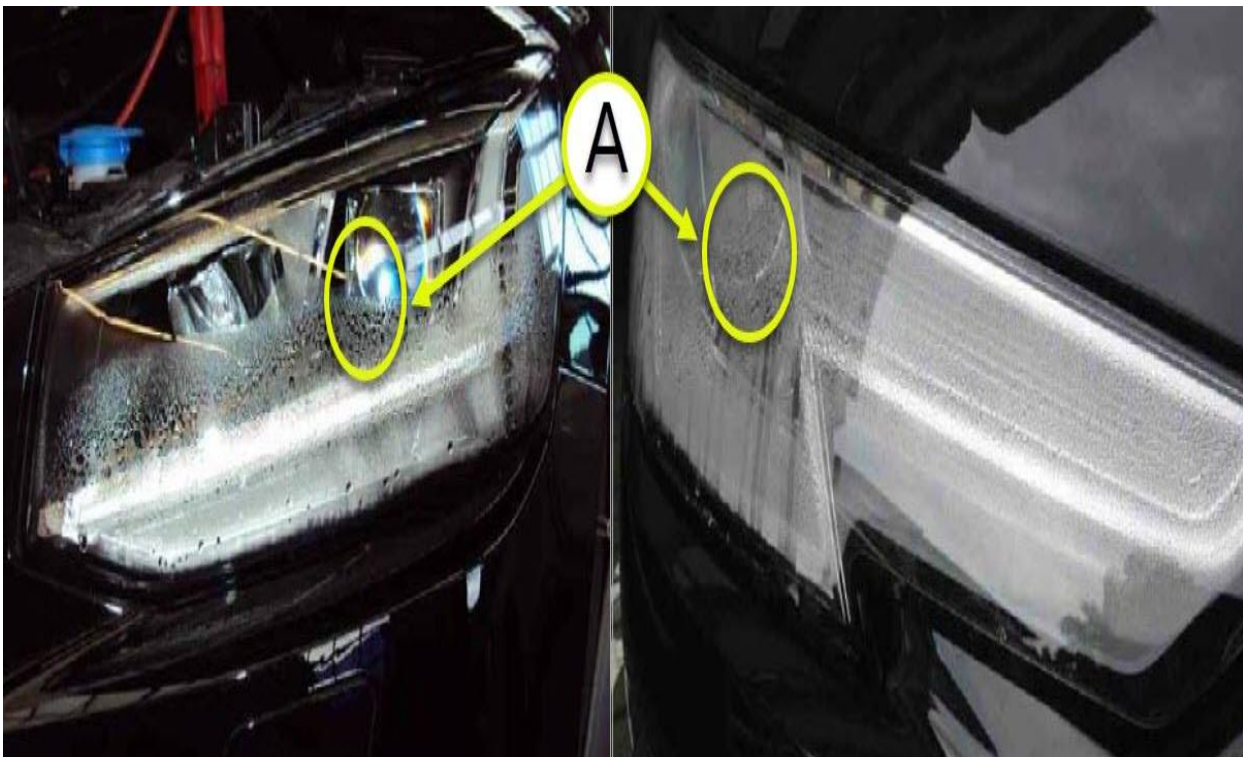
2. If water drops or condensation are present on the light emission surface (Figure 3A) after performing step one, inspect the headlamp assembly for the root cause:

- Missing cover.
- Damaged seal.
- Clogged drain.
- Outside influence.

**Figure 3. A:** Main beam light emission surface.

- In cases where the headlamp assembly is not the root cause (clogged drain and/or missing access cover), dry the headlamp assembly with compressed air.
- Perform a visual inspection of electrical connectors and any control modules attached to the headlight. If corrosion is found in one of these components, it must be repaired or replaced. Reference the repair manual for repair instructions.
