November 2019

Dealer Service Instructions for:

Customer Satisfaction Notification V46 Solenoid Pack

2016-2017 (VF) Ram ProMaster

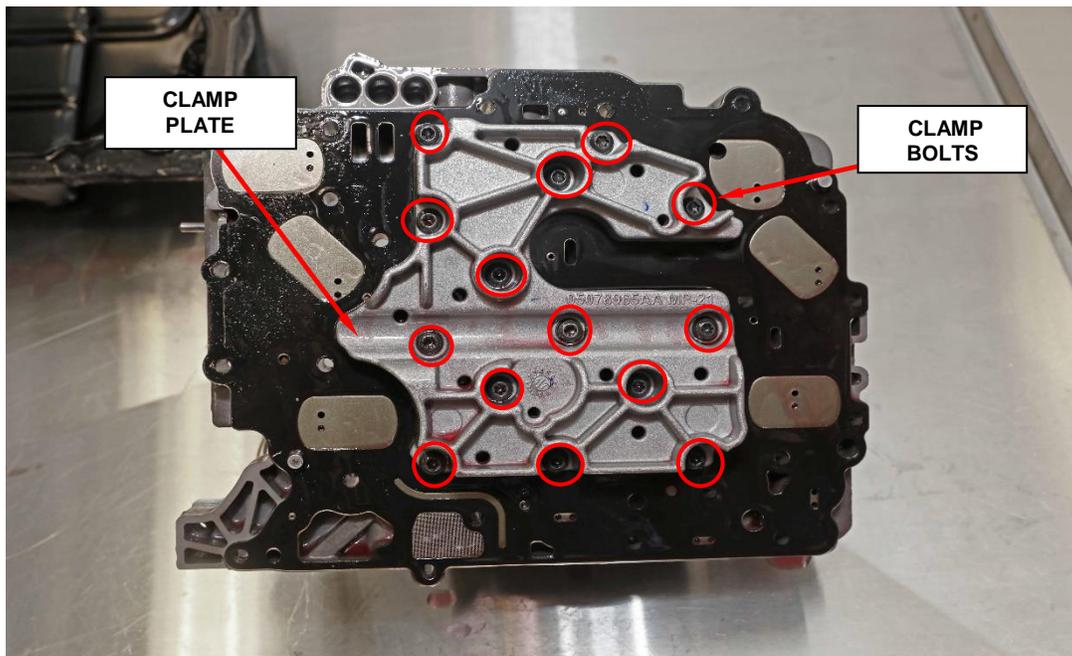
**Figure 6 – Clamp Plate**

The transmission solenoid coil terminals on about 33,000 of the above vehicles were built out of specifications, resulting in excessive interference between the solenoid and its mating connection. This interference created stress within the terminals and an intermittent electrical connection. This condition may cause the transmission to be limited to one gear and maximum speed of 30 - 45 mph and will illuminate the Malfunction Indicator Lamp (MIL) on the instrument cluster and set DTC P076A code.

20. Disconnect the electrical connectors to the pressure control solenoid and line pressure sensors.
21. Remove the solenoid pack and discard.
22. Scrape off the RTV from the valve body oil pan and the transmission.
23. Align the **NEW** solenoid pack to the valve body.
24. Install the mounting bolts and the clamp plate and tighten to 6 N·m (50 in. lbs.) (Figure 6).
