**NUMBER:** 08-111-19

**GROUP:** 08 - Electrical

**DATE:** November 2, 2019

RA3 and RA4 GPS Radio Update

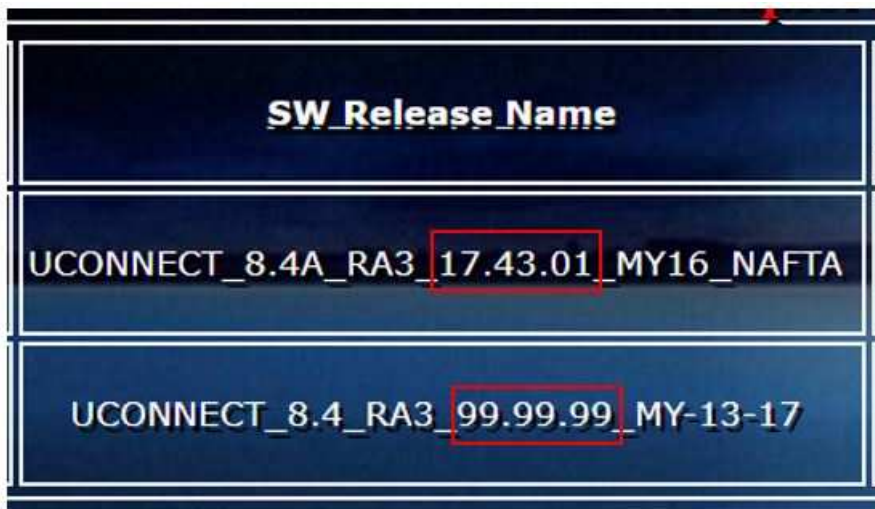
Fig. 1  
Software Version in Uconnect download Site

**NOTE: If the radio needs two USB flash drive to update the radio, first update the radio to 17.43.01/18.01.35 than use software version 99.99.99 or 88.88.88, (Fig. 1) to complete this service bulletin.**

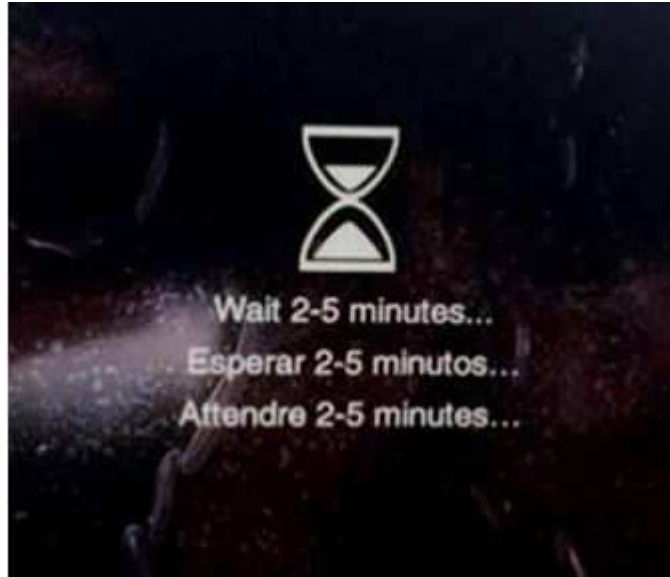
**Fig. 3**  
**Hourglass Screen**

**NOTE:** During the update process you may see multiple hourglass screens for extended periods of time (several minutes) (Fig. 3) . DO NOT remove the USB flash drive at this time. Only remove the USB flash drive when the update has completed, when the screen displays the software levels again.

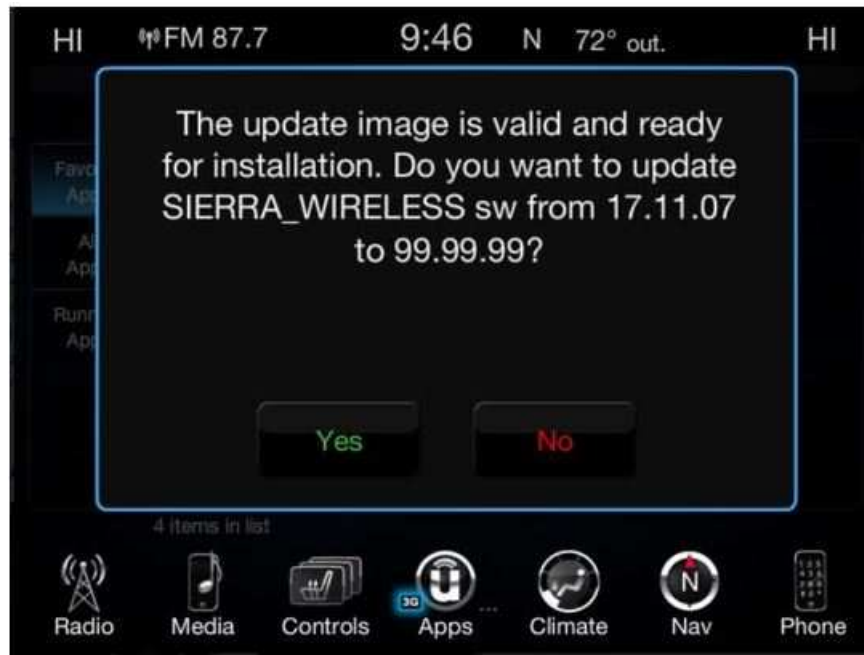
Fig. 4  
Updated Software Screen

7. The next screen display will have the old and new software levels, (Fig. 4)
8. Press the soft key “Yes” to start the update.

- After the update is done the screen will display the software levels again. For this update the software level will not change. The top will be (from) 17.43.01/18.01..5 and the next one will be (to) 99.99.99/88.88.88. (Fig. 4) .
