NUMBER: 08-112-19

UGQ Radio Enhancements

This bulletin involves inspecting and if required, updating the radio software level to 28.31.

2019 (MP) Jeep Compass

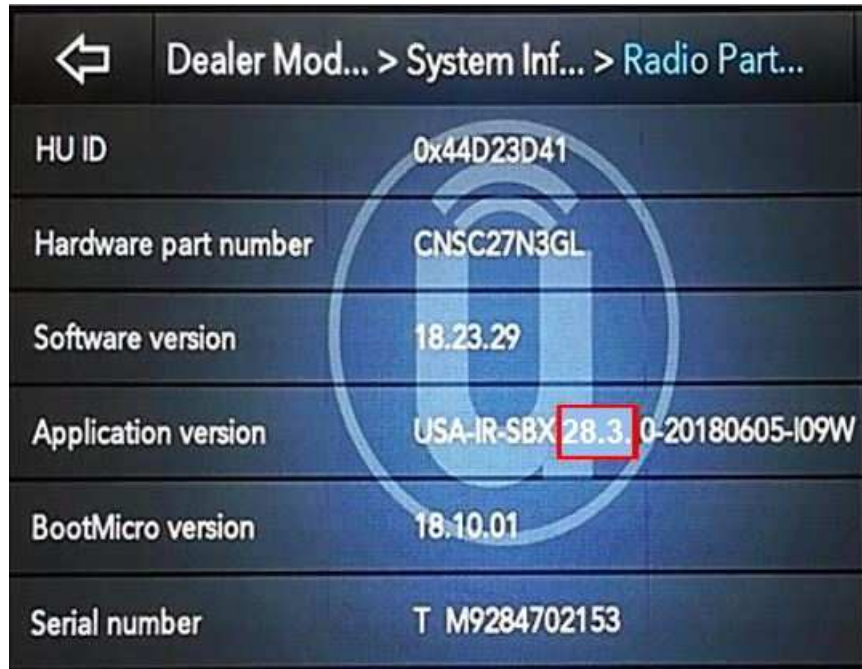
Fig. 1

1. Verify the radio software version. Radio must be in Dealer Mode to verify by following these steps:
 - a. Press and hold both lower corners of the display screen, until the Dealer Mode screen appears (approximately seven seconds). Release screen.
 - b. Select "Radio Part Information". The software version will be listed next to "Application Version" (Fig. 1) .

Radio Software Level Screen

2. Is the radio software level (Application Version) at or higher than 28.31?
 - YES >>> The radio software is already up to date. Normal diagnostic should be performed.
 - NO >>> Proceed to [Step 1](#) of the Repair Procedure.

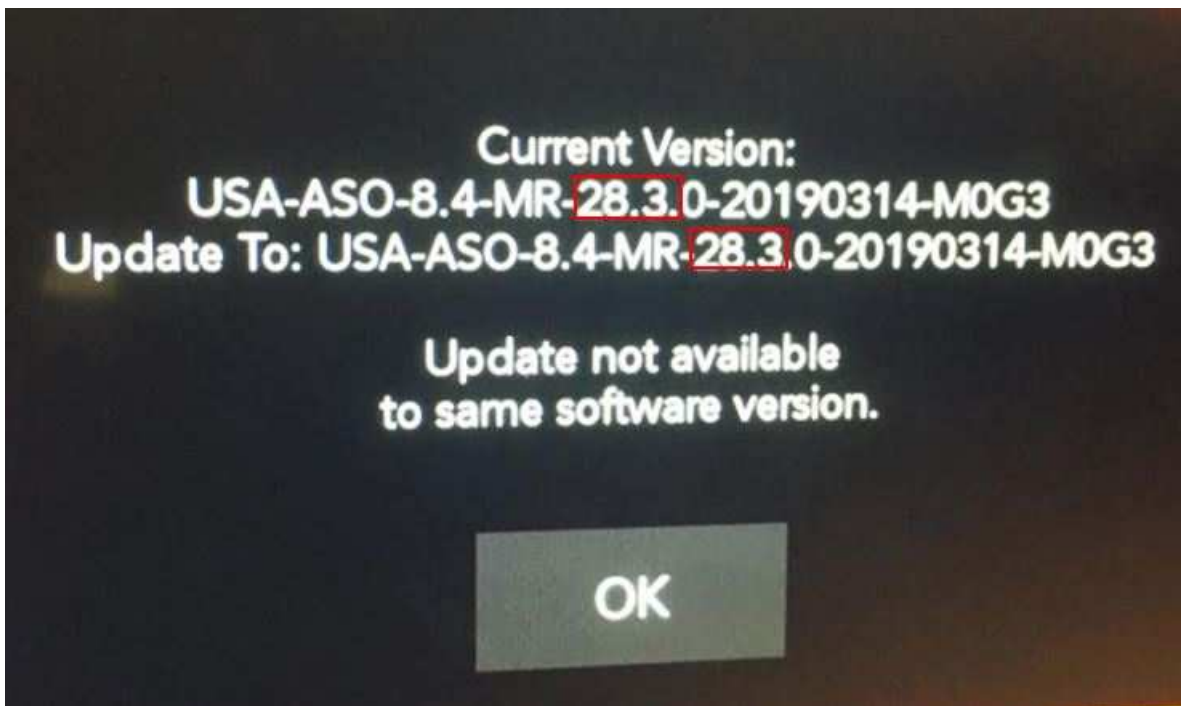
Fig. 6
Screen Displayed When Radio Software Level Is Up To Date

11. If the radio software is up to date, the screen in (Fig. 6) will be displayed. Press "OK" and remove the USB flash drive.

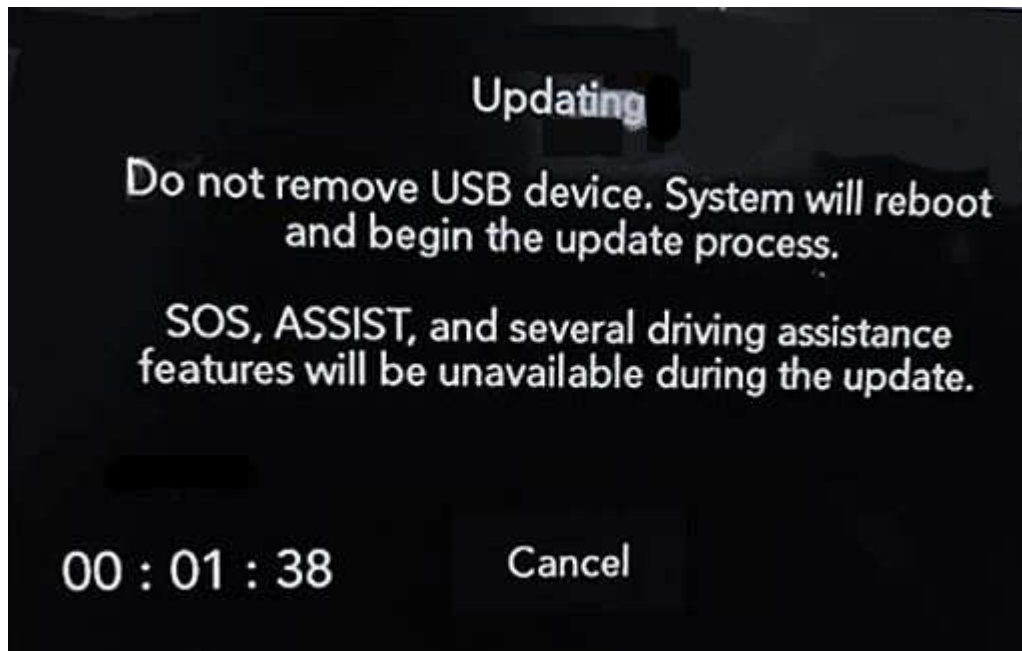
Fig. 8
Radio Update Process Begins

13. When the radio starts updating, the screen in (Fig. 8) will be displayed.

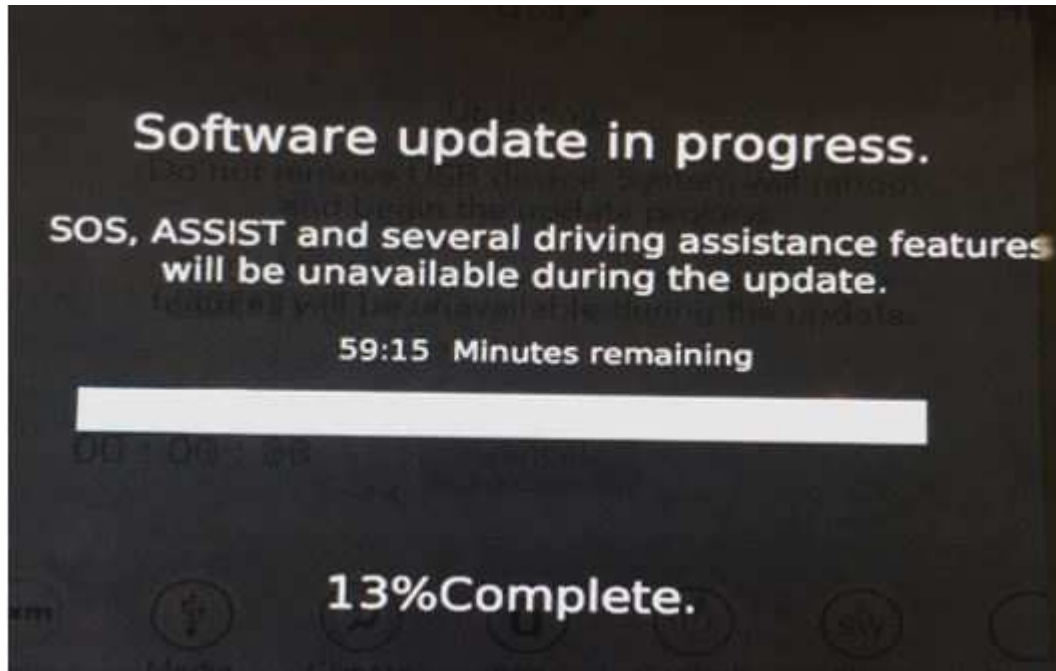
Fig. 9

NOTE: The completion indicator may not reach 100%, even though the software update has been completed. Once the software update has finished, the radio and display screen will turn off.

Software Update In Progress

14. The radio will reboot and the update will begin. The update should only take 25 minutes, the timer on the screen may display the incorrect time remaining, (Fig. 9) .

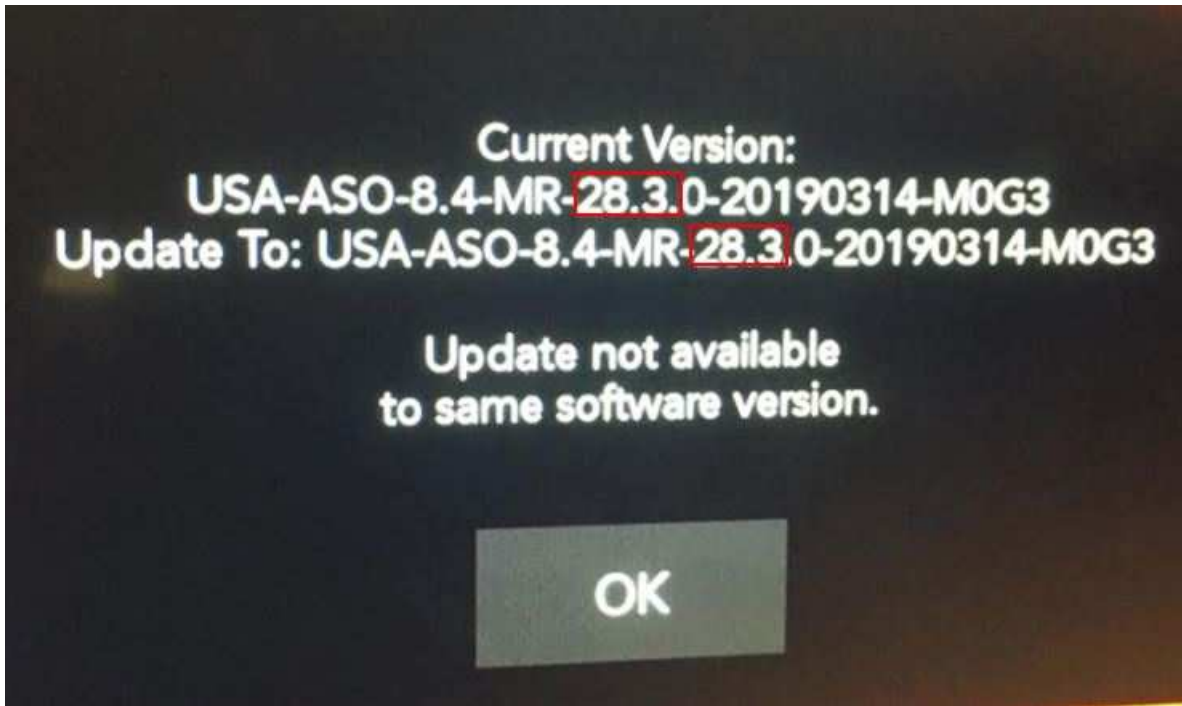
Fig. 10
Radio Software Has Been Updated.

15. After the update has completed, the radio will shut down. With the USB flash drive still inserted in the USB port, turn the ignition back to the run position. If the radio has been updated correctly, the screen in (Fig. 10) will be displayed. Press "OK" and remove the USB flash drive.
