NUMBER: 08-116-19

GROUP: 08 - Electrical

UAV Radio Enhancements

2019 (RU) Chrysler Pacifica

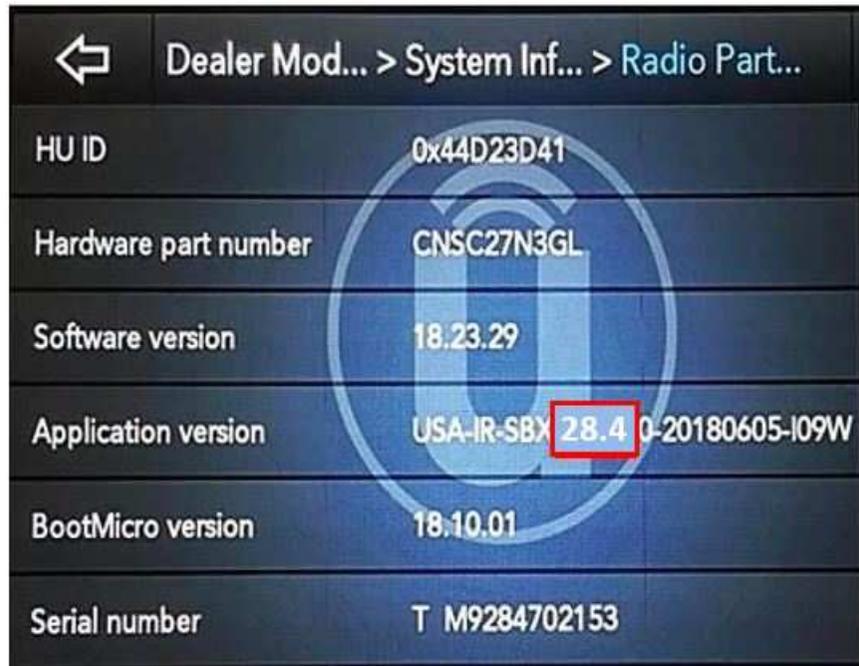
Fig. 1

Radio Software Level Screen

1. Verify the radio software version. Radio must be in Dealer Mode to verify. To put the radio in Dealer Mode, follow these steps:
 - a. Press and hold both lower corners of the display screen, until the Dealer Mode screen appears (approximately seven seconds). Release buttons.
 - b. Select "Radio Part Information". The software level will be listed next to "Application Version" (Fig. 1) .

2. Is the radio software level (Application Version) at or higher than 28.4 ?
 - YES >>> The radio software is already up to date. Normal diagnostic should be performed.
 - NO >>> Proceed to [Step 1](#) of the Repair Procedure.

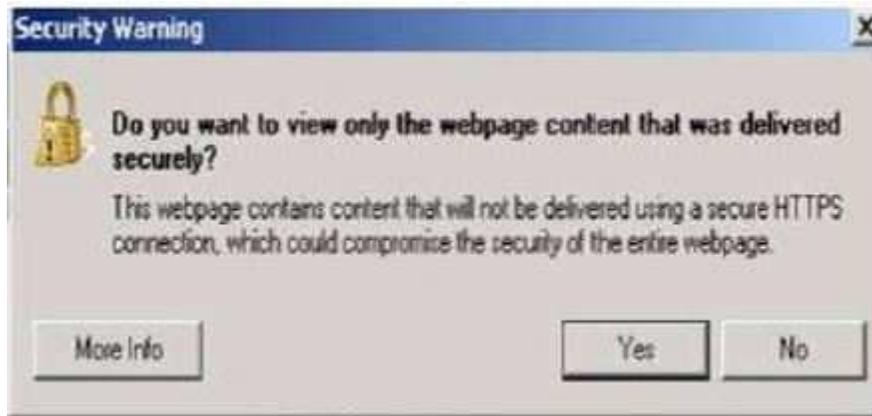
Fig. 2
Pop-Up Security Message

2. Go to DealerCONNECT>Service>Uconnect Command Center>Uconnect>More Information>Dealer software downloads to download the files.
3. If a security message appears “Do you want to view only the web page content that was delivered securely?” (Fig. 2) . Press “No” to continue.

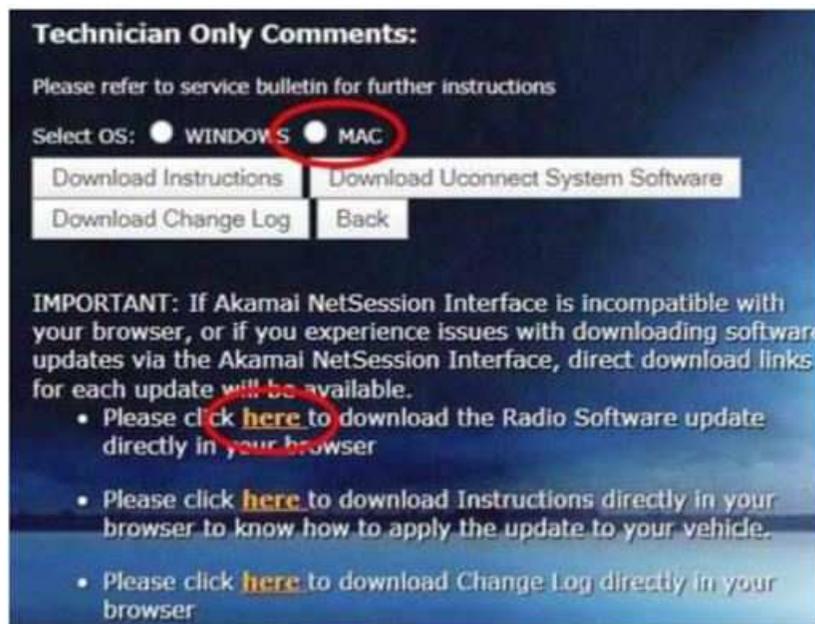
Fig. 3
MAC Download Steps

4. Use a blank USB flash drive with at least 16GB of space. Follow the on-screen instructions to download the software files.
5. Download the software update file to your local PC’s desktop. Make sure to select the “MAC” radial button for all downloads (Fig. 3) .

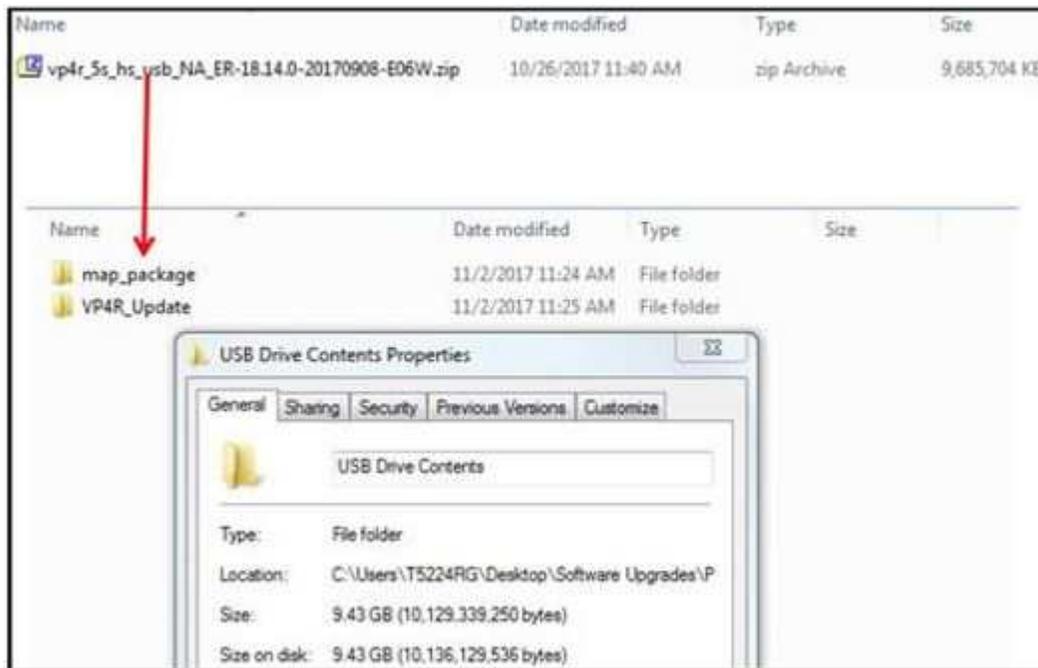
Fig. 4
Files/Folders In The USB Flash Drive

7. Unzip all the files to the root folder of USB flash drive. Files should not be within a zip folder. Your USB files should look like (Fig. 4) when you open it, displaying multiple files/folders.

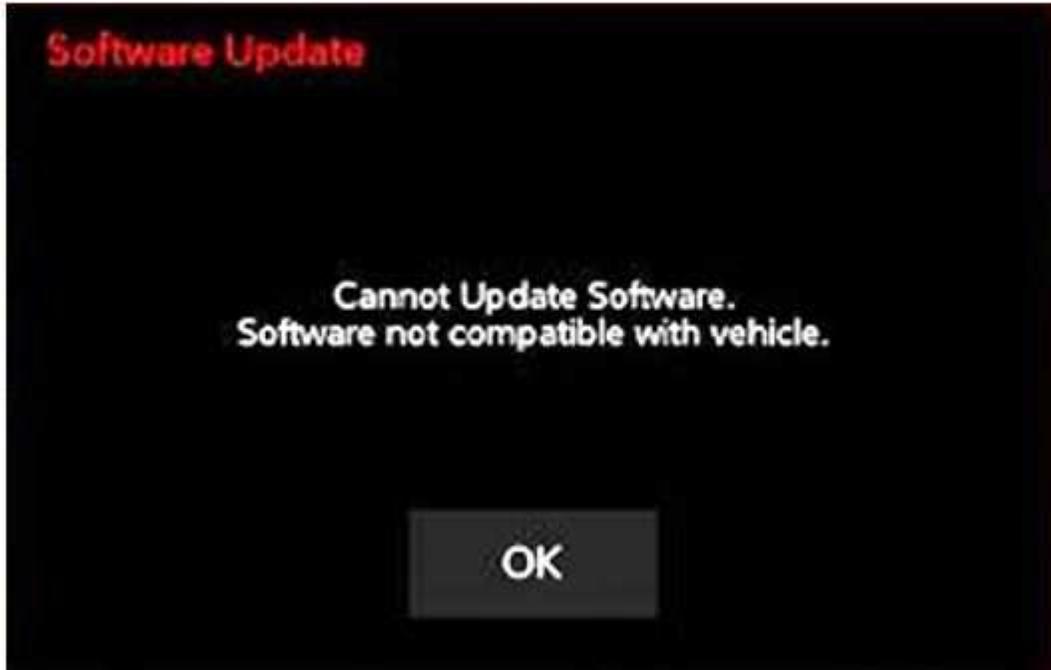
Fig. 5
Software Not Compatible

10. If the screen in (Fig. 5) is displayed, the USB flash drive was not set up correctly. Use a top name brand USB flash drive like Kingston and create a new flash drive and start the update again.

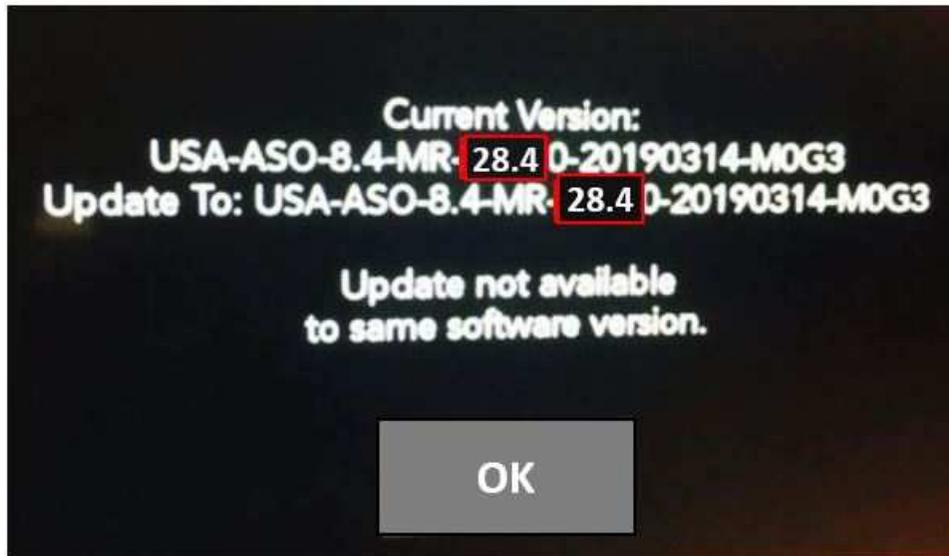
Fig. 6
Screen Displayed When Radio Software Level Is Up To Date

11. If the radio software is up to date, the screen in (Fig. 6) will be displayed. Press "OK" and remove the USB flash drive.

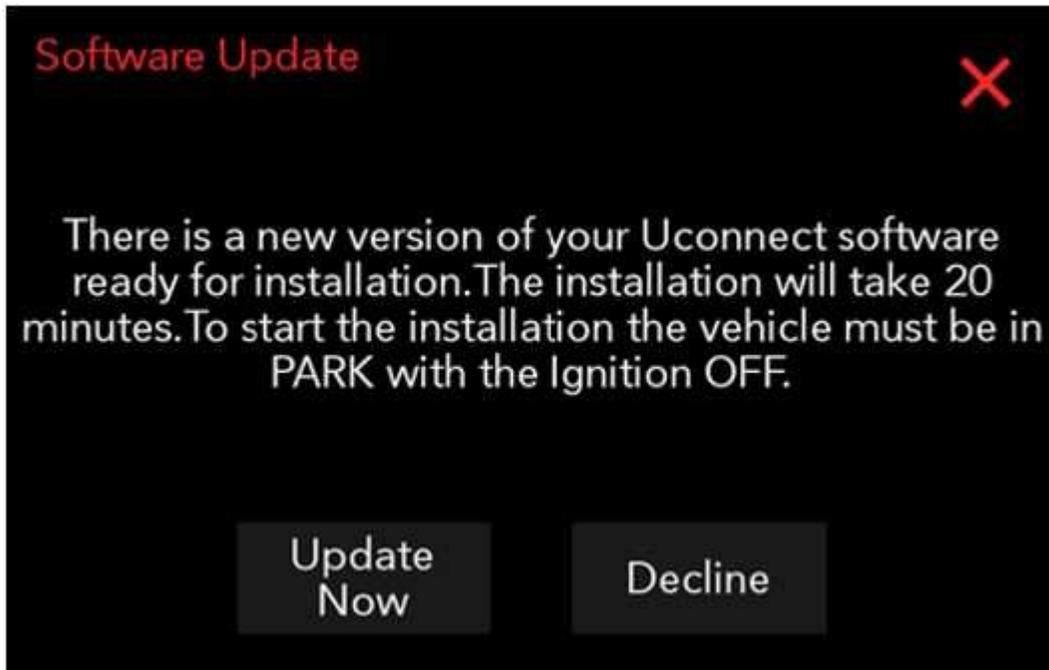
Fig. 7
Software Update Is Available

12. Once the system has verified there is an available update, press the “Update Now” button. Make sure the vehicle is in park. **Do NOT turn off the ignition at this point**, (Fig. 7) .

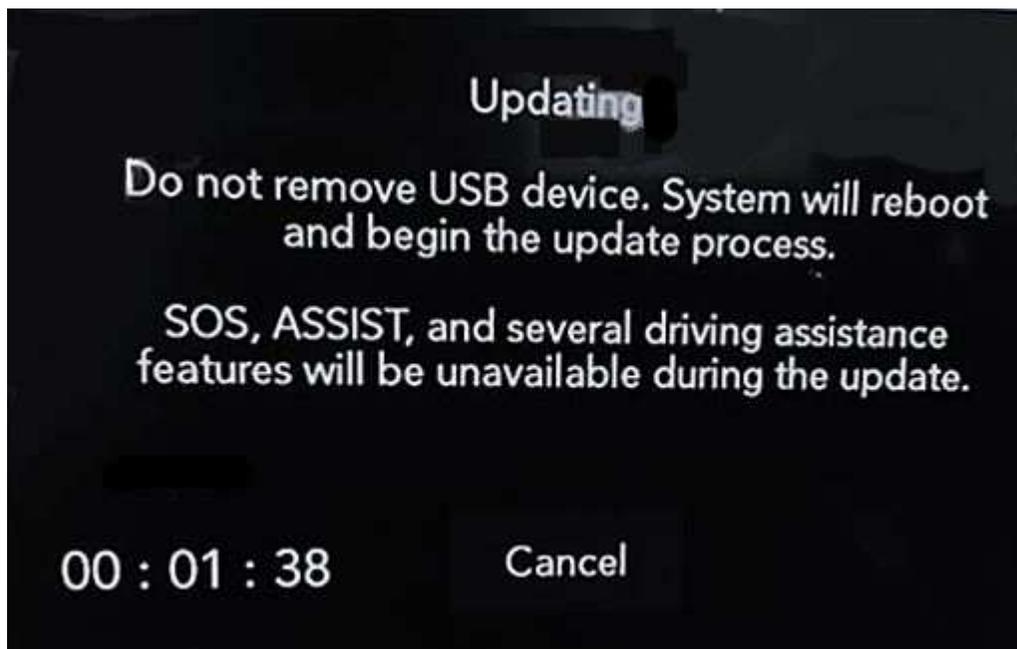
Fig. 8
Radio Update Process Begins

13. When the radio starts updating, the screen in (Fig. 8) will be displayed.

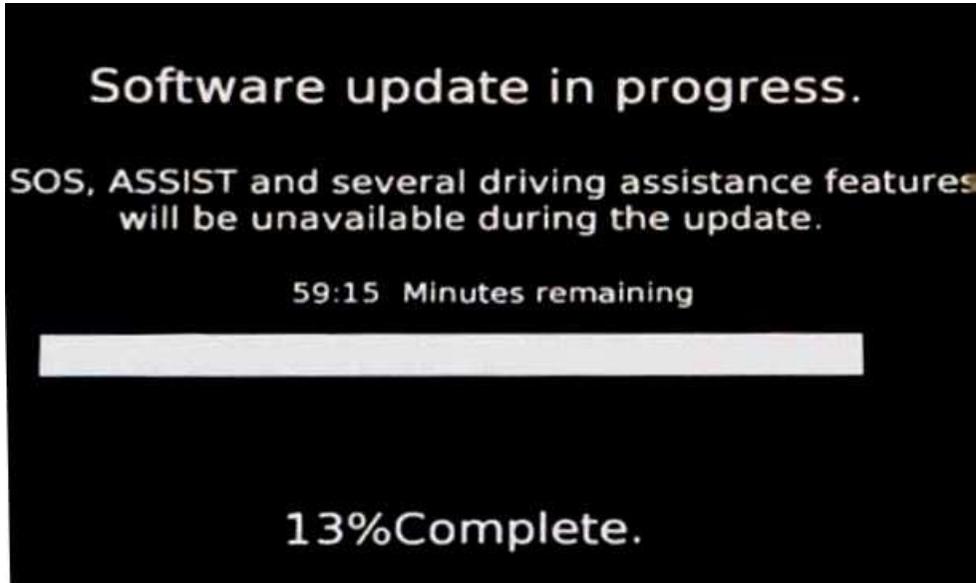
Fig. 9
Software Update In Progress

NOTE: The completion indicator may not reach 100%, even though the software update has been completed. Once the software update has finished, the radio and display screen will turn off (Fig. 9) .

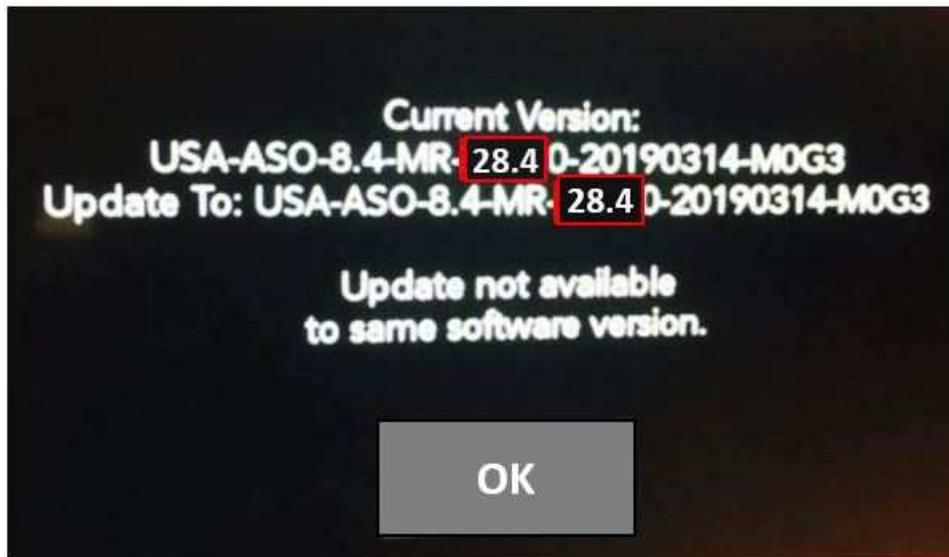
Fig. 10
Software Levels.

15. After the update has completed, the radio will shut down. With the USB flash drive still inserted in the USB port, turn the ignition back to the run position. If the radio has been updated correctly, the screen in (Fig. 10) will be displayed. Press "OK" and remove the USB flash drive.
