Service Bulletin

Bulletin No.: 19-NA-068

Subject: Malfunction Indicator Lamp (MIL) Illuminated, Intermittent Service Messages, Gauges May Be Erratic - DTCs U0073, U0121, U0100 and/or U0101 Set, G103 Inspection

Brand:	Model:	Model Year:		VIN:		Engine:	Transmission:
		from	to	from	to		
Chevrolet	TRAX	2015	2019			All	All

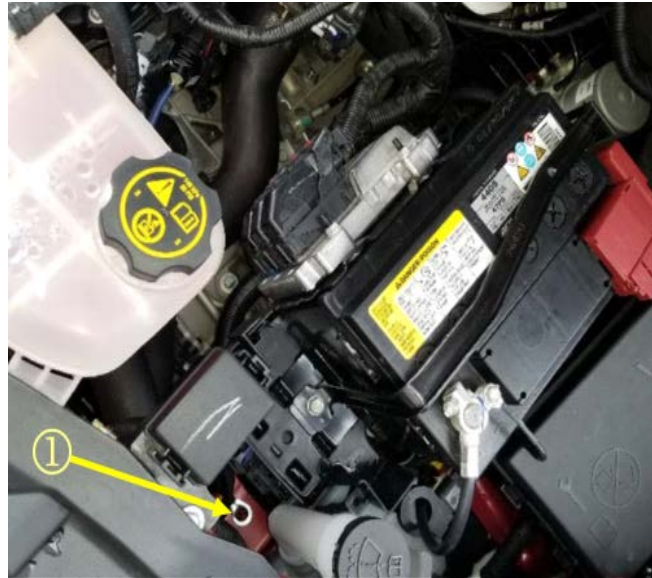
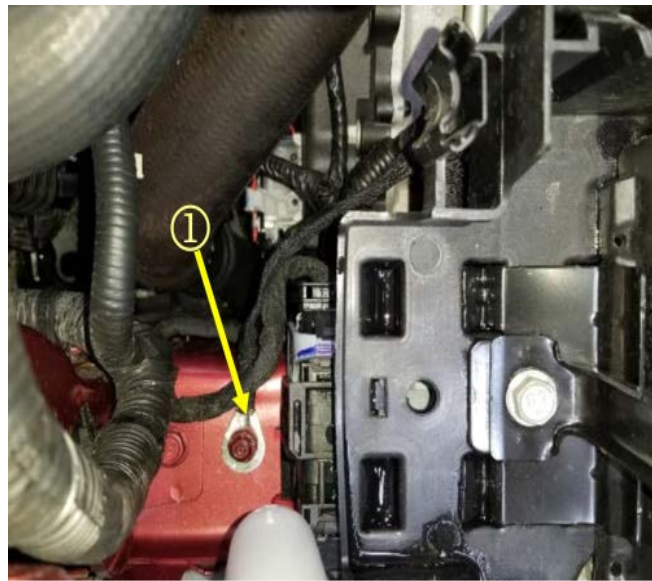
The cause of the condition may be a poor ground connection at G103 (1), located at the left front frame rail in front of the battery.

</div> <p style="text-align: right; font-size: small;">5312724</p> <p>Important: Check resistance of the stud, as well as the nut and ground eyelet. If equipped with hex shaped/anti-rotational feature, after cleaning, ensure that the eyelet fully seats down onto the stud hex feature before torquing the fastener.</p> <p>Perform inspection on ground G103; clean and/or remove paint from the grounds contact points and torque fastener to specification.</p> <p>⇒ Refer to Fastener Specifications in SI.</p>
--------------------------	---
