Service Bulletin

Bulletin No.: 19-NA-100

Date: November, 2019

Subject: Radio Software Version 22.8 Over-the-Air Update

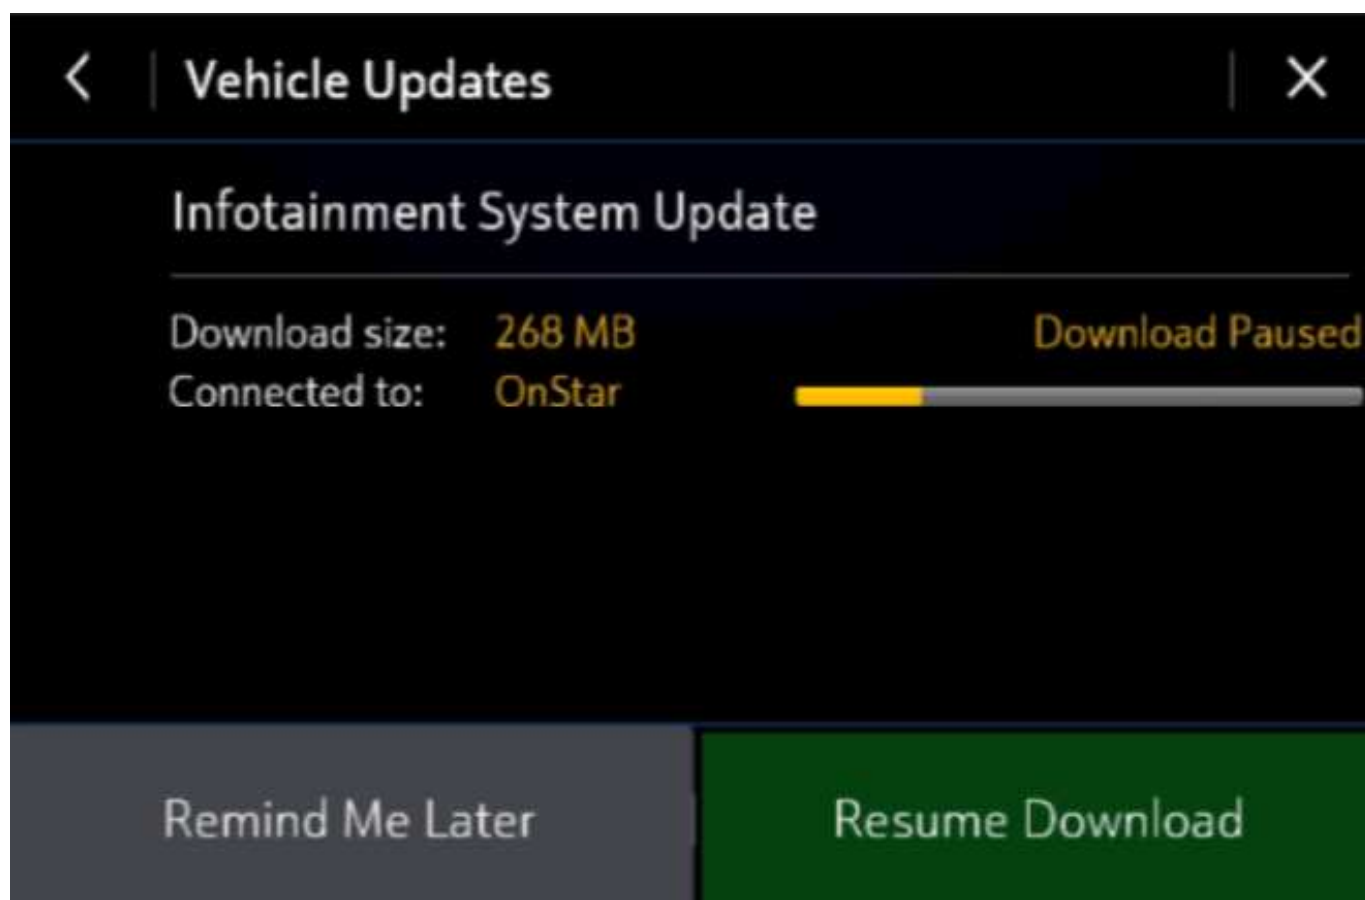
5313332

Caution: If Vehicle Update screen shows “Infotainment System Update” (such as the screen above) do not use TIS2WEB or insert a USB stick. Use of the USB stick when the Remote Update has already been downloaded, installed, or paused during installation could result in program failures or module lockup condition. The update should be completed using the Remote Vehicle Update procedure, following prompts on the infotainment screen. Refer to Update Procedure Using Remote Vehicle Update after reading the remaining information in this section if the Remote Update has already been downloaded to the radio.

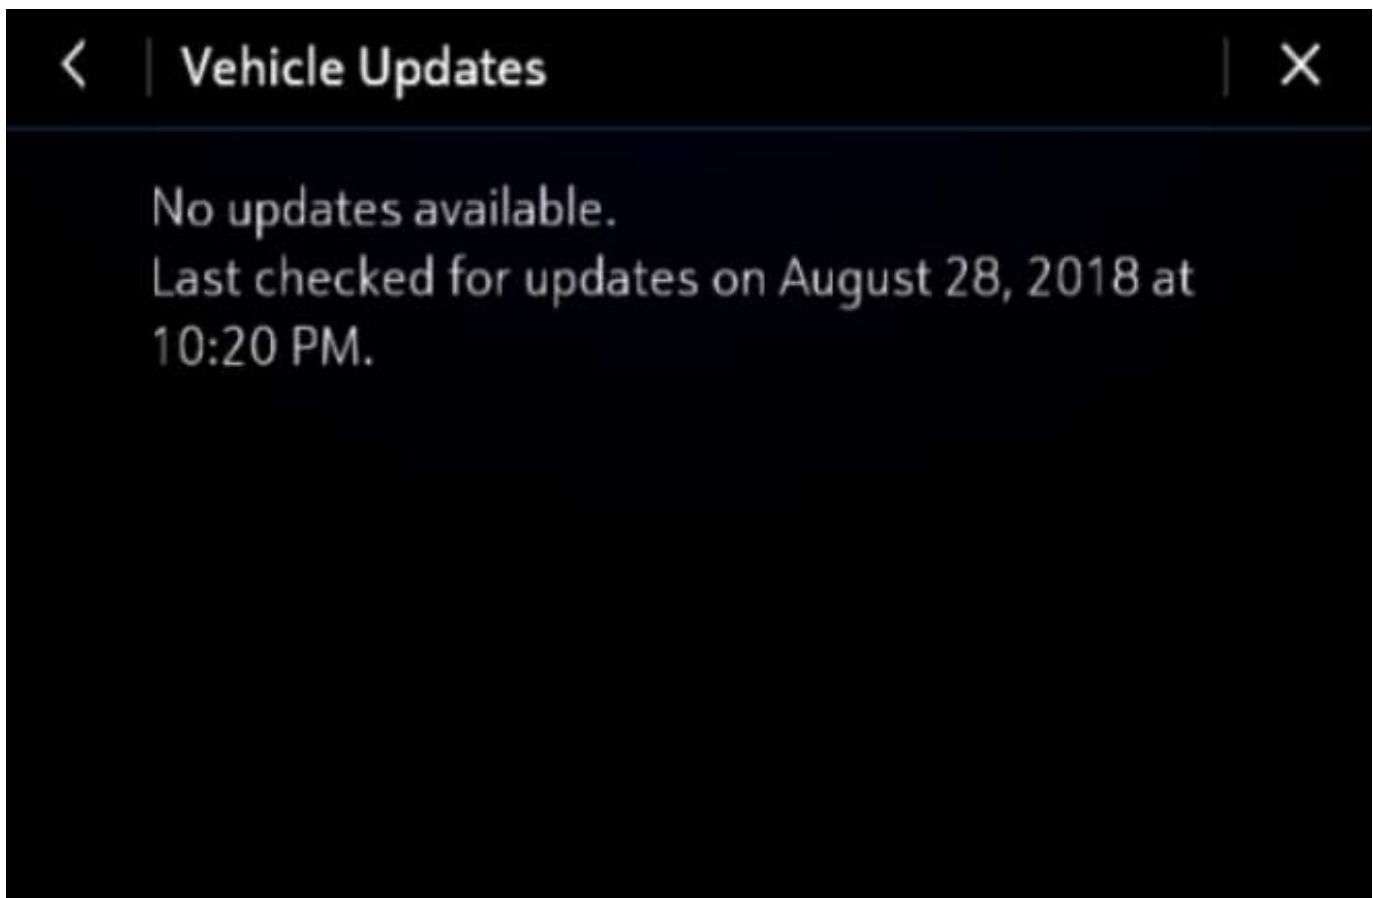
5313324

2. If no "Start Download" or "Install Now" pop up is displayed, navigate to "Settings" -> "Updates." If there is a remote package on the system, it will display "Install Now" Or "Start Download." If the screen below is shown, then there is no remote update package on the system. Navigate to Settings -> About to verify the software version. If the build number is not 22.8 or greater, update via USB.

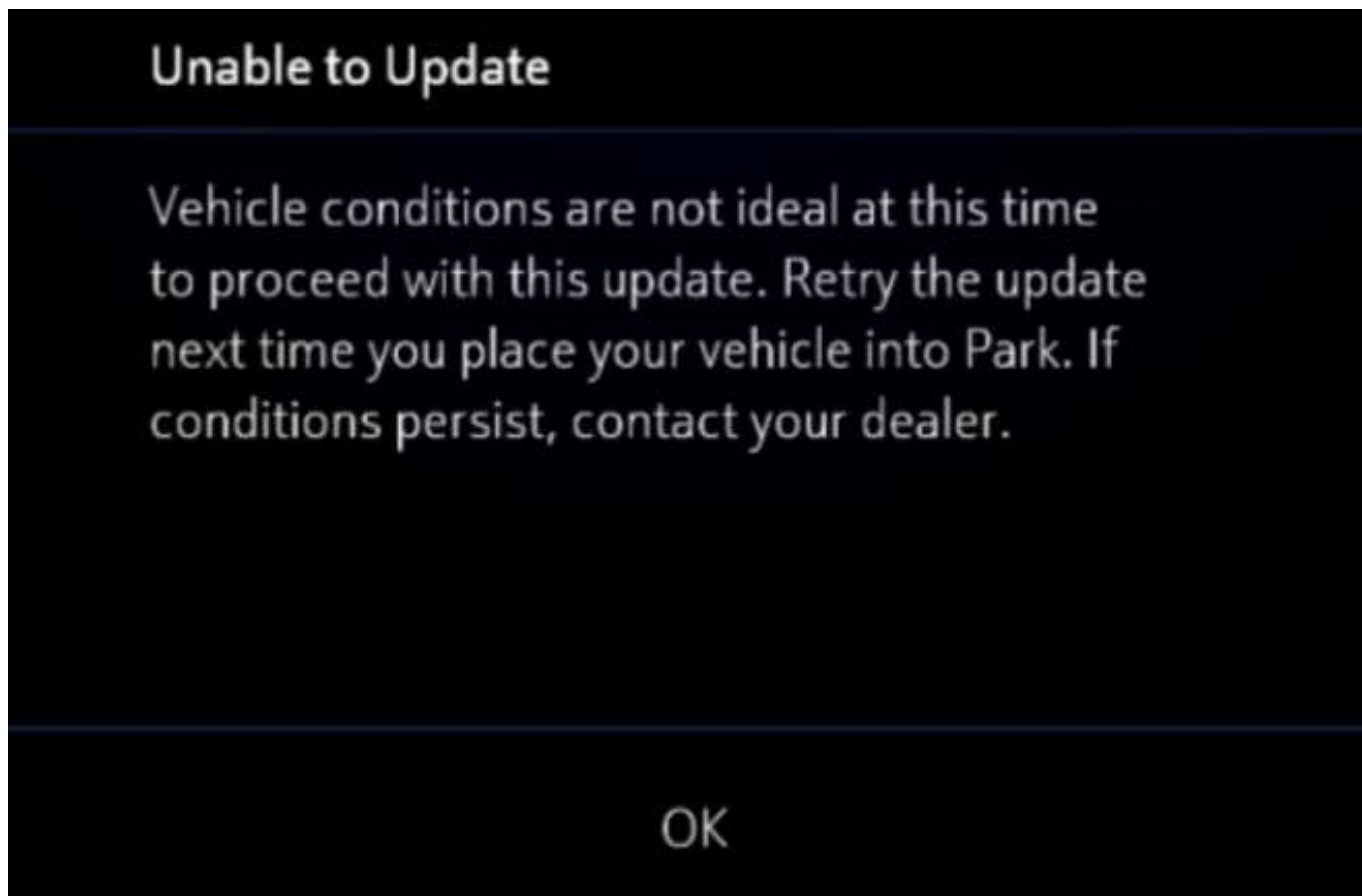
5313329

Scenario 1: Vehicle conditions are not ideal

If the above screen is shown, download the update through TIS2Web and perform USB update. Upon USB insertion while vehicle is running, the "Install Now" pop up will be presented. Ensure the vehicle battery is being maintained (using EL-49642 or battery maintainer) while performing this update.

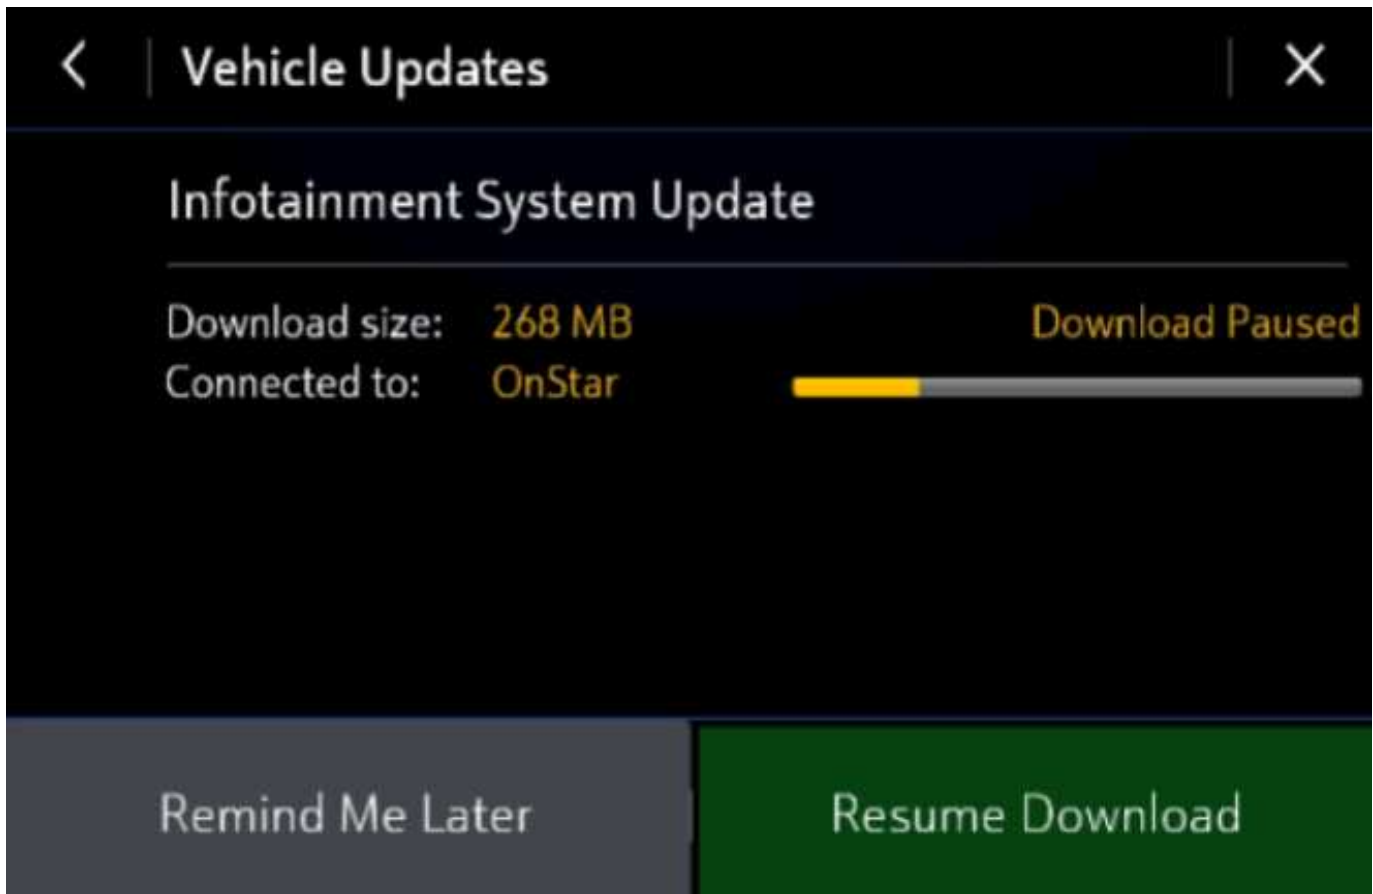
5313326

Scenario 2: Consistently Paused Download

If the above screen is shown and resuming the download repeatedly fails, a USB update will need to be performed. Turn the vehicle on, return to the home screen, and insert USB stick (see previous section). A pop up should be shown to "Install Now." Click "Install Now", verify the part number is correct and follow on screen prompts.

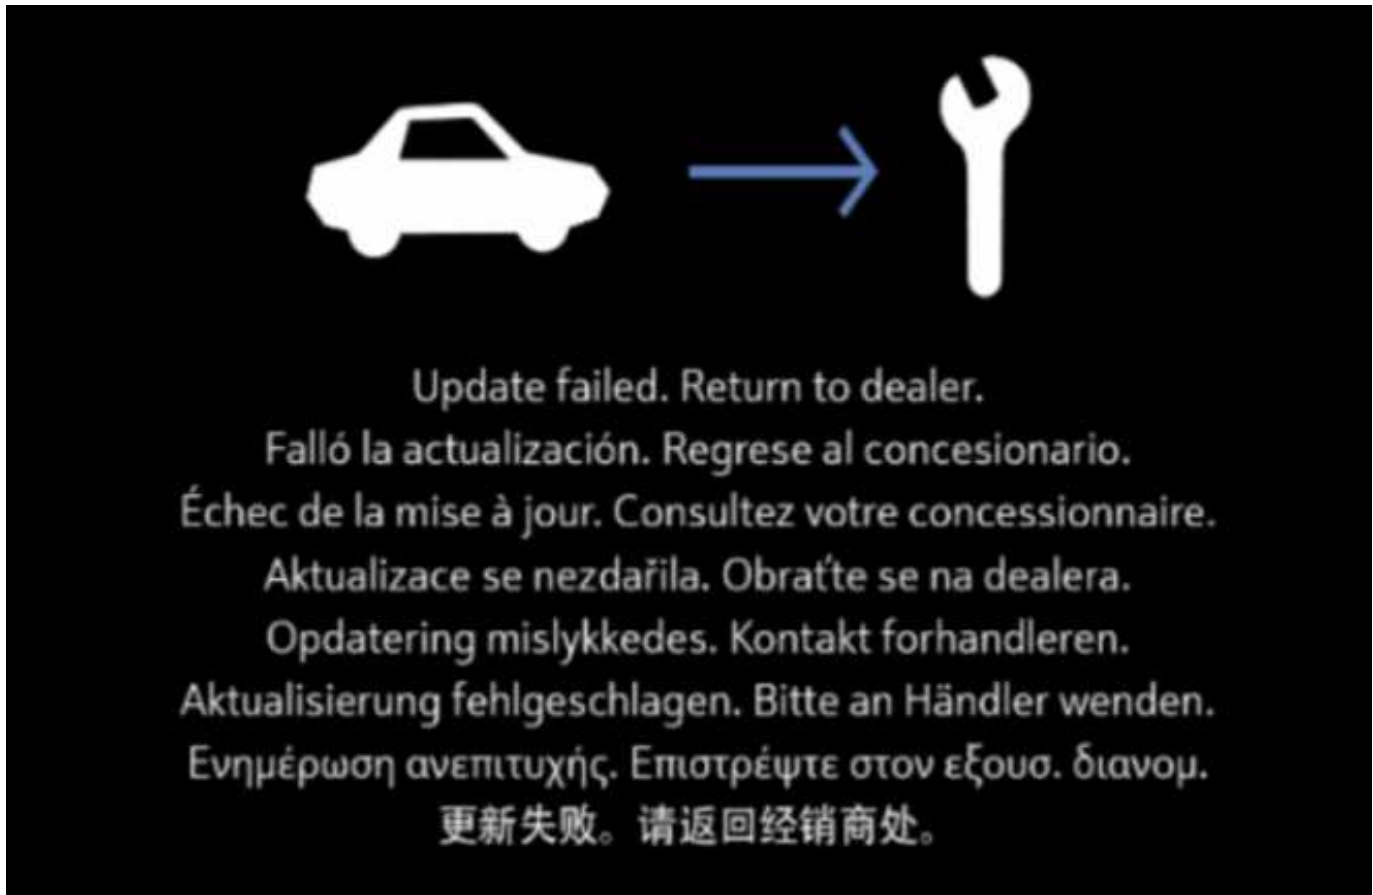
5313330

Scenario 3: Update Failed. Return to dealer screen

1. If the above screen is shown, download the update through TIS2Web and insert USB stick into the radio **twice** (USB stick is not recognized on first insertion). A blue progress bar should come on the screen and update will proceed. If this screen above is shown when trying to update the radio through USB, reformat to FAT32 on your PC, and then try to download the update through TIS2WEB again.
2. After selecting USB File Transfer, if you are prompted by TIS2Web to select a software P/N, then follow the on-screen instruction to attempt to gather the software P/N from the A11 Radio using GDS2 scan tool. If GDS2 indicates the radio is not communicating, go back to TIS2Web, select A11 Radio, and select "Per Bulletin **19-NA-100** " to complete the USB File Transfer programming event.
3. If the screen above is shown again, contact the GM Technical Assistance Center (TAC) for assistance.
