Service Bulletin

Bulletin No.: 19-NA-153

Subject: Malfunction Indicator Lamp (MIL) Illuminated - DTC P0741 Set

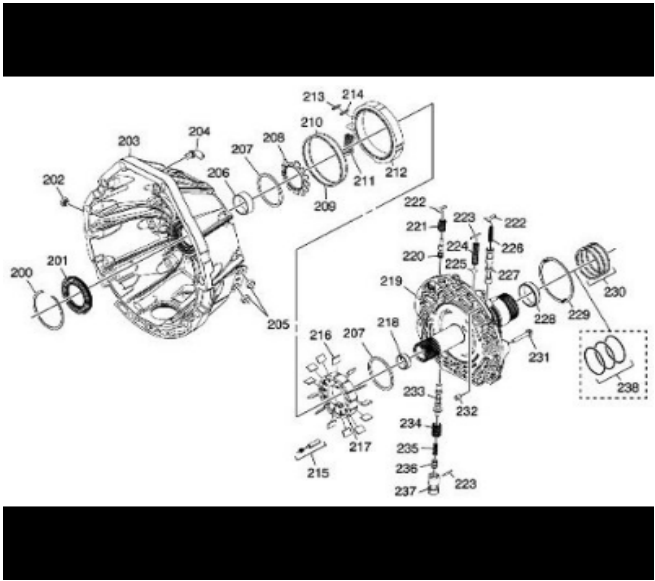
<p style="text-align: right;">5448383</p> <p>This condition may be caused by a damaged turbine shaft front bushing (218) in vehicles with mileage less than 7,000 miles (approx. 11,000 km).</p> <p>⇒ The turbine shaft may also be damaged in the journal area that is in contact with this bushing.</p>
<p>Cause 2</p>	<p>This condition may be caused by a damaged clutch friction material in the torque converter in vehicles with mileage above 30,000 miles (approx. 48,000 km).</p>
<p>Correction</p>	<p>Perform a line pressure check.</p> <p>⇒ If the line pressure is low, check the trans pump for damage and refer to the latest version of P11447.</p> <ol style="list-style-type: none"> 1. Connect GDS to the vehicle for a road test. 2. Select TCM and navigate to the TCC dynamic test screen. 3. Drive the vehicle at approximately 10 mph (16 km/h) and command the TCC on and off several times. Note if the TCC engages; <p>⇒ Should feel TCC engagement and see tachometer drop.</p> <p>⇒ TCC slip speed will drop to near zero.</p> <ul style="list-style-type: none"> • If TCC does not engage, refer to SI for P0741 to test for circuit/electrical problem and/or sticking TCC apply valve. • If the TCC does engage, refer to the Service Procedure below.

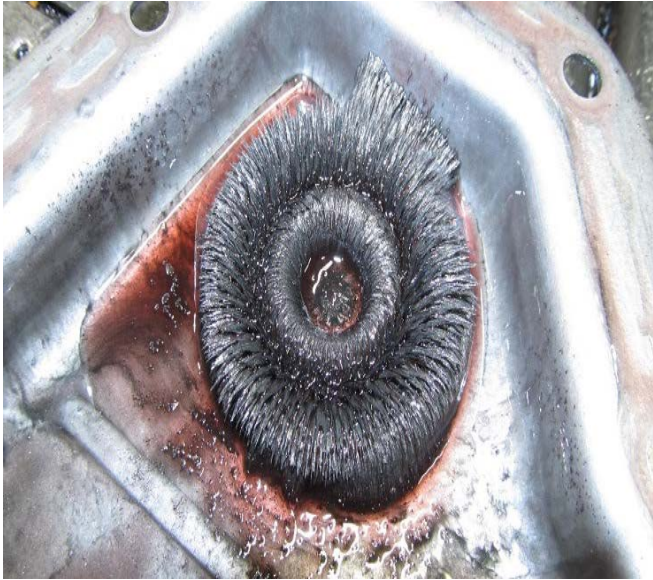
5360216

2. Remove the transmission oil pan.
3. Inspect the magnet in the pan for excessive metal accumulation.
 - If there was no signs of metal in the oil pan, install the pan and no further work is required.
 - If there was excessive metal shaving in the oil pan magnet, continue to step 4.

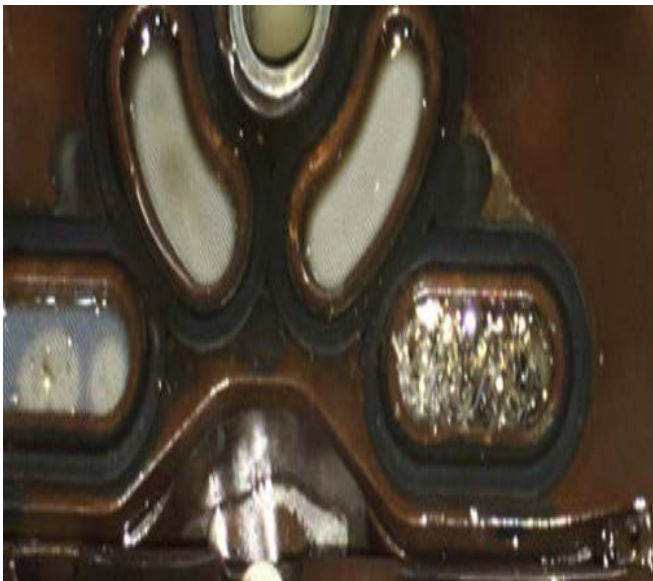
5360222

4. Remove the upper and lower valve body and clean thoroughly.
5. Inspect the TEHCM solenoid screen for debris:
 - If there was no signs of metal in the TEHCM, install the pan and no further work is required.
 - If there was excessive debris in the TEHCM, replace the TEHCM/solenoid valve body **Only** if there is debris on the screen as shown above and continue

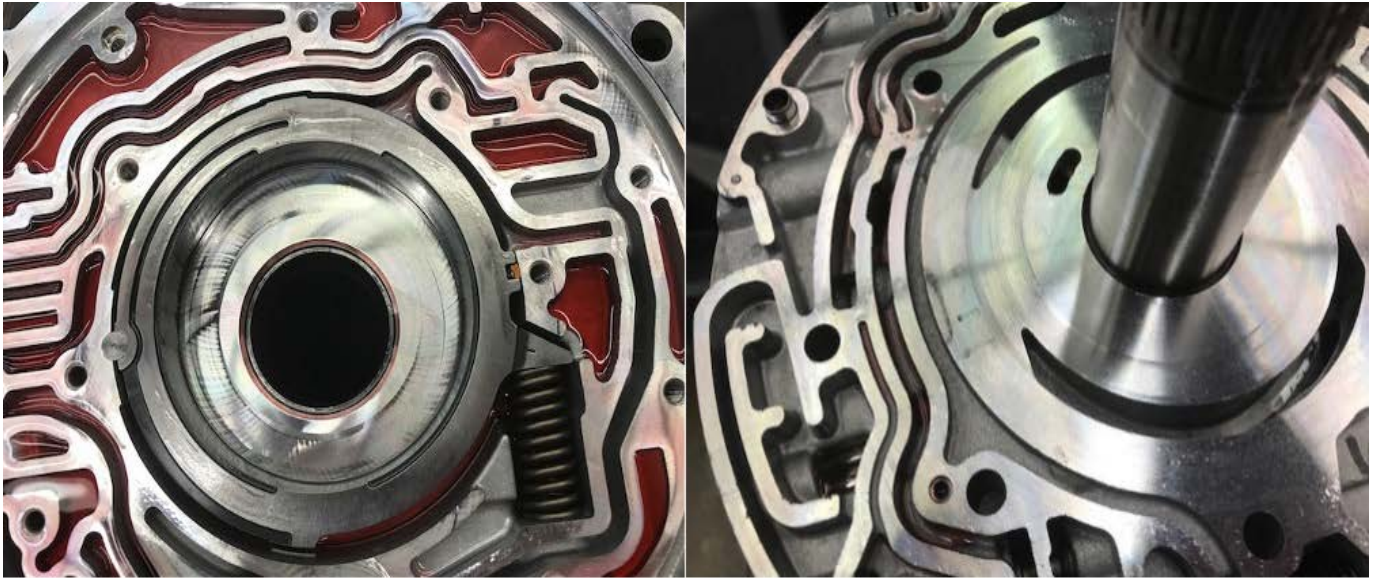
5360776

Do Not replace the pump if no signs of damage or excessive wear was not validated during inspection as shown above.

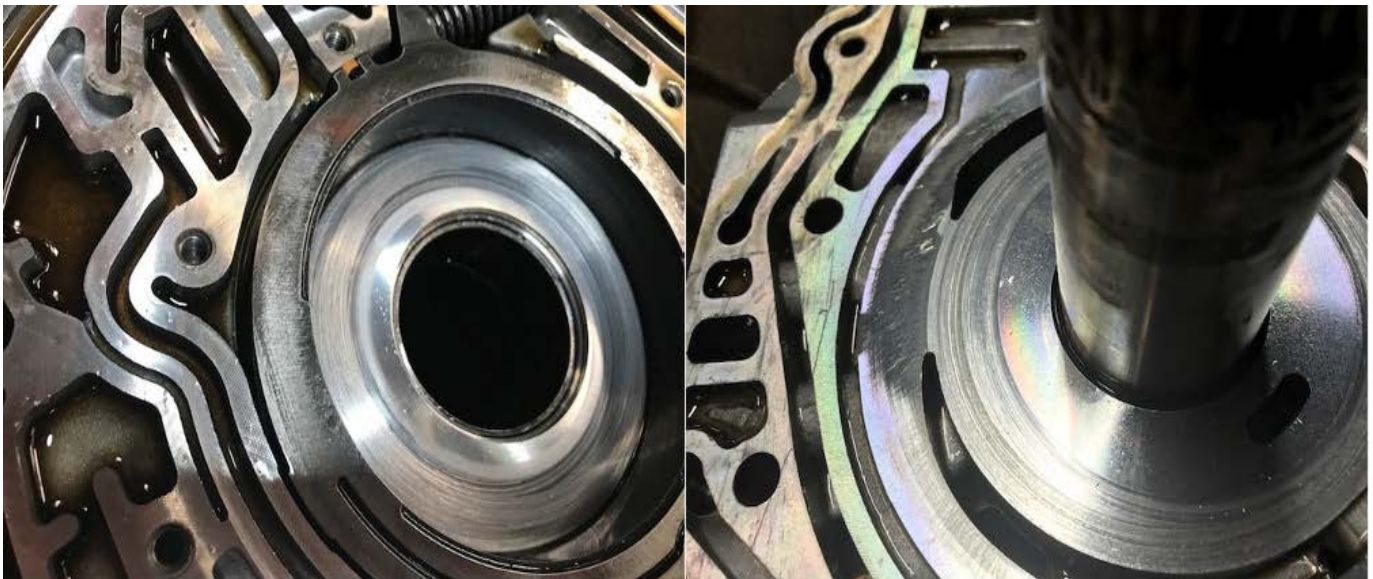
5360218

Note: Refer to the latest version of PI1447 for possible bushing/shaft scoring. Replace parts as necessary.

Perform an inspection of the transmission pump for signs of excessive wear as shown above.

Replace pump components as necessary.
