Service Bulletin

Bulletin No.: 19-NA-167

Subject: Water Leak into Interior, and/or Various Electrical Concerns, Liftgate Actuator Noisy or Inoperative

Brand:	Model:	Model Year:		Date Breakpoint:		Engine:	Transmission:
		from	to	from	to		
Cadillac	XT5	2017	2020			All	All
Cadillac	XT6	2020	2020				
GMC	Acadia VIN N	2017	2017				
	Acadia	2018	2020

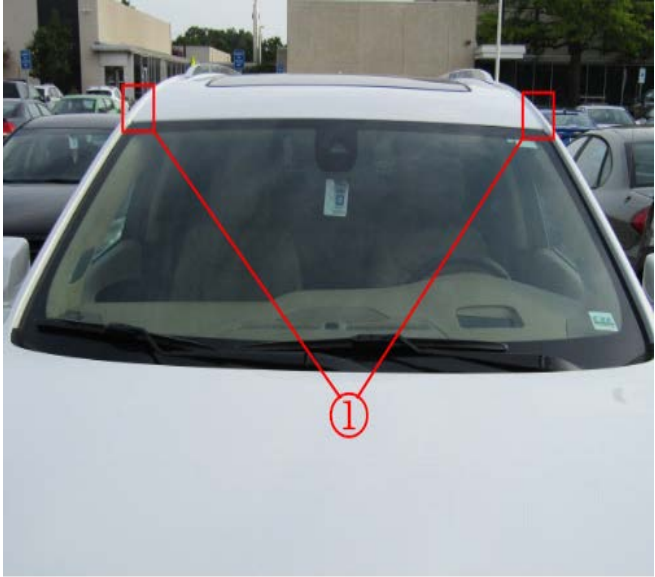
5379776

Involved Region or Country	North America, Russia, Israel, Palestine, Japan, South Korea, Europe, Middle East
Additional Options (RPOs)	
Condition	<p>Some customers may comment on seeing water leak into the interior, or wet carpet. This condition could occur at either the front and/or rear, and on the right and/or left side.</p> <p>Some electrical concerns or issues may occur, such as power locks cycle or are inoperative after a car wash or rain in the XT5 and Acadia, or the liftgate actuator may be noisy or inoperative in an XT6.</p>
Cause	<p>The cause of the condition may be possible "pin hole" voids in the roof panel to outer ring laser braze and seam sealer. The pin holes are most commonly found near the top of the windshield at the A - pillars, or the top of liftgate near the D - pillars. Examples of the leak areas are shown below.</p> <p>Possible Front Laser Braze Water Leak Areas (1)</p>

Following the Service Procedure below, inspect the forward and rear laser braze corners of the roof ditch, at the upper windshield and rear liftgate areas.

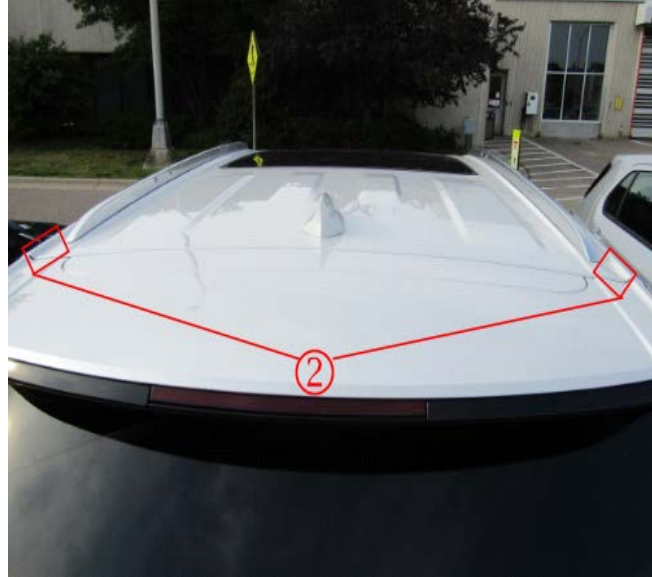
5379781

Possible Rear Laser Braze Water Leak Areas (2)

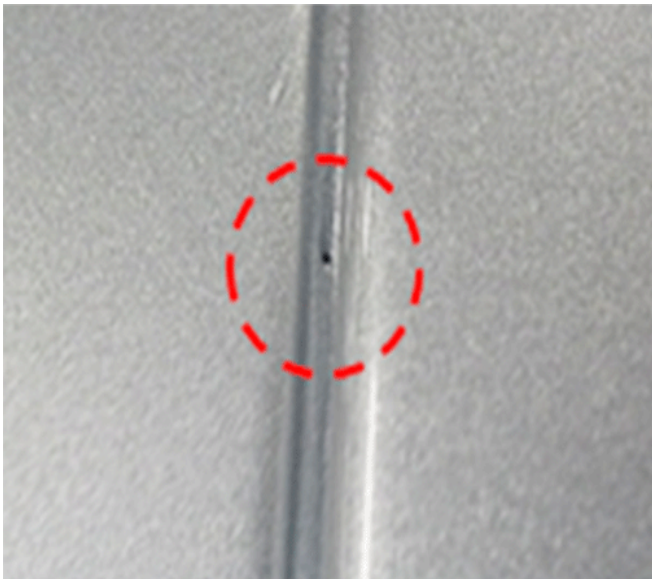
4233899

Note: The pin holes/cracks may be more difficult to see on darker color finishes. A front and rear example of a visible pin hole are shown in the graphics above.

1. Visually inspect the front right and left roof laser braze, then the rear right and left roof laser braze, for pin holes or a crack.
2. Seal the holes/crack in any laser braze area following the steps below:
 - 2.1. Mix a small amount of *Kent Automotive High-Tech Clear Seam Sealer, P/N 10200 (5 oz tube), or equivalent, WITH the proper touch up paint color.
 - 2.2. Avoiding excess sealer build up within the ditch, work a small amount of the sealer into the hole with a gloved finger.
 - 2.3. Wipe away any excess sealer with a light amount of solvent on a rag or paper towel. The solvent will help the sealer flow into the hole/crack.
3. Clean and dry any wet trim. Refer to Floor Carpet Drying in SI.
4. Address and repair any electrical concerns as necessary.
