# Technical Service Bulletin

| <b>Technical Service Bulletin:</b> TSB190190 | <b>Released Date:</b> 11-Nov-2019 |
| <b>Aftertreatment Selective Catalytic Reduction (SCR) Cracked/Broken Outlet Flange</b> | |

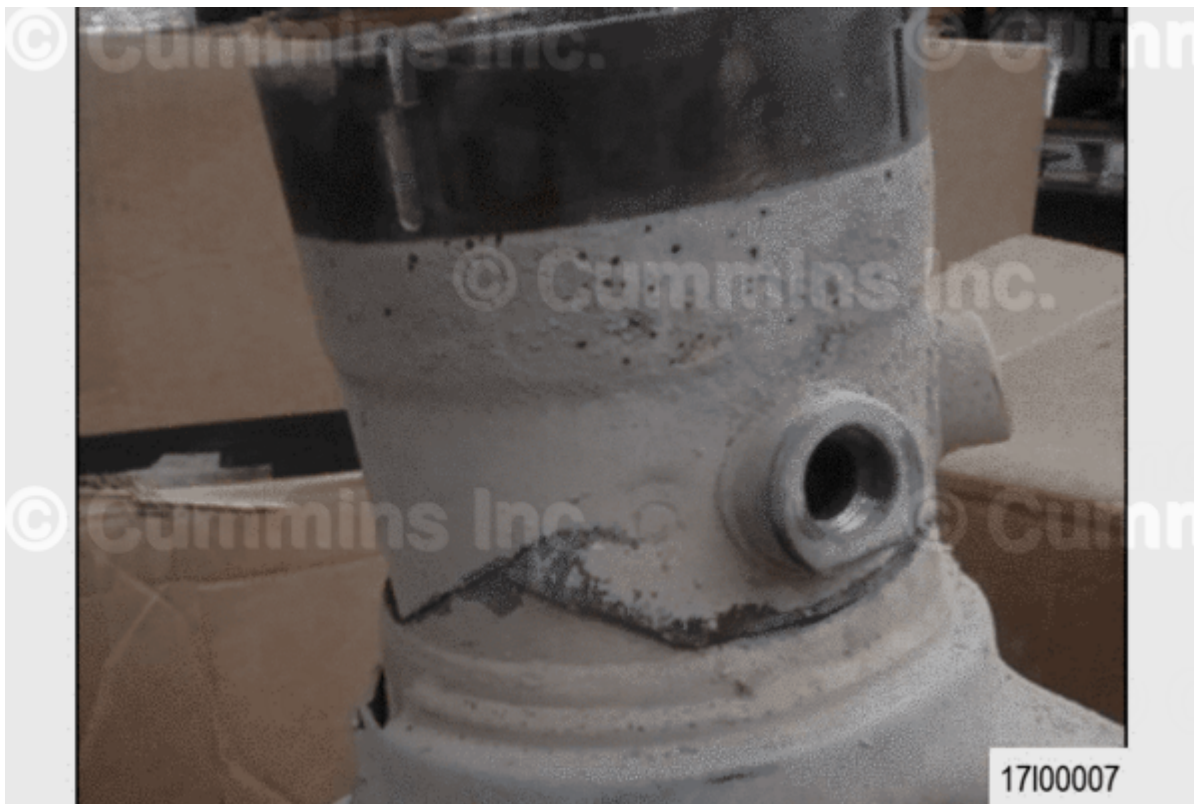
- An exhaust leak is present on the outlet of the aftertreatment selective catalytic reduction (SCR) outlet flange.

- Excessive stress is applied causing cracking or breakage of the aftertreatment SCR outlet flange.
- See Figures 1 and 2 below for examples of cracked/broken outlet of the aftertreatment SCR.

Figure 1, Cracked Aftertreatment SCR Outlet Flange.

If the aftertreatment SCR outlet flange is cracked or broken; replace the aftertreatment SCR. See corresponding Service Manual. Reference Procedure 011-036 in Section 11.

Do **not** weld or modify the aftertreatment SCR outlet flange to correct the malfunction.

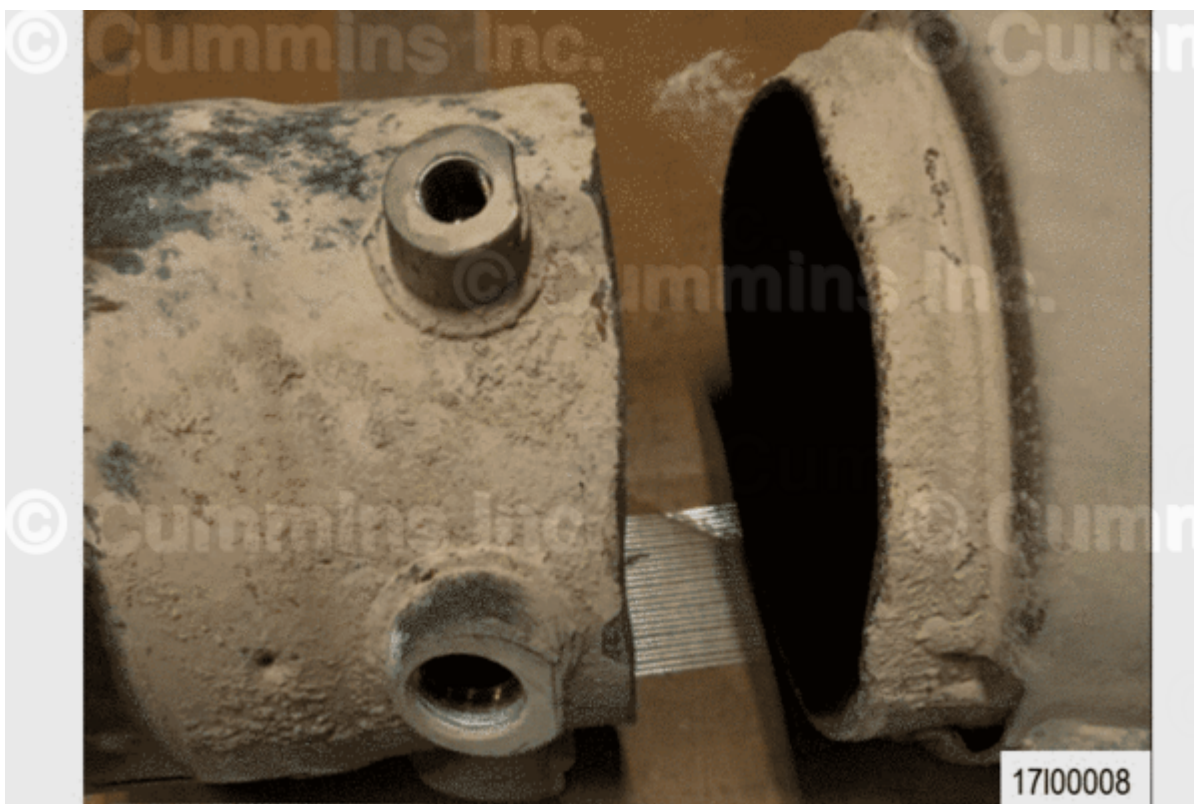
Figure 2, Broken Aftertreatment SCR Outlet Flange.
