# Service Bulletin

Bulletin No.: 18-NA-147

**Subject:** Speedometer and/or Tachometer Needle May Be Incorrect by Up to 6 Degrees

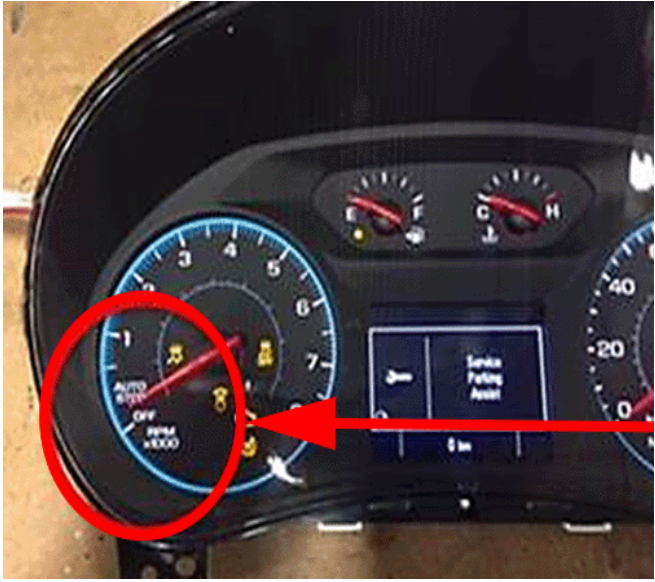
<p style="text-align: right;">5069753</p> <p>Some customers may comment that the speedometer and/or tachometer may be incorrect by up to 6 degrees.</p>
<b>Cause</b>	This may be due to a manufacturing concern with the instrument panel cluster.
<b>Correction</b>	<p>If this concern is experienced, compare the instrument panel cluster calibration/software part numbers to those in TIS2web to determine if any updated instrument panel cluster programming updates are available.</p> <p>If present, program the instrument panel cluster as outlined in the <i>Instrument Cluster Programming and Setup</i> procedure in SI and re-evaluate the concern making sure to complete all required programming events outlined.</p>
