Service Bulletin

Bulletin No.: 19-NA-213

Subject: Service Calibration for Service ESC and/or Service Park Brake Messages

Brand:	Model:	Model Year:		VIN:		Engine:	Transmission:
		from	to	from	to		
Buick	Envision	2018	2020			All	All
Chevrolet	Equinox						
GMC	Terrain						
Holden	Equinox

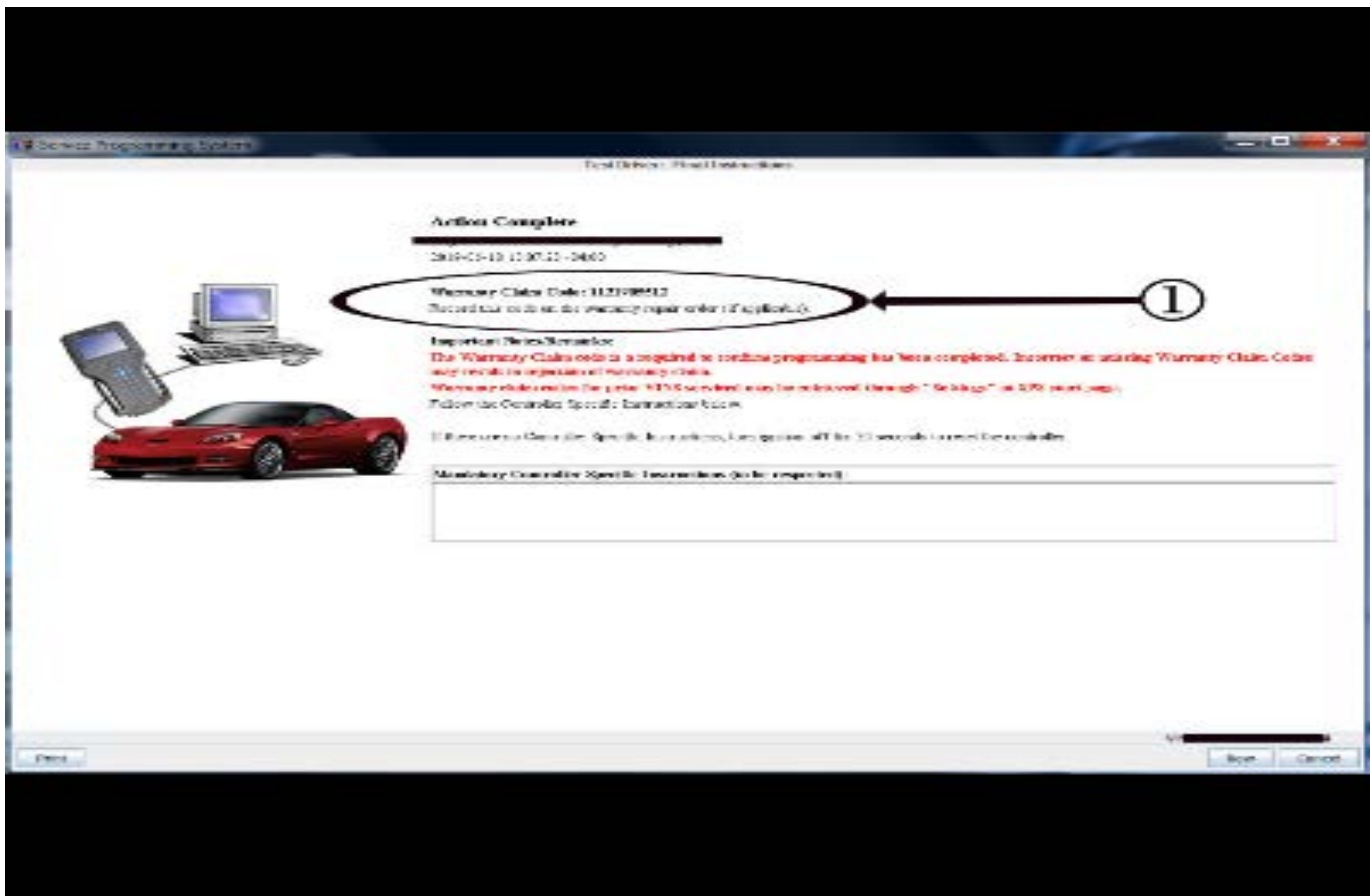
5431209

1. Verify if the Electronic Brake Control Module (EBCM) has the latest software available.

- If the vehicle does not have the most current level of software, reprogram the EBCM to the latest software available. Refer to *K17 Electronic Brake Control Module: Programming and Setup* in SI.
- If the vehicle has the most current level of software, refer to SI to perform system diagnostics.

Note: To avoid warranty transaction rejections, you **MUST** record the warranty claim code provided on the SPS Warranty Claim Code (WCC) screen on the job card. Refer to callout 1 above for the location of the WCC on the SPS screen.
