## Service Bulletin

#### Subject: Service Stabilitrak Message Displayed with Stability Control Disabled

Brand: Model:	Model	Model Year:		VIN:		Engine:	Transmission:
	woder.	from	to	from	to		
Buick	Envision	2019	2019			All	All

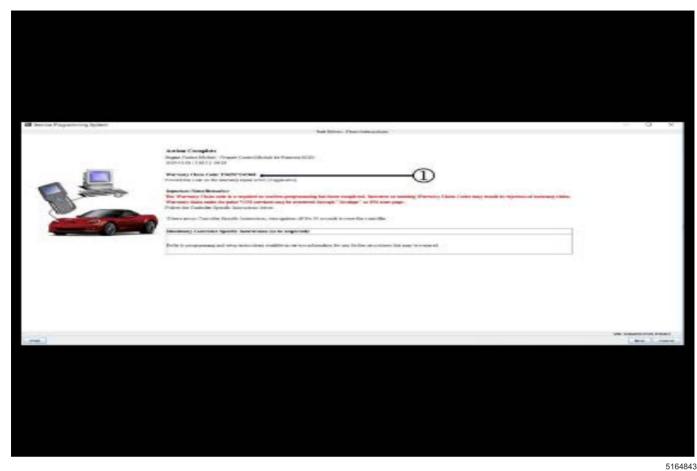
**Note:** If the Same Calibration/Software Warning is noted on the SPS screen, select OK and follow screen instructions. After a successful programming event, the WCC is located in the Service Programming System dialogue box of the SPS Summary screen. No further action is required. Refer to the Warranty section of the bulletin. 1. Reprogram the Electronic Brake Control Module. Refer to K17 Electronic Brake Control Module: Programming and Setup in SI.

2. Record SPS Warranty Claim Code on job card for warranty transaction submission.
