# Service Bulletin

Bulletin No.: 19-NA-244

**Subject:** Harsh 3-2 Downshift During Closed Throttle Coast Down When Coming to a Stop

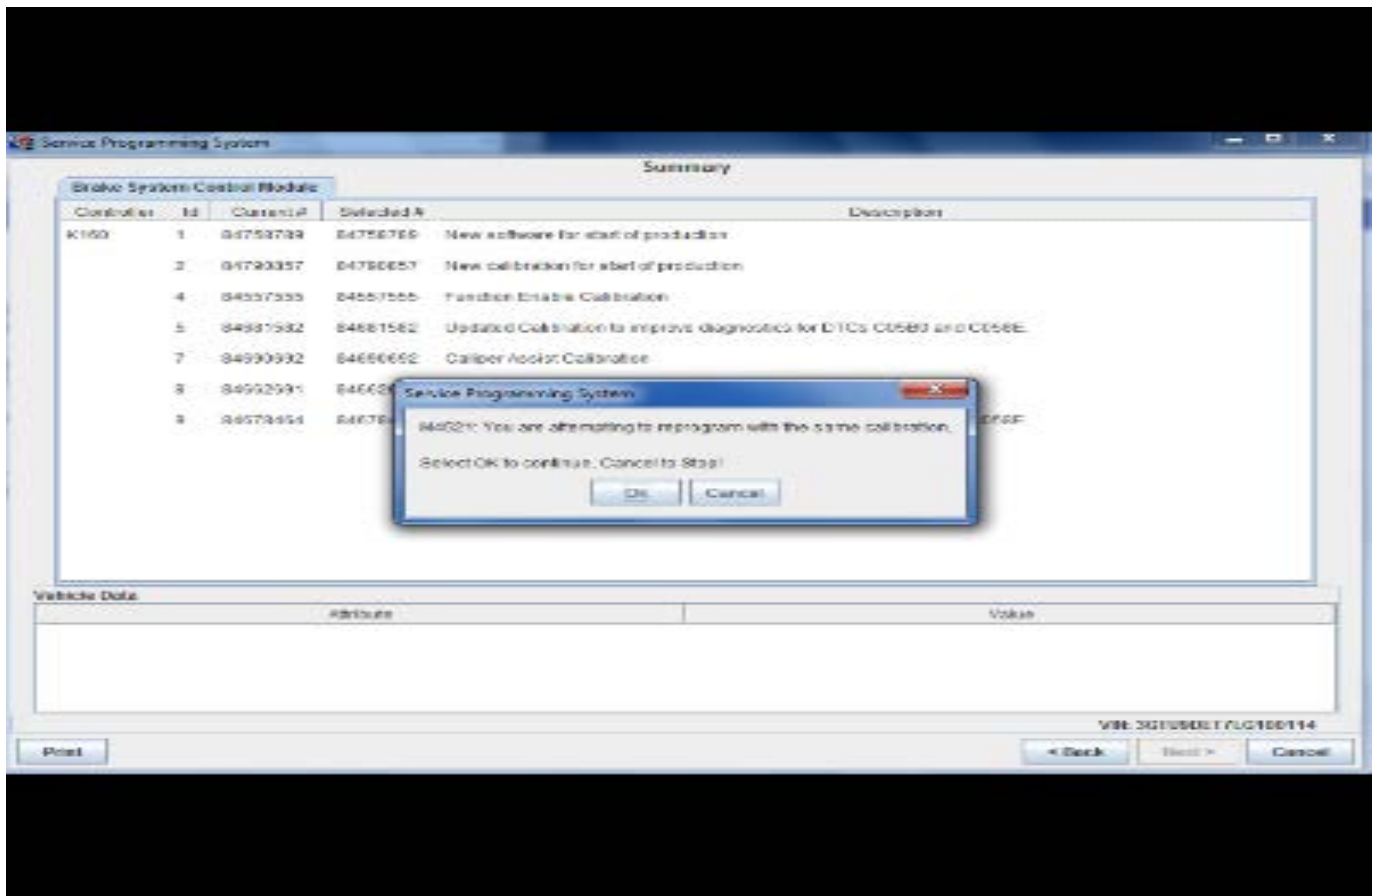
5431207

**Note:** If the Same Calibration/Software Warning is noted on the SPS screen, select OK and follow screen instructions. After a successful programming event, the WCC is located in the Service Programming System dialogue box of the SPS Summary screen. No further action is required. Refer to the Warranty section of the bulletin.

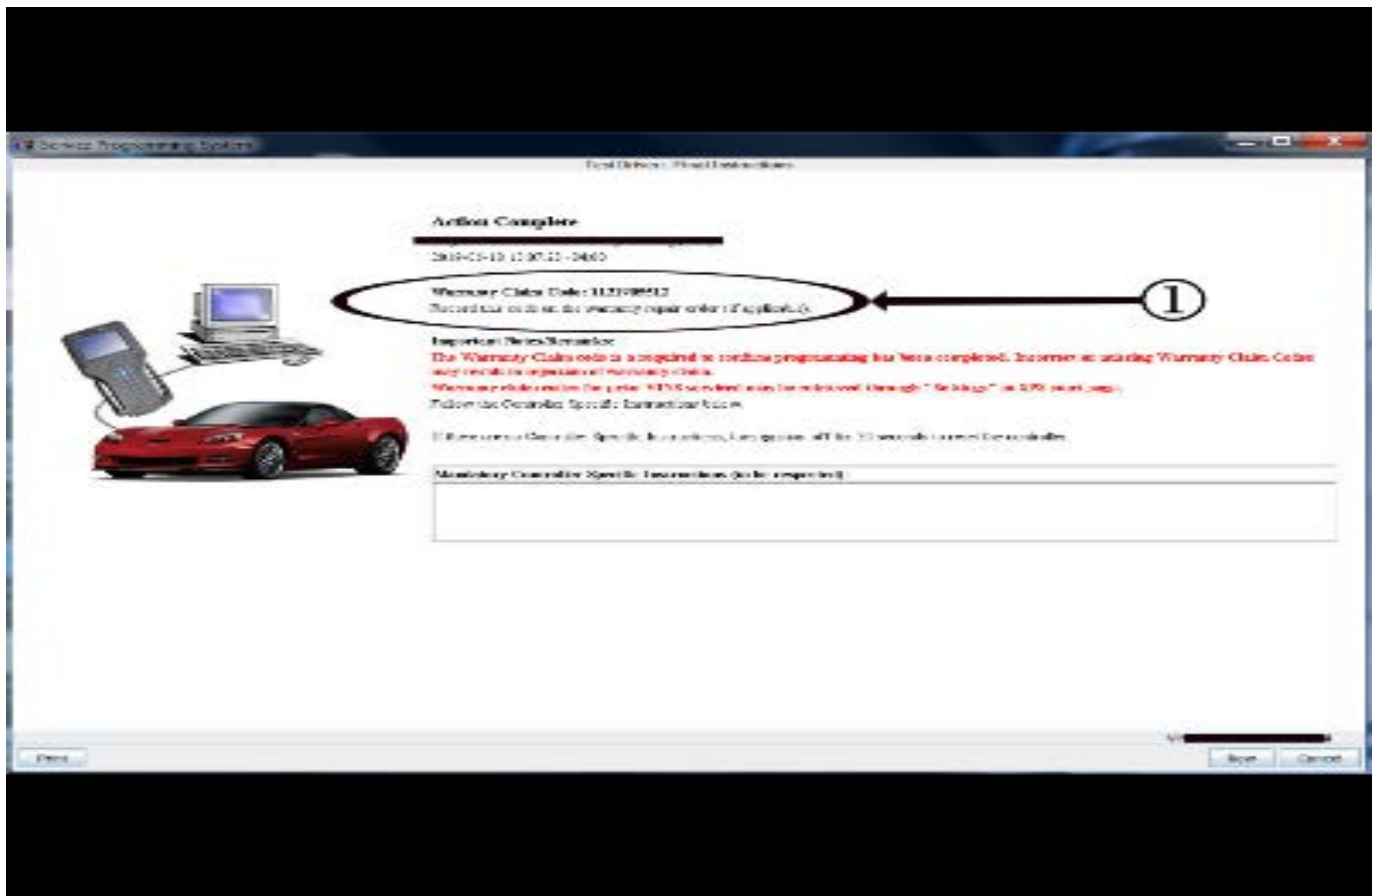
5431209

**Note:** To avoid warranty transaction rejections, you **MUST** record the warranty claim code provided on the SPS Warranty Claim Code (WCC) screen on the job card. Refer to callout 1 above for the location of the WCC on the SPS screen.

- Record SPS Warranty Claim Code on job card for warranty transaction submission.
