# Service Bulletin

Bulletin No.: 19-NA-249

**Subject: Radio Favorites Grayed Out or Unavailable At Times**

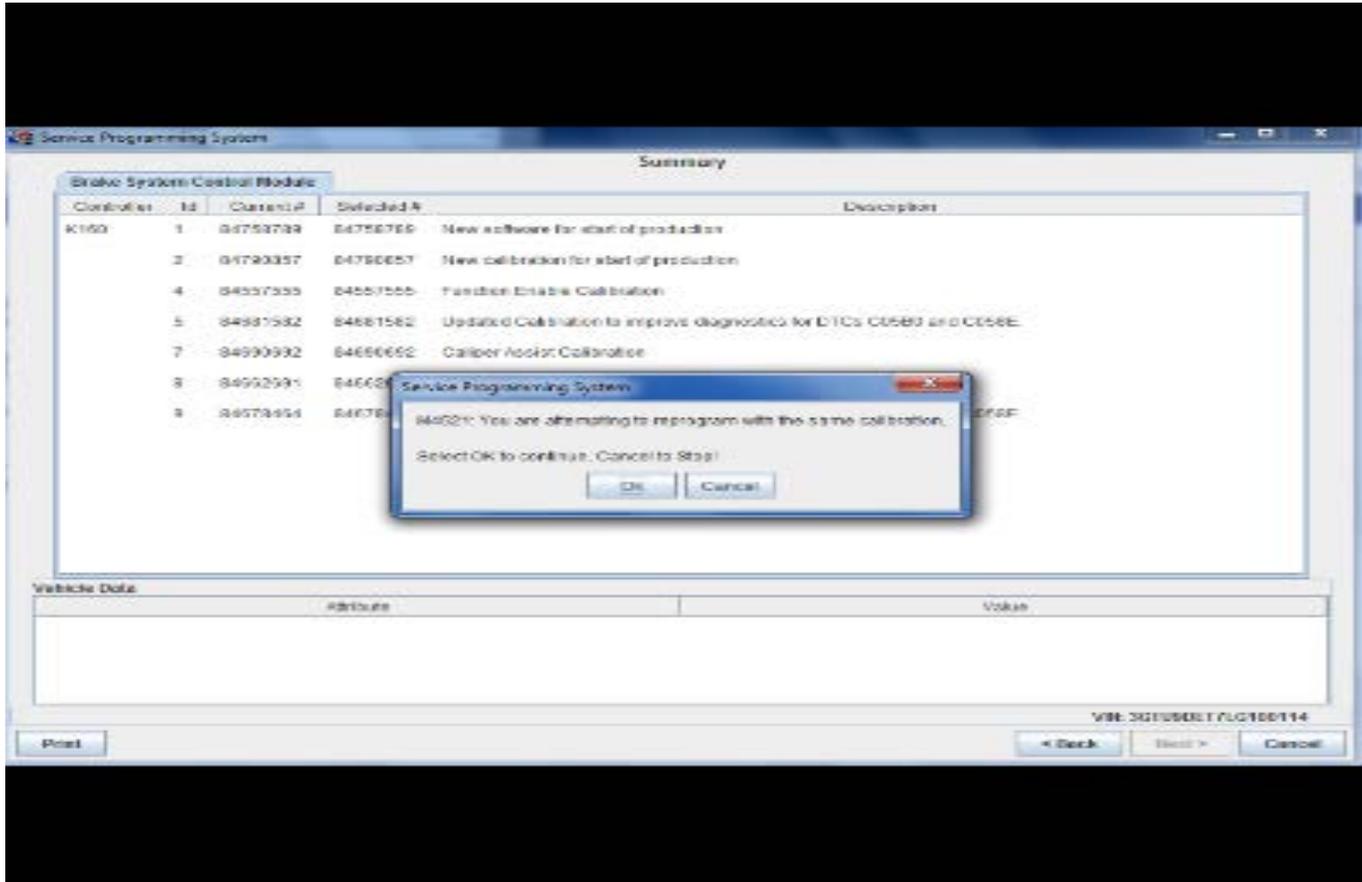
5431207

**Note:** If the Same Calibration/Software Warning is noted on the SPS screen, select OK and follow screen instructions. After a successful programming event, the WCC is located in the Service Programming System dialogue box of the SPS Summary screen. No further action is required. Refer to the Warranty section of the bulletin.

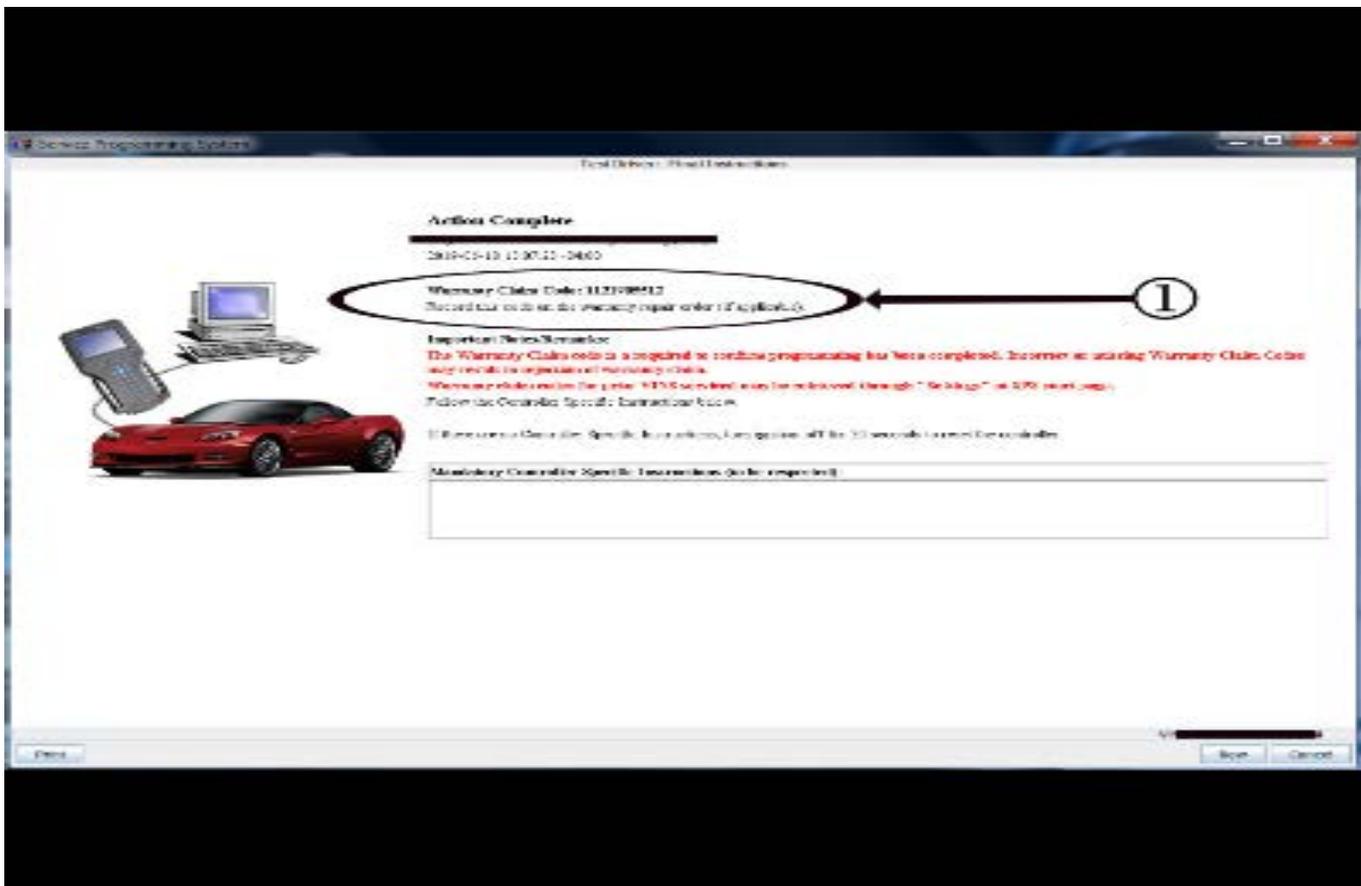
5431209

**Note:** To avoid warranty transaction rejections, you **MUST** record the warranty claim code provided on the SPS Warranty Claim Code (WCC) screen on the job card. Refer to callout 1 above for the location of the WCC on the SPS screen.
