Service Bulletin

Bulletin No.: 19-NA-256

Subject: Diagnostic Tips for Knocking, Rattle, Squeak and/or Squeal Type Noise from Engine – Engine Replacement Recommendations for HFV6 Gen 1 and Gen 2

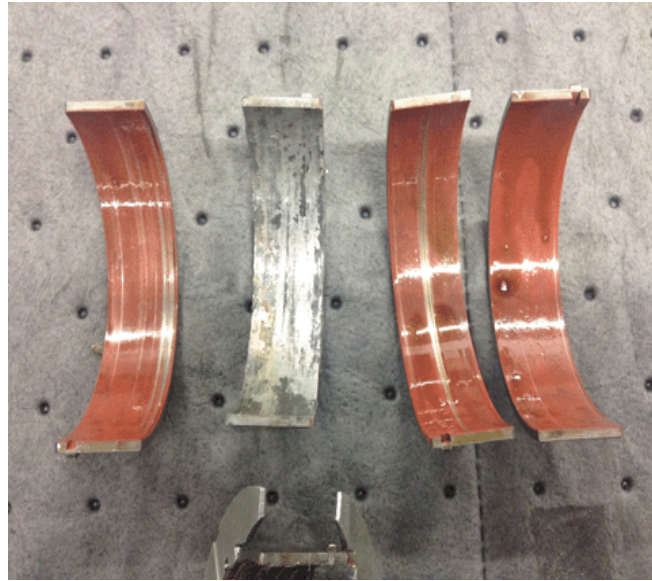
3961446

1. Verify there is metal in the engine oil by removing the oil pan.
2. Remove the main or rod bearing caps:
 - If the main and/or rod bearing are not the cause of the debris, refer to SI for further diagnostics.

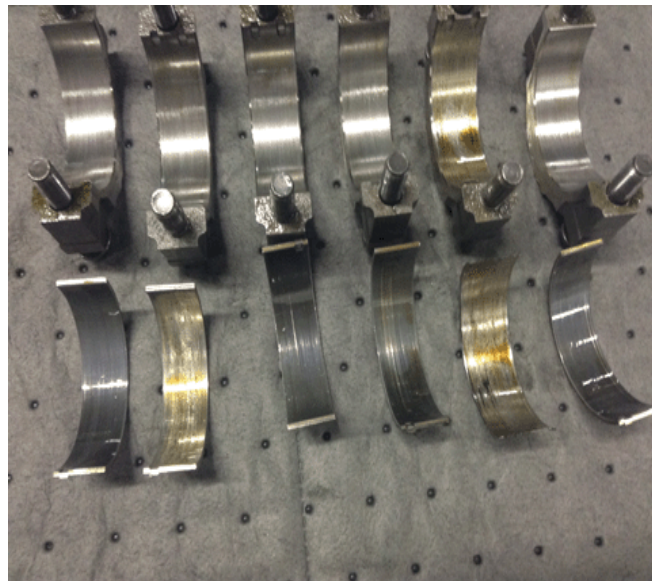
3961447

- If the main and/or rod bearings are found to be the cause of the debris, before deciding whether to replace the engine or repair it, refer to the Service Procedure below before making that determination.
