Service Bulletin

Bulletin No.: 19-NA-257

Subject: Pickup Box Out of Alignment

Brand:	Model:	Model Year:		VIN:		Engine:	Transmission:
		from	to	from	to		
Chevrolet	Silverado 1500 (New Model)	2019	2020			All	All
GMC	Sierra 1500 (New Model)

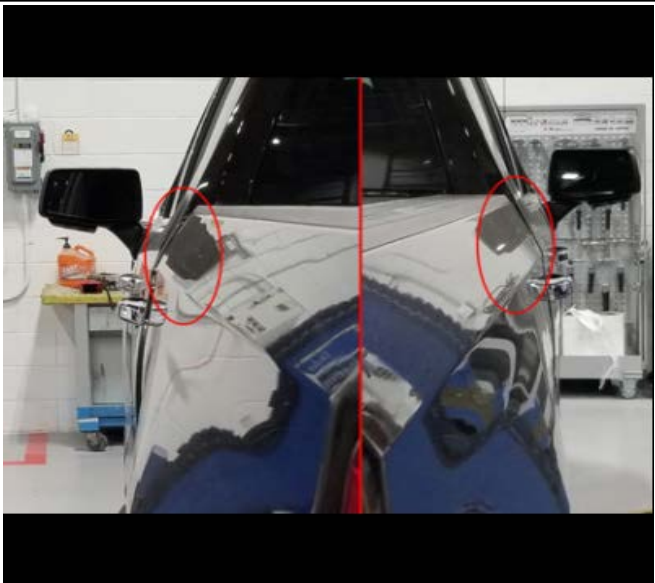
<p style="text-align: right;">5442974</p> <p>The pickup box appears to be out of alignment from side to side of the truck. The condition is more noticeable from rear of truck, down the side.</p>
Cause	The cause of the condition may be the pickup box was misaligned from the assembly plant.
Correction	Adjust the pickup box to within tolerance, following the steps in the Service Procedure below.

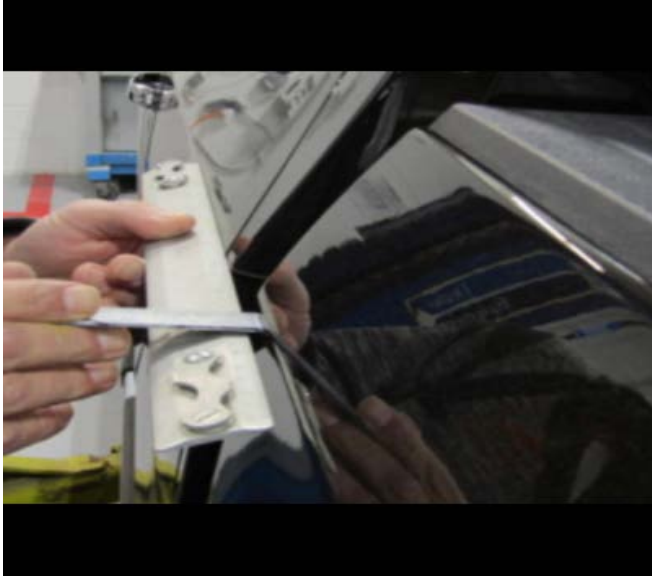
5442975

1. Using a straight edge on the side of the cab corner at the upper body line, measure the distance to the pickup box. The box should be sub-flush with cab and within 2.5 mm (0.10 in) total difference side to side.
 - If the box is sub-flush AND the distances ARE within the 2.5 mm (0.10 in) range side to side, no box alignment is necessary.
 - If the box IS NOT sub-flush AND the distances ARE NOT within the 2.5 mm (0.10 in) range side to side, continue on to the box alignment procedure.

Note: Measure the cab to box distance on both sides of the vehicle.

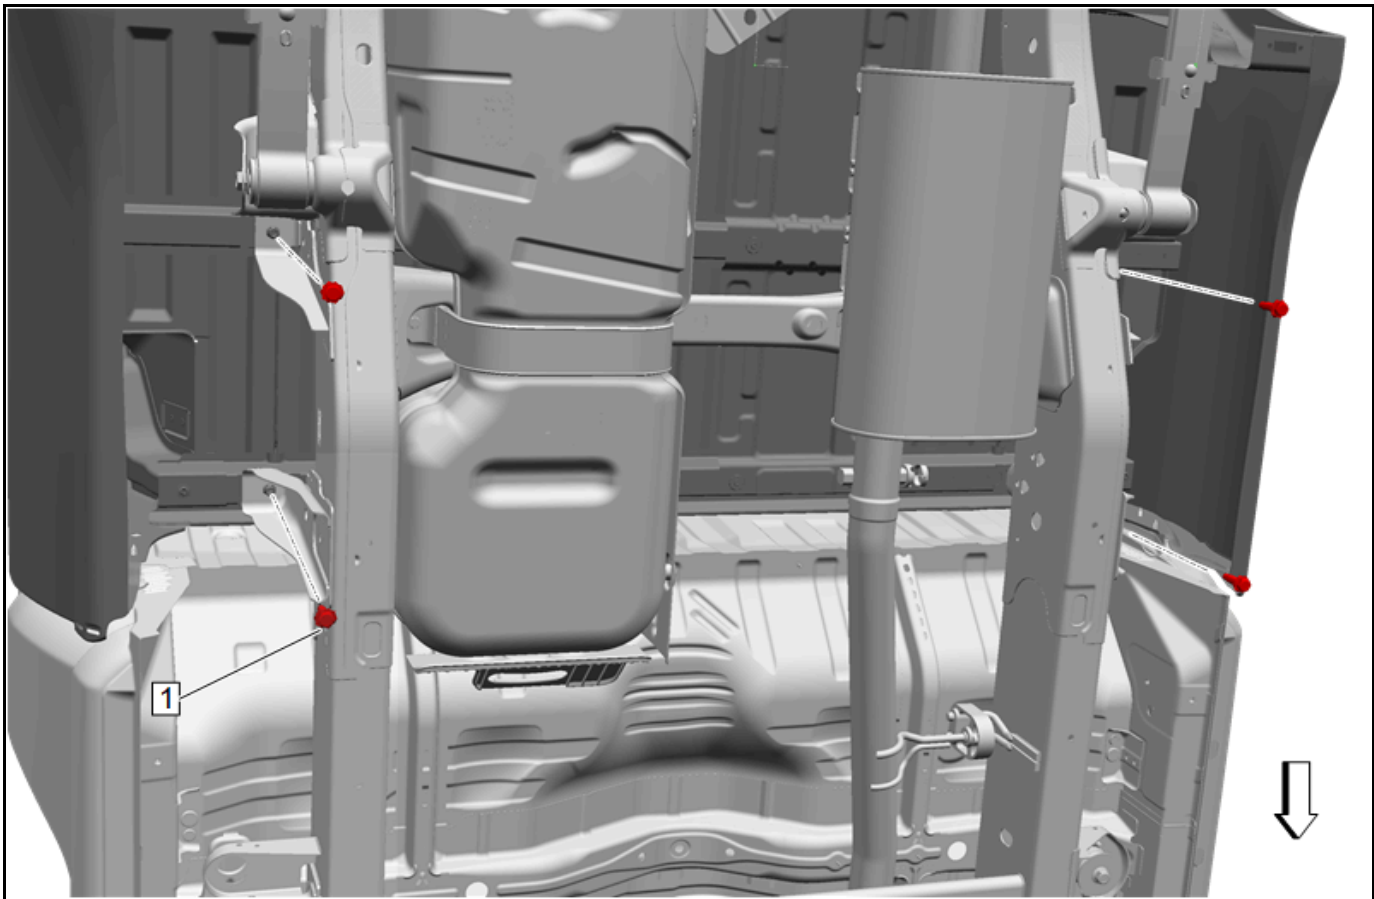
4998459

Note: Long pickup box shown above, has 4 front bolts, short box only has 2.

4. Remove the **front** pickup box bolts (1) and clean any sealer that may prevent movement between the bolt and frame. Reinstall the bolts and hand turn a couple of turns.

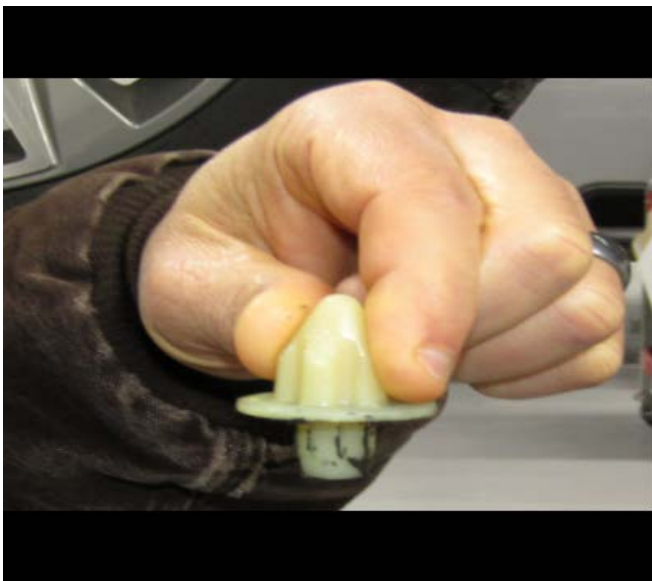
5442977

Note: If box alignment is limited due to locating pins in the bed preventing correct alignment, the front locating pin can be removed.

5. Remove the front bed to frame locator pin, as necessary.
6. Align the pickup box to within specifications. Box should be sub-flush with cab and within 2.5 mm (0.10 in) total difference side to side.
7. Tighten all pickup box bolts. Refer to Fastener Specifications in the Body Repair section in SI, for proper Torque specifications
8. Remove any tape/protection that was applied.
