# Service Bulletin

Bulletin No.: 19-NA-259

**Subject:** HVAC Pop Up on Infotainment Screen Blank, Displays Red Box, or Has Incomplete Information After Initial Start Up

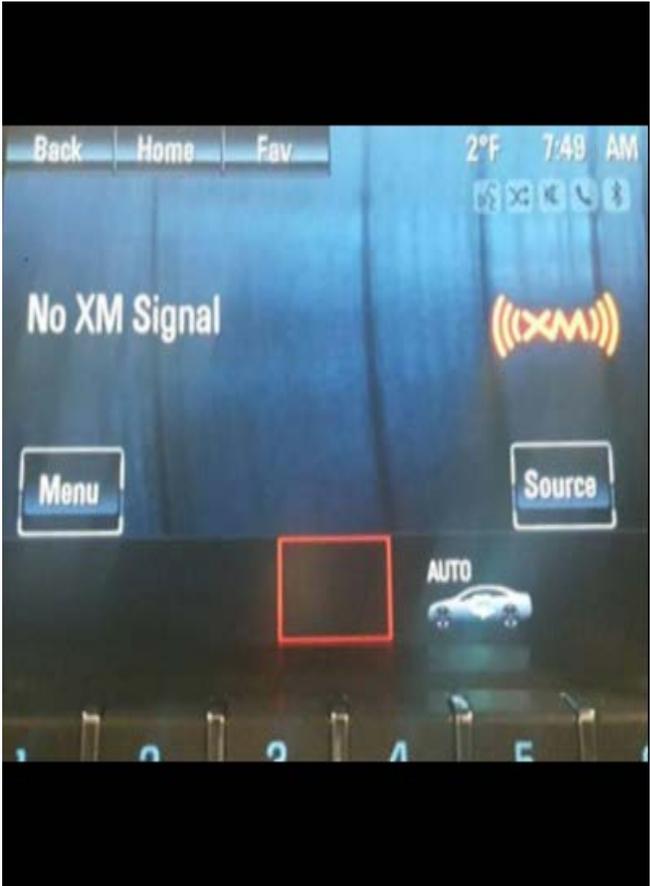
<p><b>Condition</b></p>	<p>On rare occasions, some customers may report that the HVAC Pop Up on the infotainment screen is blank, displays a red box, or contains incomplete information as shown in the example below.</p>

1. Reprogram the HVAC Control Module. Refer to *HVAC System Control Module Programming and Setup* in SI.
