Service Bulletin

Bulletin No.: 19-NA-263

Subject: Information on Sludge Inside Oil Fill Cap

Brand:	Model:	Model Year:		VIN:		Engine:	Transmission:
		from	to	from	to		
Chevrolet	Silverado 1500	2020	2020			LM2	
GMC	Sierra 1500

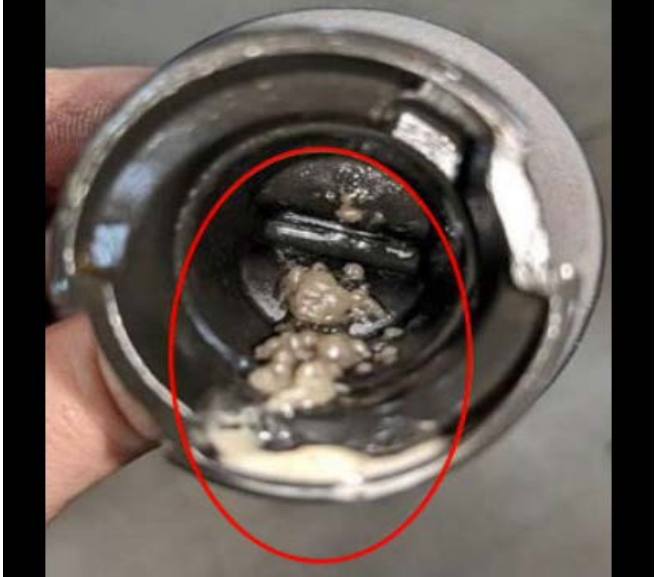
<p style="text-align: right; font-size: small;">5445249</p> <p>Some customers and/or technicians may comment that sludge is forming in the oil cap. – This may be noticed while vehicle is being serviced for oil change.</p>
Information	<p>This condition may be caused by the DEF fluid by-products interacting with engine lubricant.</p> <p>– At low ambient temperature, condensation of DEF fluid by-products that interact with engine lubricant forms the sludge, which is visible under the oil fill cap. This sludge is not harmful for engine and operators and tends to disappear at high ambient temperature condition.</p> <p>The cap can be cleaned by wiping off the sludge. No other steps or part replacement required. This will not affect engine performance or durability.</p>
