Service Bulletin

Bulletin No.: 01-08-42-001M

Subject: Exterior Lamp Condensation and Replacement Guidelines

Models: 2020 and Prior GM Passenger Cars and Trucks

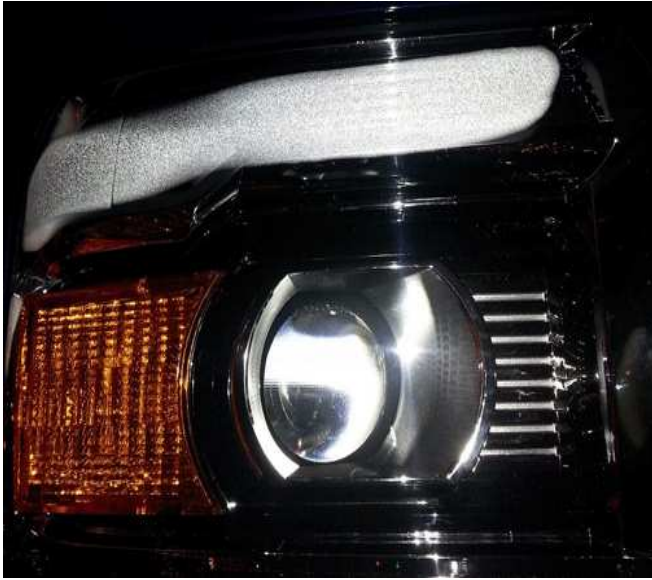
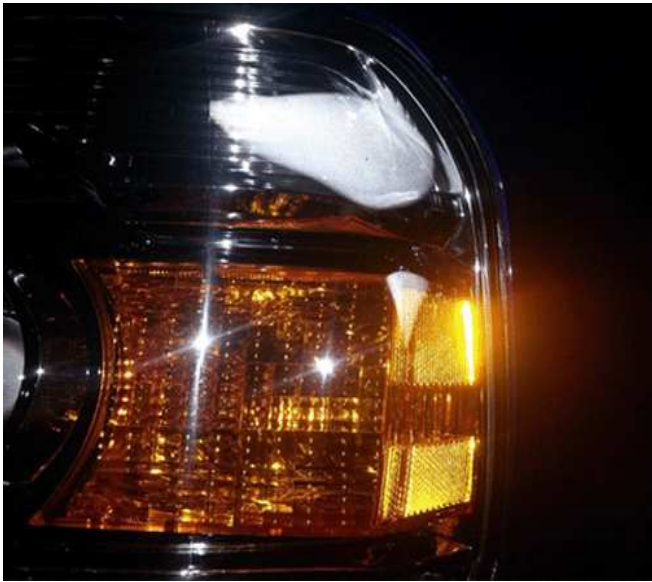
2014 Sierra Headlamp, Full and Partial Examples

A Fine Mist or White Fog on the Inside Surface of the Lamp Lens Occurring After a Period of High Humidity

- May be located primarily in the lens corners (near the vents) and SHOULD NOT cover more than half the lens surface.
- The condition should clear of moisture when the vehicle is parked in a dry environment, or when the vehicle is driven with the lights ON.
- A comparison of the equivalent lamp on the opposing side of the vehicle indicates a SIMILAR performance.

If the above conditions are noted, the customer should be advised that replacement of a lamp assembly may not correct this condition.

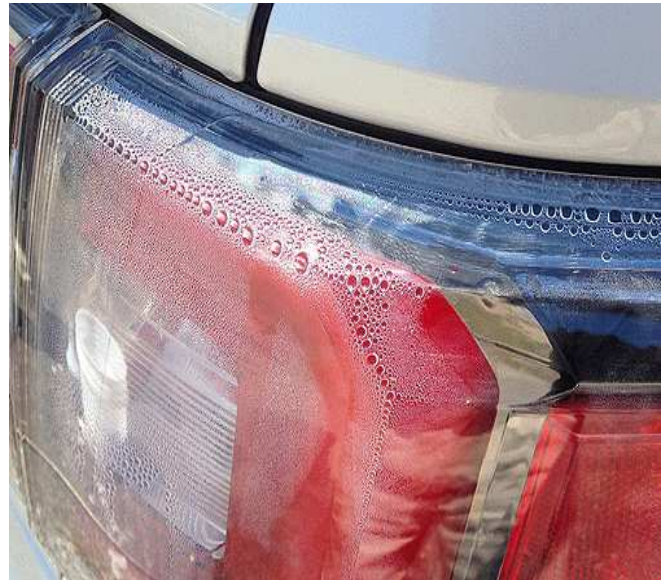
2014 Acadia Tail Lamp Example

Numerous & Various Size Drops of Water Collecting on the Inside Surface of the Lamp Lens After the Vehicle Has Been Exposed to Rain or a Car Washing Environment

- A condition that covers more than half the surface of the lamp lens.
- An accumulation of water in the bottom of the lamp assembly.
- A condition that WON'T clear when the vehicle is parked in a dry environment, or when the vehicle is driven with the lights ON.
- A comparison of the equivalent lamp on the opposing side of the vehicle indicates a different performance.

Note: Any of the conditions listed below would indicate the need to service the lens or lamp assembly.

If a lamp is found to be exhibiting a leak, review the most recent version of Service Bulletin 02-08-42-001 for information regarding impact damage and modification inspection.

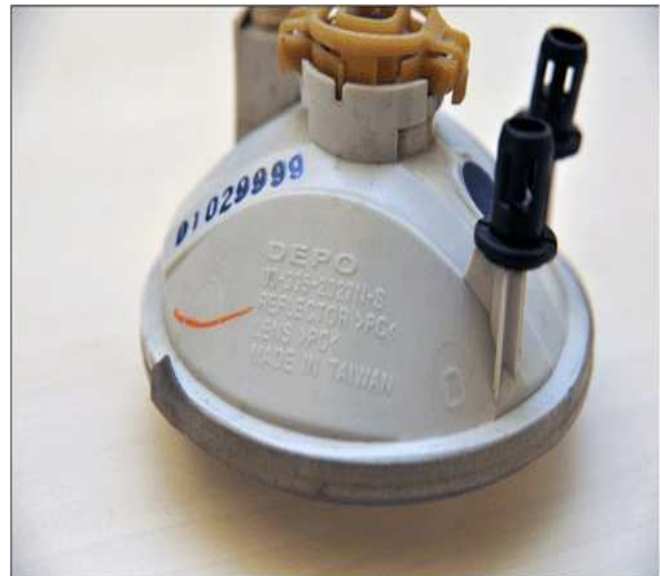
2650251

This fog lamp was returned for retaining moisture. As you can see it is marked with the Depo brand (it is also called out on the front lens).

The most reliable way to identify a non OE part is to compare it to the replacement service part or a like vehicle. Many do have the application called out on the part with the letters GM being present. Notice that they almost never underscore it, as that would be a trademark violation. They often use substandard wiring, sockets, vent patches and unsealed connectors.
