Service Bulletin

Bulletin No.: 08-03-10-006G

Subject: Tire Slowly Goes Flat, Tire Air Loss, Low Tire Pressure Warning Light Illuminated, Aluminum Wheel Bead Seat Corrosion (Clean and Resurface Wheel Bead Seat)

Models: 2005-2020 GM Passenger Cars and Light Duty Trucks

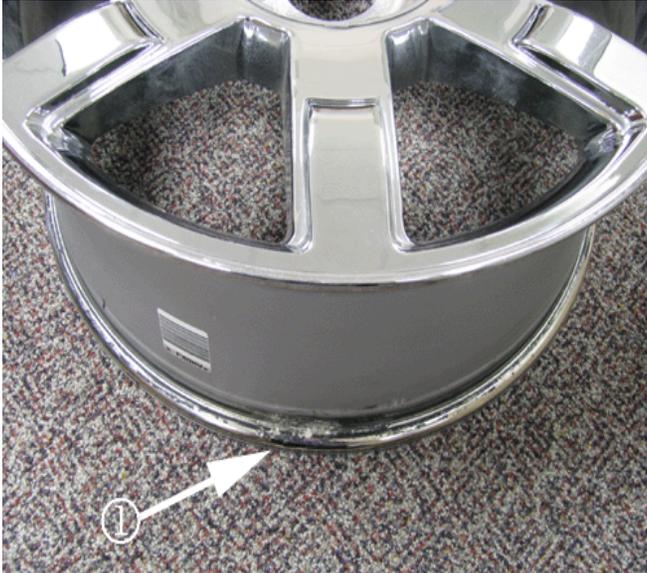
2103715

1. Remove the wheel and tire assembly for diagnosis. Refer to *Tire and Wheel Removal and Installation* in SI.
2. After a water dunk tank leak test, if you determine the source of the air leak to be around the bead seat of the wheel, dismantle the tire to examine the bead seat. Shown below is a typical area of bead seat corrosion.

Typical Location of Bead Seat Corrosion

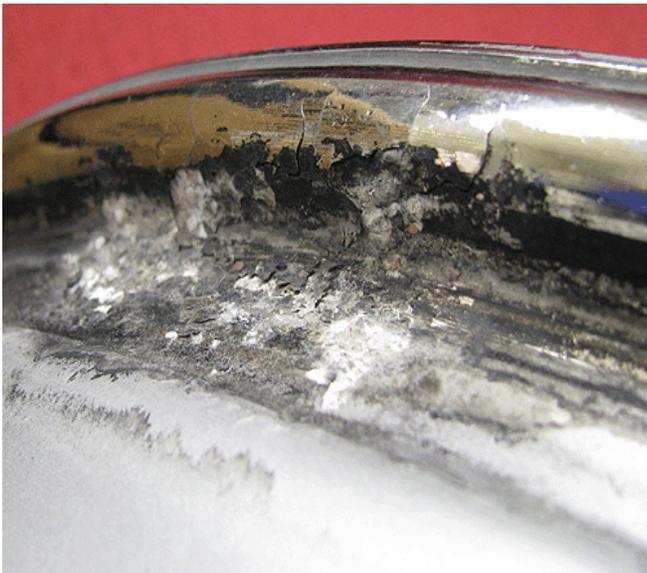
2103722

3. Bead seat corrosion is identified by what appears like blistering of the wheel finish, causing a rough or uneven surface that is difficult for the tire to maintain a proper seal on. Below is a close-up photo of bead seat corrosion on an aluminum wheel that was sufficient to cause slow air loss.

Close-Up of Bead Seat Corrosion

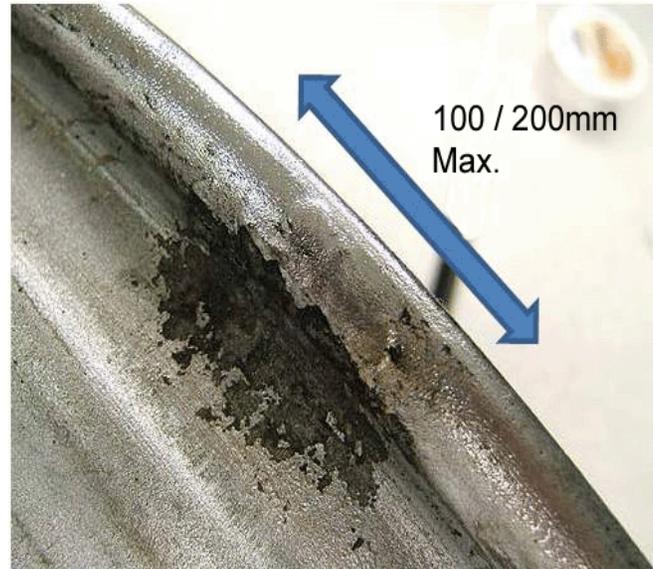
2365347

4. If corrosion is found on the wheel bead seat, measure the affected area as shown below.

- For vehicles with 32,186 km (20,000 mi) or less, the total allowable combined linear area of repairable corrosion is 100 mm (4 in) or less. If the total area(s) of corrosion exceed these dimensions, the wheel should be replaced.

- For vehicles that have exceeded 32,186 km (20,000 mi), the total allowable combined linear area of repairable corrosion is 200 mm (8 in) or less. If the total area(s) of corrosion exceed these dimensions, the wheel should be replaced.

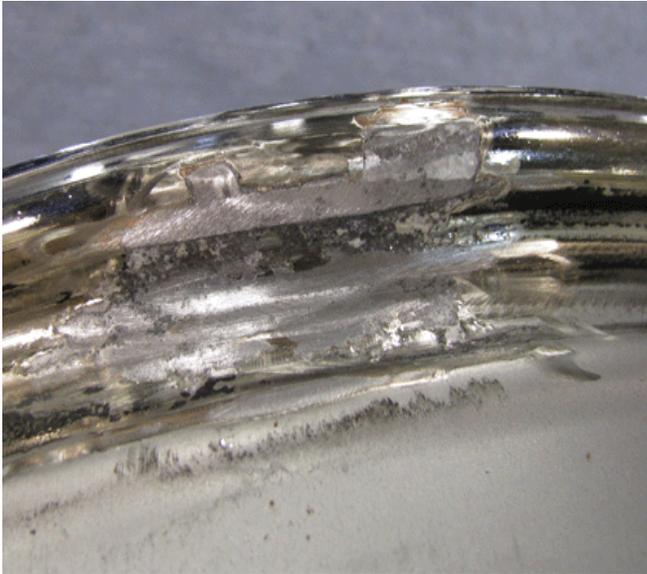
2103726

Acceptably Prepared (Cleaned-Up) Wheel Surface

5. In order to correct the wheel leak, use a clean-up (fine cut) sanding disc or biscuit to remove the corrosion and any flaking paint. You should remove the corrosion back far enough until you reach material that is stable and firmly bonded to the wheel. Try to taper the edge of any flaking paint as best you can in order to avoid sharp edges that may increase the chance of a leak reoccurring. The photo below shows an acceptable repaired surface.

Important: Remove ONLY the material required to eliminate the corrosion from the bead seating surface. DO NOT remove excessive amounts of material. ALWAYS keep the sealing surface as smooth and level as possible.

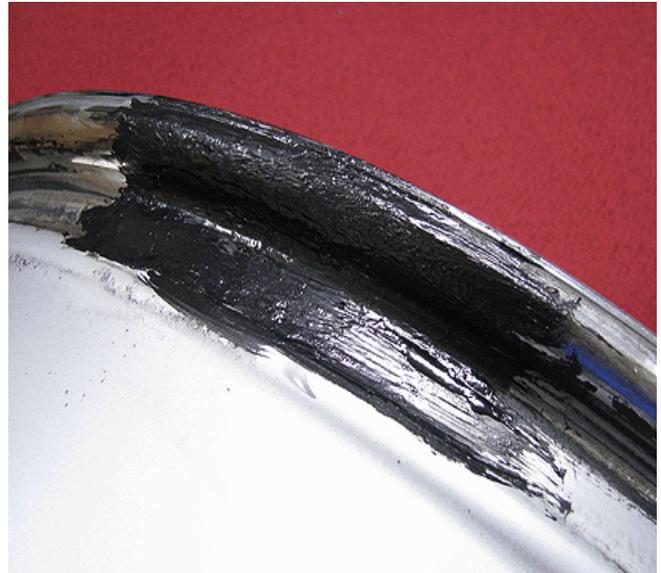
2103731

Coated and Sealed Bead Seat

- Once the corrosion has been eliminated, you should coat the repaired area with a commercially available tire sealant such as Patch Brand Bead Sealant or equivalent. Commercially available bead sealants are black rubber-like coatings that will permanently fill and seal the resurfaced bead seat. At 21°C (70°F) ambient temperature, this sealant will set-up sufficiently for tire mounting in about 10 minutes.
