Technical Service Bulletin

GROUP Campaign	NUMBER 19-01-036H
DATE November, 2019	MODEL(S) Ioniq (AE) HEV/PHEV/EV, Kona (OS) EV

SUBJECT ELECTRIC WATER PUMP (EWP) CAN CASE REPLACEMENT
- (CAMPAIGN T4G)

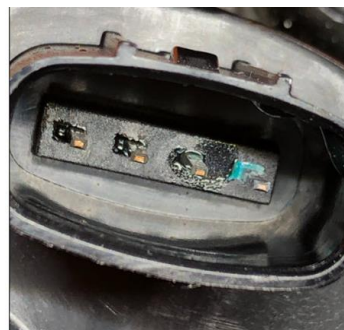
EWP part side

2. Inspect the inside of both connectors of the EWP connection for coolant contamination:

- **No contamination is found:**
Continue to next step 3.
- **Contamination is found:**
Skip to (section-**E**) (page-9) to replace the EWP assembly and (section-**F**) (page-10) vehicle harness EWP connector.

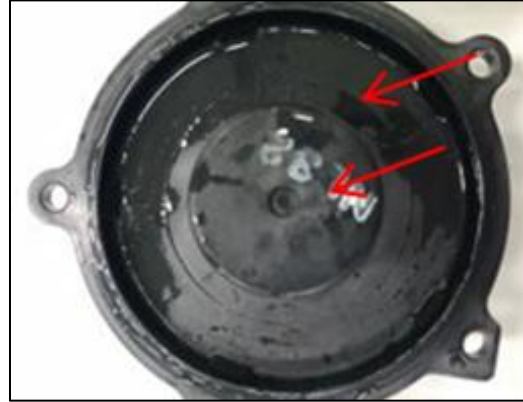
- **Can Case** (on the side facing the stator):

Inspect for evidence of any coolant leak or contamination stains found on the inside of any of the following EWP components:

NOTE: If no contamination was found in any of the above 3 components proceed to the next page-8 to replace the Can Case only.
