# Technical Service Bulletin

GROUP	NUMBER
Body Exterior	19-BD-010H
DATE	MODEL(S)
November, 2019	Palisade (LX2)

**SUBJECT** WHISTLING/WIND NOISE FROM DOOR GLASS AREA

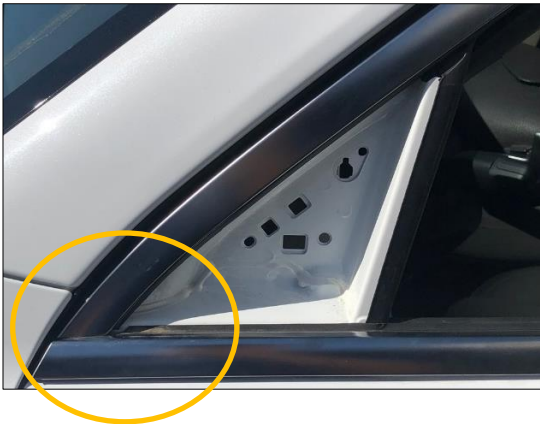
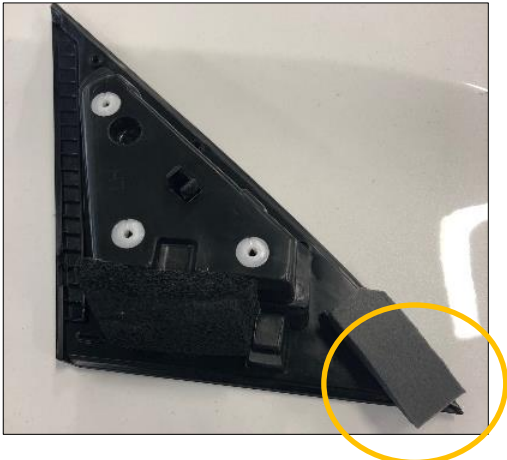
SYMPTOM	INSPECTION	REPAIR
<p><b>Whistling noise from the lower side of the A-pillar</b></p> <p><b>Front Door Glass Run</b> (82530/82540)</p>	<p>A gap between the lower molding area of the glass run A-pillar and the door panel.</p> <ul style="list-style-type: none"> <li>The glass run comes off the door panel due to rubber deformation during production.</li> </ul>

<ol style="list-style-type: none"> <li>Attach a high density sponge pad on the deformed area of the door garnish. <ul style="list-style-type: none"> <li>Cut the pad to fit the shape of the door garnish.</li> </ul> </li> </ol>

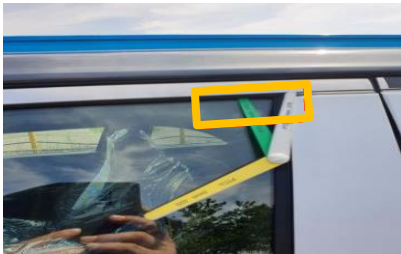
<p><b>Whistling noise from the upper side of the B-pillar</b></p> <p><b>Front Door Glass Run</b> (82530/82540)</p>	<p>No contact between the glass run and door glass</p> <ul style="list-style-type: none"> <li>Poor adhesion between the door glass and glass run</li> </ul>

<ol style="list-style-type: none"> <li>Replace the glass run (P/N: 82530 / 82540).</li> </ol>

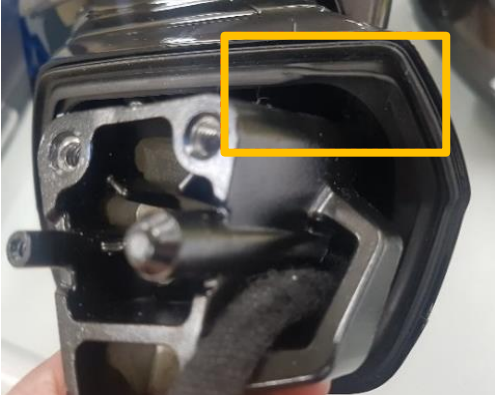
SYMPTOM	INSPECTION	REPAIR
<p><b>Wind noise from lower side of the A-Pillar</b></p> <p><b>Outside Mirror (87610/87620)</b></p>	<p>Gasket folding during assembly causing friction between the gasket and door panel.</p>

<p>1. Replace the outside mirror assembly (P/N: 87610 / 87620).</p>
<p><b>Wind noise from upper side of the B-pillar</b></p> <p><b>Door frame Garnish (82250/82260)</b></p>	<p>Glass run not completely inserted into the B-pillar causing interference between the glass run and door molding.</p> <ul style="list-style-type: none"> <li>• Difficulty assembling the door molding upper clip</li> </ul>
