<b>HYUNDAI</b> <b>Technical Service Bulletin</b>	<b>GROUP</b> <b>AUTOMATIC TRANSMISSION</b>	<b>NUMBER</b> <b>19-AT-024H</b>
	<b>DATE</b> <b>NOVEMBER 2019</b>	<b>MODEL</b> Accent (RB/HC), Azera (TG/HG), Elantra (UD/MD/JK/AD/ADa/GD/PD), Santa Fe (CM/AN/NC), Kona (OS) Sonata (YF/LF/DN8, Sonata YF HEV/LF HEV/PHEV), Tucson (LM/TL) Veloster (FS/JS)
<b>SUBJECT:</b> AUTOMATIC TRANSAXLE DIAGNOSIS (6-SPEED) INHIBITOR/RANGE SWITCH DTC P0705, P0706, P0707 & P0708

***This TSB supersedes TSB 17-AT-005 to update the Service Procedure and applicable vehicles.***

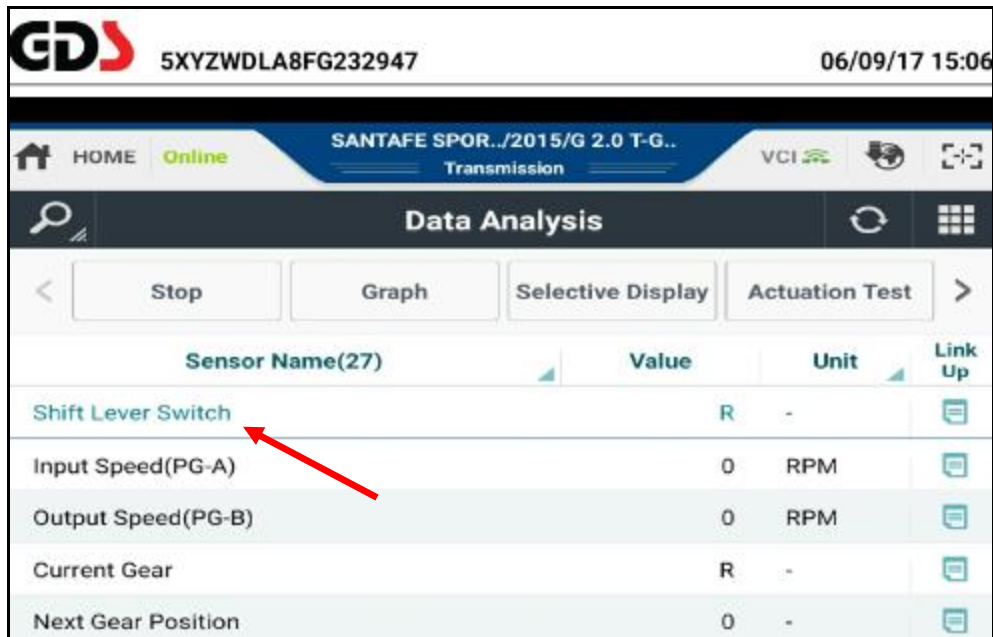
1. Turn the ignition key to the ON position or push the Start/Stop Button two times without depressing the brake pedal.
2. Attach a GDS and check for DTC in the “Automatic Transaxle” menu. **Record the DTC and description.** Delete the DTC.
3. Select **Data Analysis, AT** menu and **Shift Lever Switch**. Move the shift lever through all gears (P, R, N and D) and monitor the Shift Lever Switch.

4. If the Shift Lever Switch shows:
  - The correct shift lever position, the wiring **currently** has no open/short circuits. Go to Step 6.
  - Does not show the correct shift lever position, go to Step 5.
5. Visually check the wiring harness between the ECU and inhibitor switch for a damaged wire or open circuit/short circuit to ground. Check for a damaged pin or pin not fully inserted into the connector.
  - If damage is found, repair or replace the control wiring and drive the vehicle to confirm the repair.
  - If no damage or open/short circuit is found, go to Step 6.

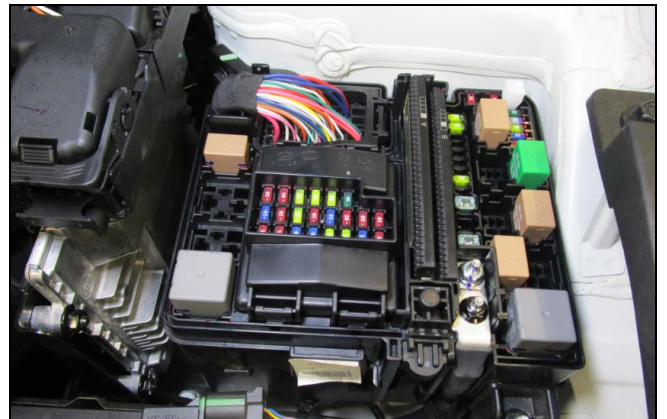
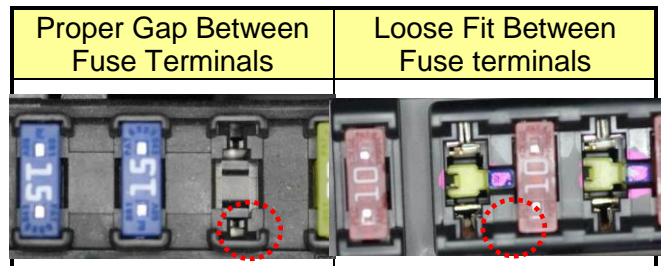
7. Check the TCU and TCU2 fuse in the junction box in the engine compartment:
  - Check the fuse for an open circuit.
  - Check the fuse for correct capacity.
  - Check the fuse holder for a tight fit.
  - Check for loose or damaged wires.

If damage or intermittent open circuit is found, repair or replace the junction box and front harness.

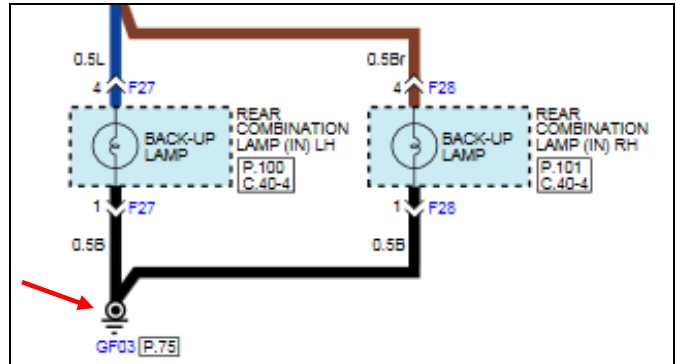
8. Check the rear combination lamp ground for tightness.

Turn the ignition and headlights on. Use a DVOM to check the voltage drop between the combination lamp wiring terminal and ground.

**Specification: Less than 0.2 V.**

- If more than 0.2V, clean the terminal and bolt threads and tighten the bolt.
- If less than 0.2V, go to Step 9.
