Technical Journal

TITLE:
P5(SPA)/P6(CMA) Software Download Guide

REF NO: TJ 31543.9.0	ISSUING DEPARTMENT: Technical Service	CAR MARKET: United States and Canada	
PARTNER: 3 US 7510 Volvo Car USA		ISSUE DATE: 2019-11-01	STATUS DATE: 2019-11-05
FUNC GROUP: 3018	FUNC DESC: Software	Page 1 of 3

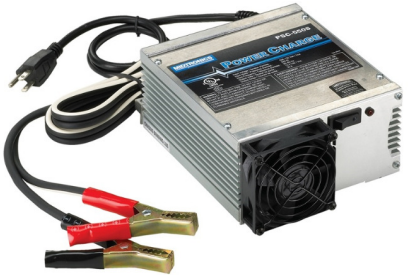
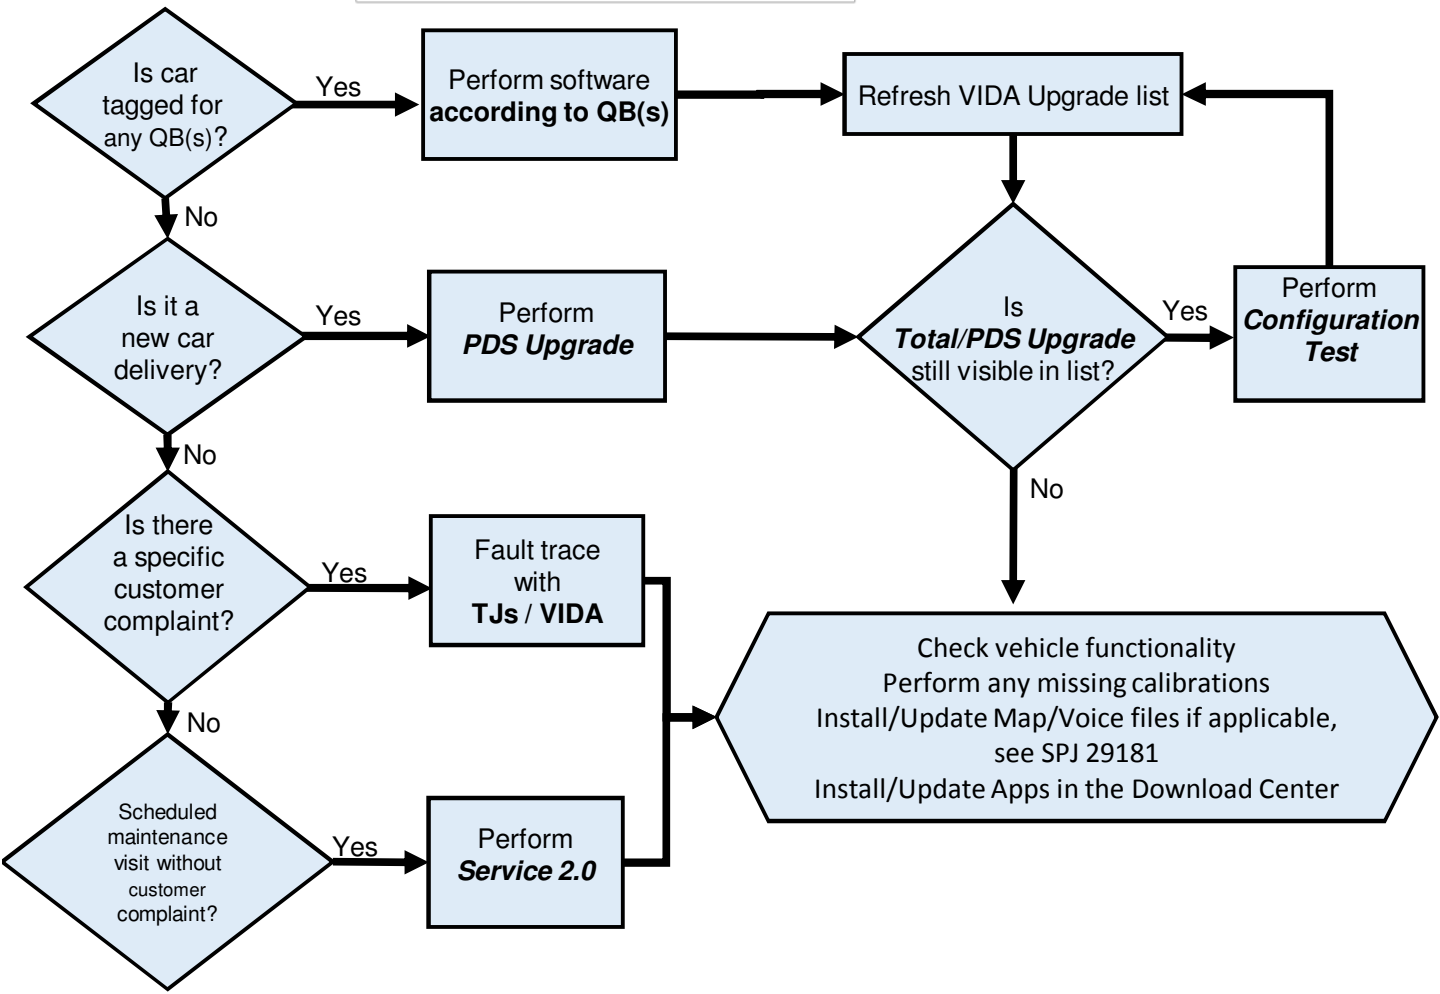
CEM - Battery State of Charge (SoC)
 80 %

CEM - Battery current
 14.56 A

Use VIDA **Service Functions** **12 V power overview** to confirm
battery State of Charge is over 70%
and positive current is entering the battery.
