Technical Journal

TITLE:
Upper front suspension, knocking noise

REF NO: TJ 34391.7.0	ISSUING DEPARTMENT: Technical Service	CAR MARKET: United States and Canada	
PARTNER: 3 US 7510 Volvo Car USA		ISSUE DATE: 2019-11-12	STATUS DATE: 2019-11-18
FUNC GROUP: 7230	FUNC DESC: Spring front, helical spring and torsion	Page 1 of 4

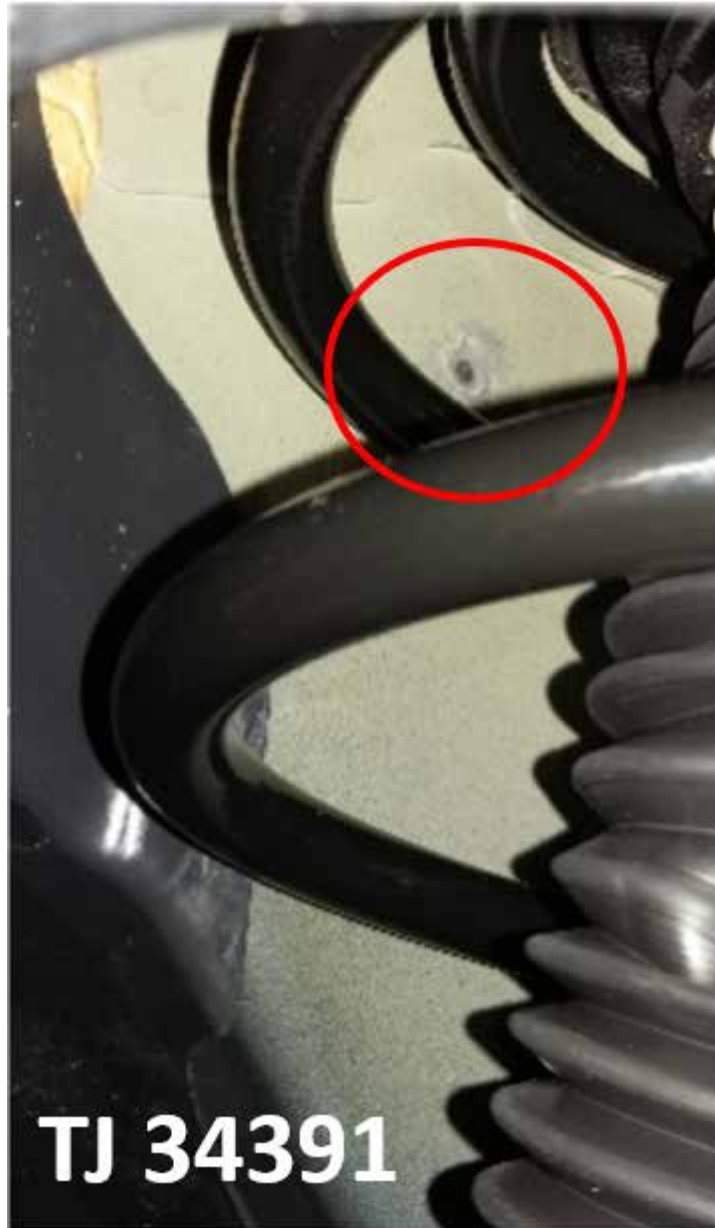
If there is a knocking noise from the front suspension when driving over a road bump, on rough roads or when turning to left or right when manoeuvring (like turning in a parking spot), then follow the advice under Service.

If the front spring upper area is touching the body according to the attached photo **TJ34391.png**.

If the problem is confirmed, replace both front spring coils according to VIDA and also apply some anti-corrosion agent on the body to cover the scratch marks.

Valid for chassis range **0086790-0088992** and structure week **201839-201840**.

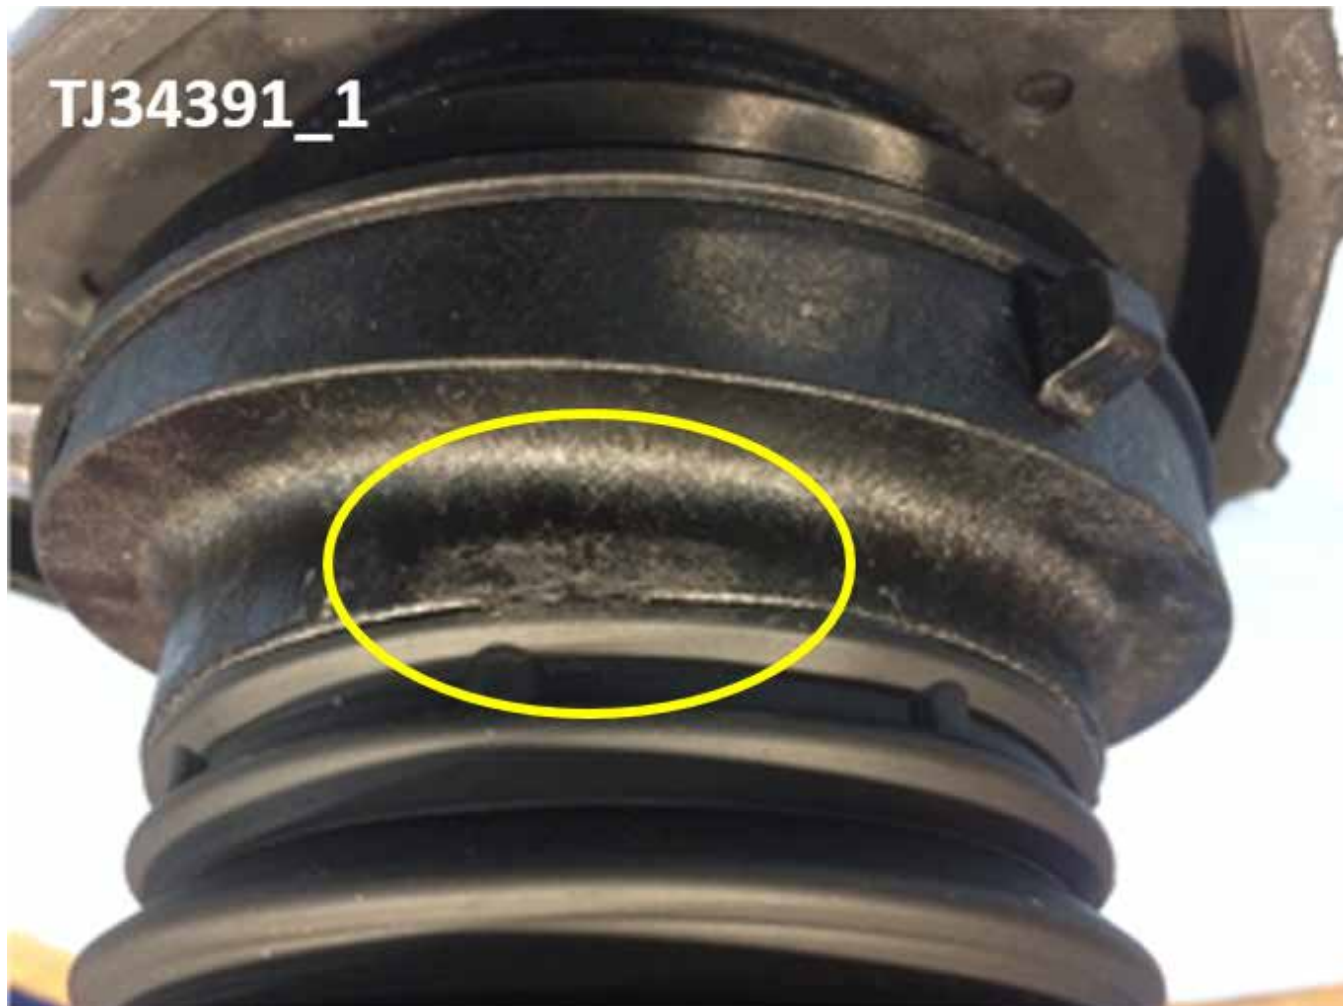
If the front spring is in conflict with the upper bearing according to the attached photo **TJ34391_1.png**.

If the problem is confirmed, replace both front spring coils and topmount bearings according to VIDA.

Valid for chassis range **0061086-0242506** and structure week **201825-201940**.
