Corrosion on Cab at Lower Corner(s) of Center Stop Lamp Assembly

YEAR(S)	MODEL(S)	ADDITIONAL INFORMATION
2007 - 2020	Tundra

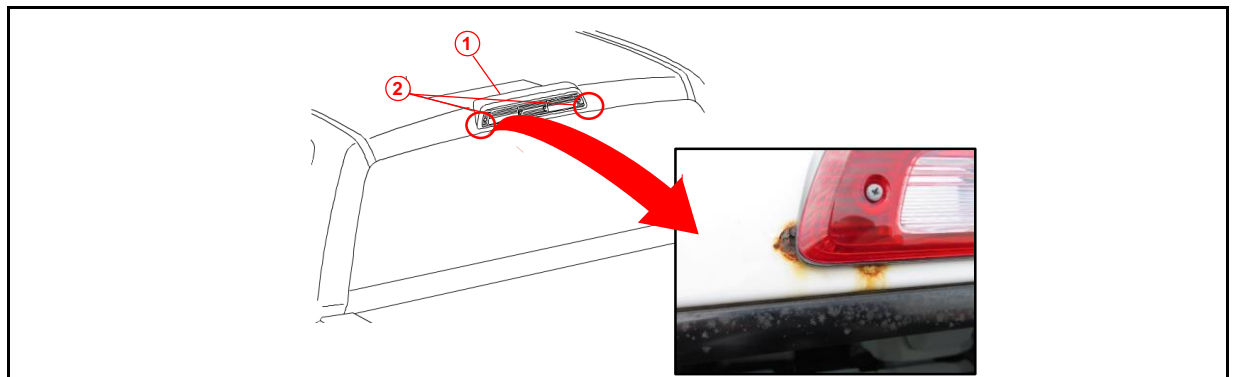
Figure 1.

Does surface corrosion and/or perforation corrosion exist at the lower corner(s) of the center stop lamp assembly?

1	Center Stop Lamp Assembly
2	Surface Corrosion and/or Perforation Corrosion

2. Order the center stop lamp assembly service part and sublet to a body shop for repair of the surface corrosion and/or perforation corrosion.
3. Confirm the repair.
