Subject		Market
Pioneer Navigation Displayed Pink Screen & Reset		USA
Service Category	Section	
Audio/Visual/Telematics	Outline-Audio/Visual/Telematics	
Applicability		
15CY Pioneer Navigation

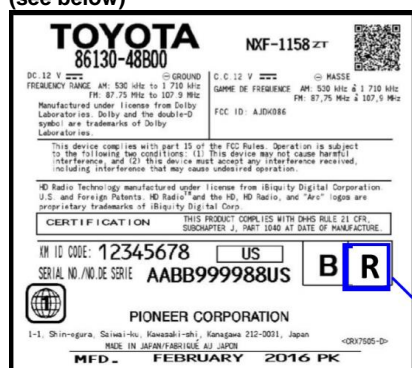
Confirm the condition. Ensuring the multimedia system is updated to the latest software will provide the best system performance. All Pioneer exchange radios as of 2/1/2019 have been updated to the latest software version A11A8010 and can be identified by the updated "R" marking on the part label. (see below)

If the condition occurs while using version A11A8010 software, please create a TAS case and contact TAS for instruction prior to diagnosing or repairing of the vehicle. If it is a weekend or holiday, continue with diagnosis and repair. Please save all parts and/or details and contact TAS on the next available work day.
