Squeak/groan noise from steering intermediate shaft area

2019-2020 RAV/HV

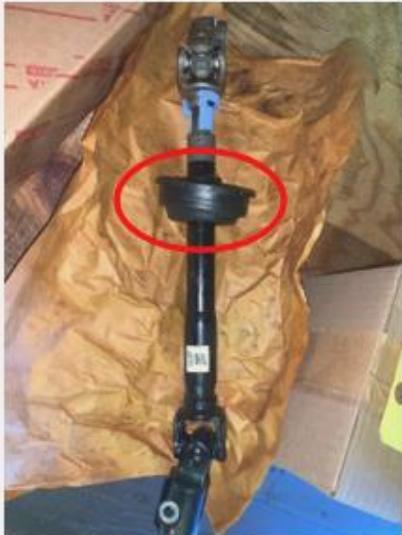
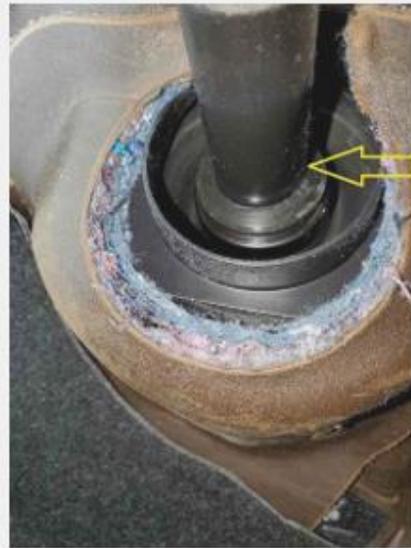
Customer states that there is a squeak or groan noise from the steering column area when turning the steering wheel.

Do not apply any lubricant or water to intermediate shaft or seal. This could damage the seal or lead to a repeat repair. Isolate noise using stethoscope and replace affected components.
