SIB 41 06 19

## DELIVERY STOP: CHECK BLIND PLUGS

## MODEL

| E-Series | Model Description | Production Date |
|---|---|---|
| G20 | 330i, 330i xDrive Sedan NA | March 27, 2019 – August 21, 2019 |

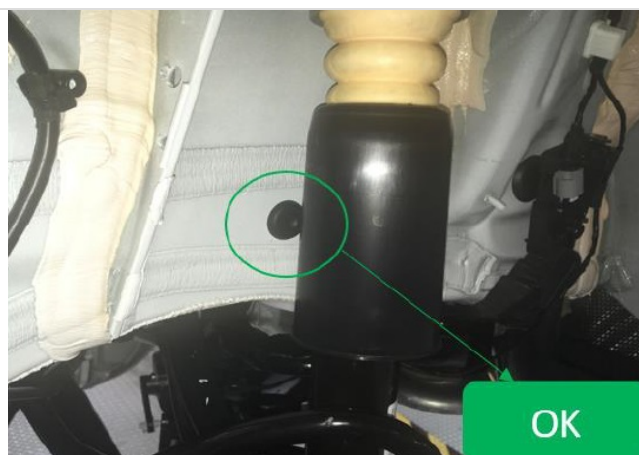
1. Inspect both sides of the vehicle body, just inboard of the rear shock absorber in the area shown.

**Is the body plug (circled) installed?**

**No:** Install a blind plug in one or both sides, depending on whether one or both blind plugs are missing. You are finished.

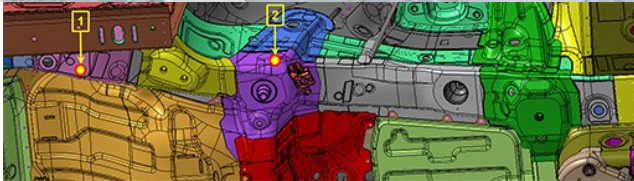
5. If there is no moisture coming out of the hole, remove the mounting plug (2) and with a small light or borescope check for moisture.

6. Was there moisture present in either hole (1) or hole (2)?

4. Looking from under the vehicle, locate the rear paint plug (1) and drill it out using a 10 mm drill bit.

**NO:** Replace the missing plug(s) (07 14 7 127 540) from step 2.

Reinstall the mounting plug (2) removed in step 5.

Install a seal plug (07 14 7 127 539) into the drilled-out paint plug (1) in step 4. Repeat for other side if needed. You are finished.
