SIB 51 36 19

2019-11-20

GROANING OR RATTLING NOISE COMING FROM FRONT OF TRUNK AREA

E-Series	Model Description	Production Date
G20	3 Series Sedan	Up to June 25, 2019

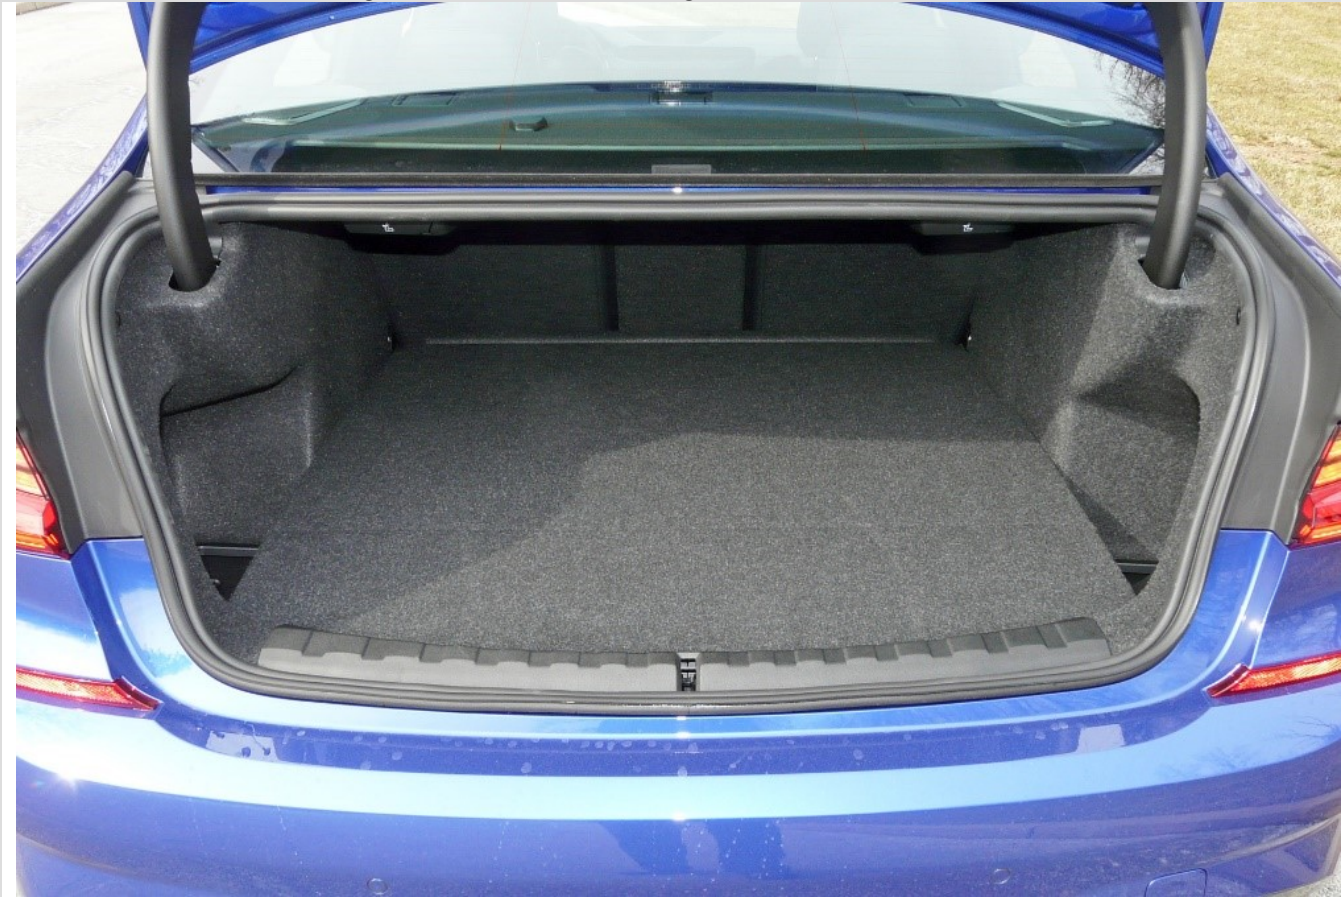
A groaning or rattling noise can be heard coming from the rear window acoustic seal area, where the seal meets the trunk lid. The noise can be heard while driving on rough roads, especially when the trunk space has been expanded by lowering the rear seat backrests.

The affected seal runs along the bottom of the rear glass as indicated below.

The trunk lid rubs against the seal and causes a noise when there is any movement.

Remove the seal and discard. No replacement seal of any type is needed.

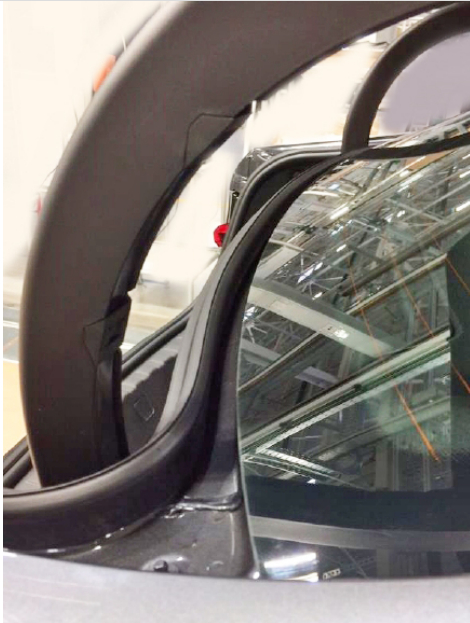
The picture shows the seal completely removed.

2. Remove any adhesive residue with cleaning agent R1 (83 19 2 211 217) or a suitable alternative.
