SIB 51 37 19

2019-11-21

**DELIVERY STOP: CENTER CONSOLE COVER**

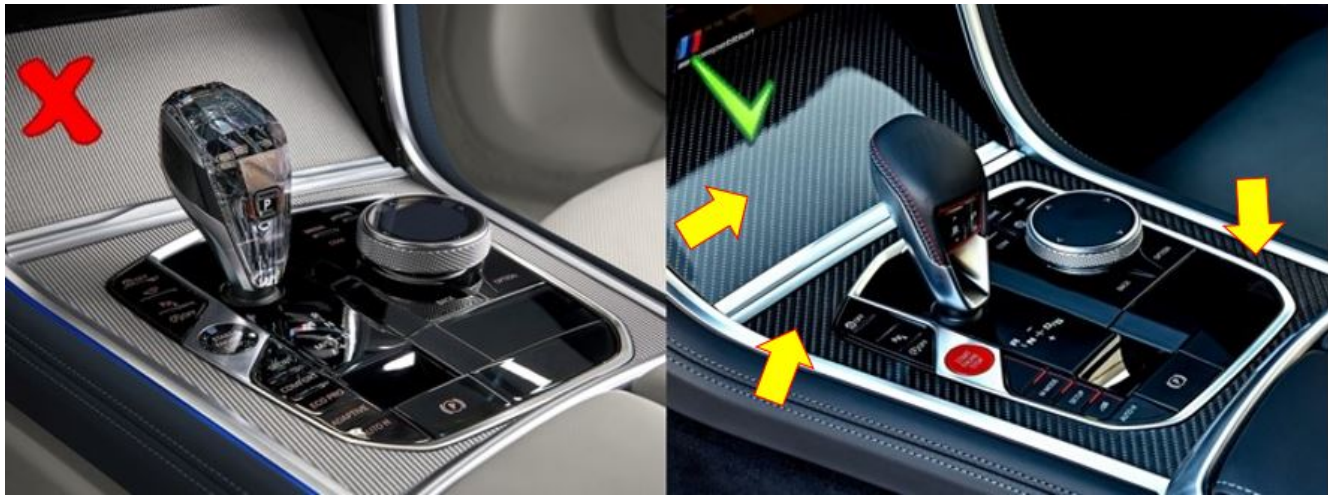
A center console trim panel with integrated cupholder bin cover was installed which does not match the surrounding interior trim. There is no influence on the cupholder cover's functionality.

The wrong trim panel was installed during vehicle production.

Replace the incorrect trim panel and integrated cupholder cover ("metal mesh effect" on left) with the correct one ("carbon fiber look" on the right).

Install the correct trim panel with integrated cupholder cover.

Refer to ISTA operation 51 16 146 "Replacing the decorative trim on the center console."
