SIB 62 01 19

INSTRUMENT CLUSTER AND ONBOARD COMPUTER INTERMITTENTLY INOPERATIVE

2019-11-20

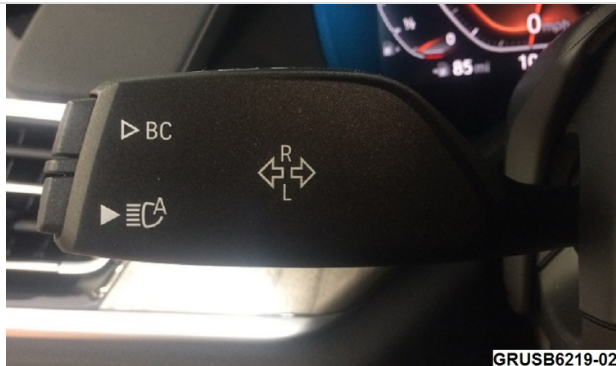
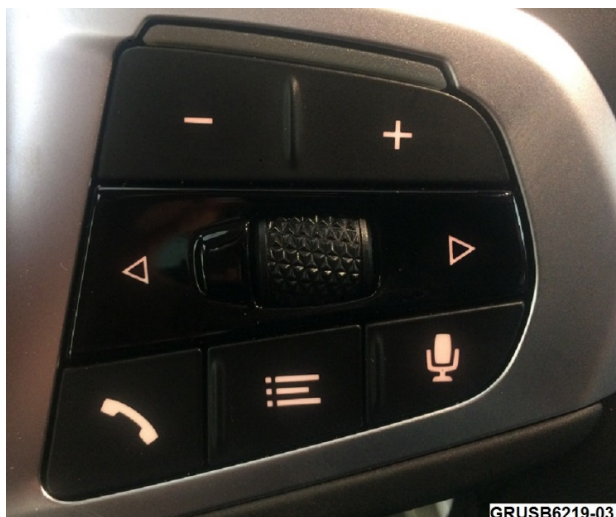
Instrument Cluster (KOMBS18) functions are intermittently inoperative, including:

- On-board Computer (BC) button on turn signal stalk (BC button shown at left)
- Radio displays
- Menu button
- Turn signal displays
- Arrows on multifunction steering wheel
- MFL thumbwheel control (shown at left)

Additionally, the audio source, radio station, or music track cannot be changed using the MFL.

Unfavorable software at system start-up.

Program the vehicle.
