## SIB 64 10 19

2019-11-20

## SERVICE ACTION: OPTIMIZING THE WATER DRAIN

E-Series	Model Description	Production Date
F25	X3 Sports Activity Vehicle	By VIN list
F26	X4 Sports Activity Coupe

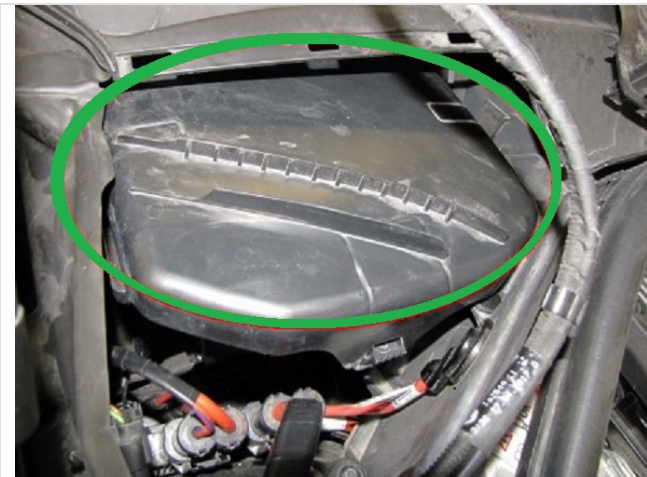
Unlock the retaining tab (black arrow) and lift the filter box lid (1) up.  
Check whether the lid has the water guiding channels (refer to the 2 photos below).

- **Yes**, no further measures are required.
- **No**, install a new lid on the filter box.

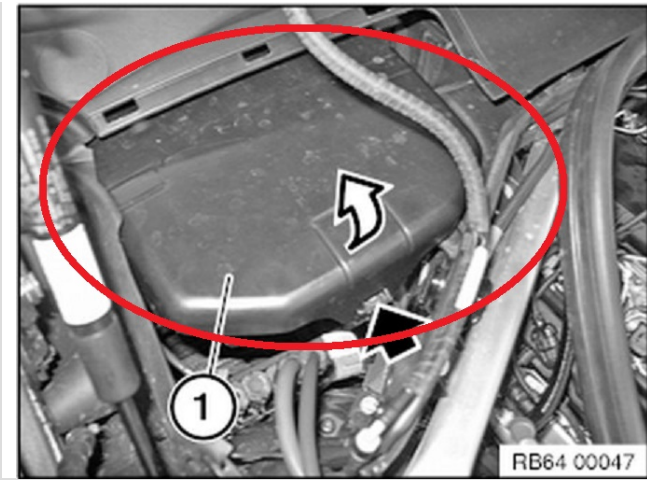
**YES** - This is a filter box lid with the integrated water guiding channels.

Do not replace this style lid.

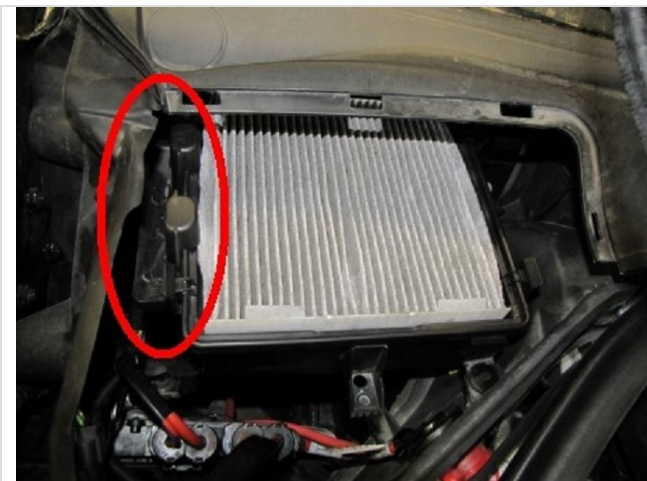
**NO**-This is a smooth filter box lid which was installed prior to July 2013 production.

**Replace this style lid.**
