SIB 65 21 19

AUDIO PLAYBACK NOT POSSIBLE

2019-11-07

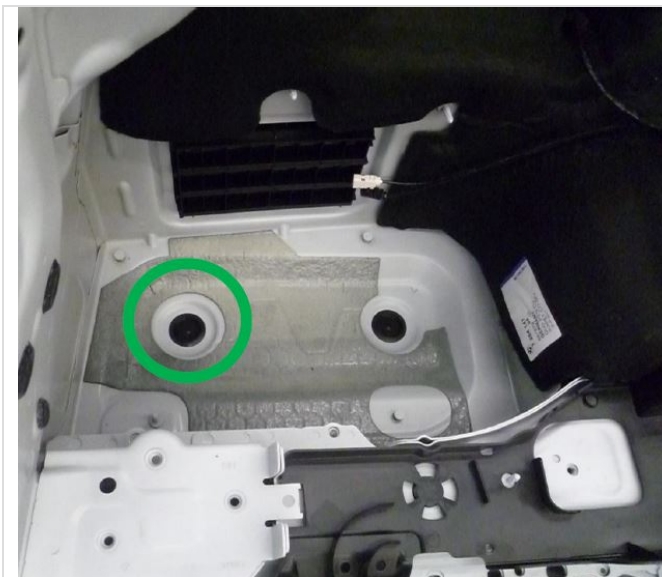
Failure of the audio amplifier due to water ingress in the luggage compartment.

Location (circled) for installation of water drainage grommet.

1. Perform a vehicle test.
2. Proceed with diagnosis of any system faults not related to the amplifier.
3. If only the amplifier has failed, then remove the amplifier as per Repair Instructions 65 12 072.
4. With the amplifier removed, install a water drainage grommet P/N 07 14 9 883 356 (aka sealing cap/seal plug) in the luggage compartment (refer to image below).
